EXPERIMENTAL RESEARCH ON SEISMIC RETROFITTING OF R/C CORNER
BEAM-COLUMN-SLAB JOINTS UPGRADED WITH CARBON FIBER
REINFORCED POLYMER (CFRP) SHEETS

İbrahim Topcu

Master of Science

Boğaziçi University

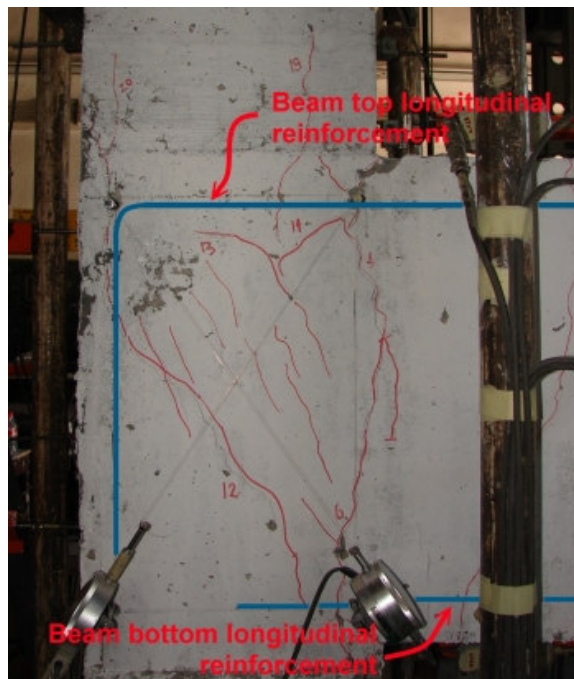
On the other hand, in the pull direction of loading, first diagonal shear crack in the joint region occurred at the drift level of 0.75% when the lateral load was 75 kN. Although diagonal shear cracks in the joint region were observed, the applied lateral load was still increasing up to drift level of 1.40% and reached the maximum of 94 kN. After that drift level, joint shear deformations governed the behavior in pull direction of loading which resulted in gradual decrease of lateral load (Figure 4.2).

Figure 4.2. Joint shear cracks of US3-C-Control at the drift level of 1.75%

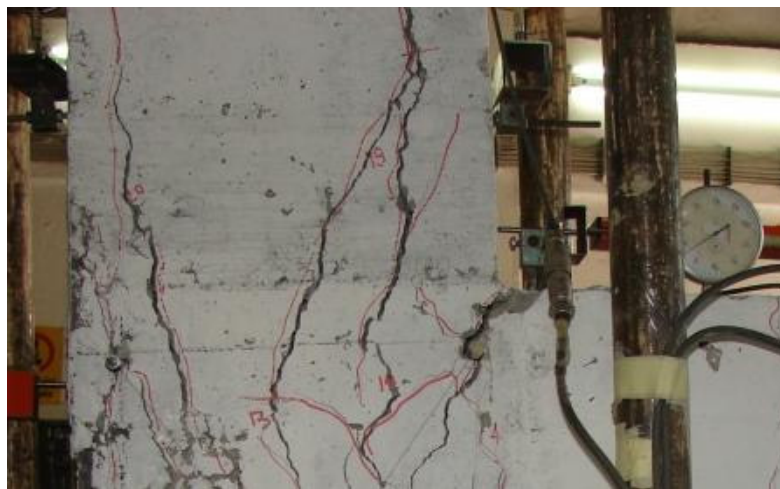
(a) Top column shear cracks

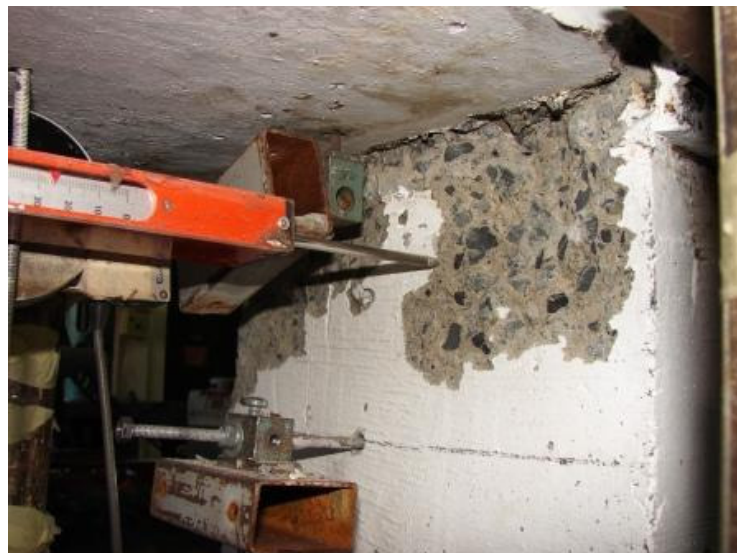
(b) Bottom column damage due to slippage

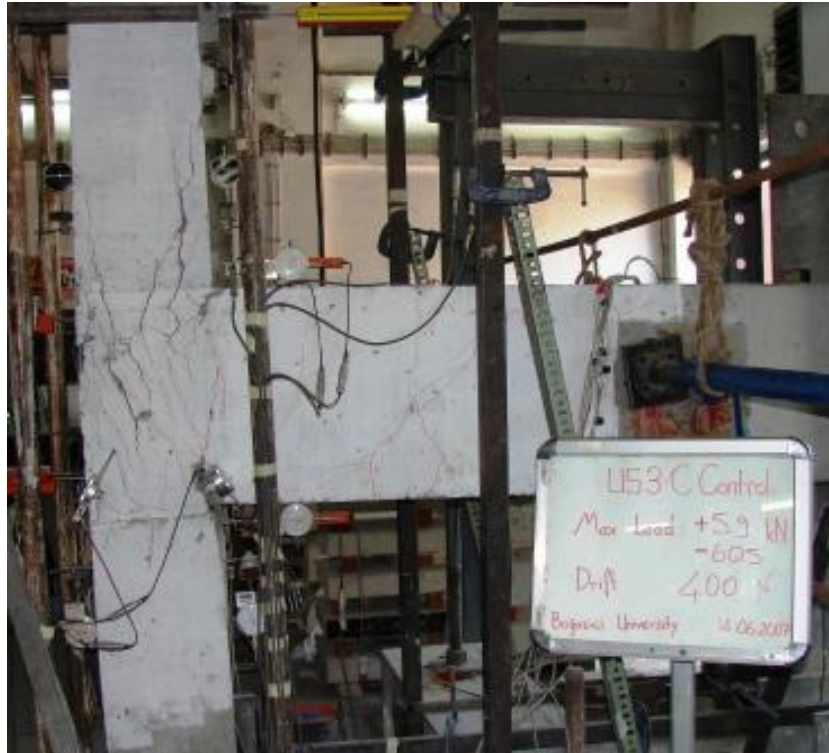
(a) Crack Pattern of US3-C-Control in pull direction of loading

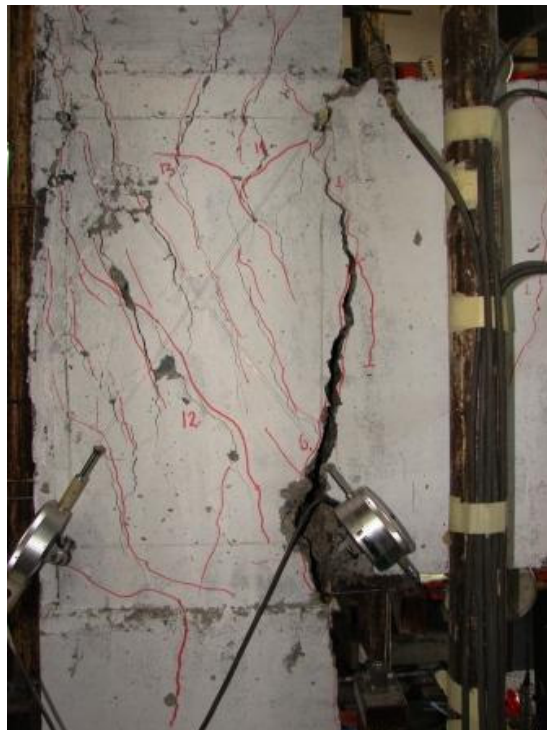
(b) Crack Pattern of US3-C-Control in push direction of loading

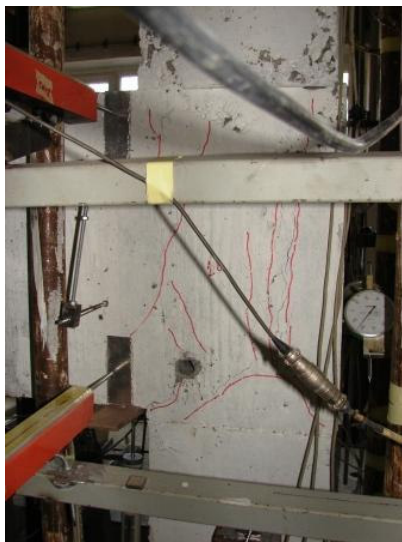
(a) Vertical cracks at the east side of the joint at 2.20% drift level (initiation of concrete spalling)

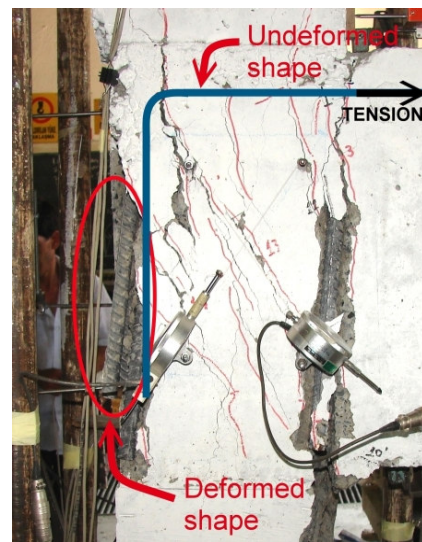
(b) Spalling due to longitudinal beam top bars slippage (3.50% drift level)

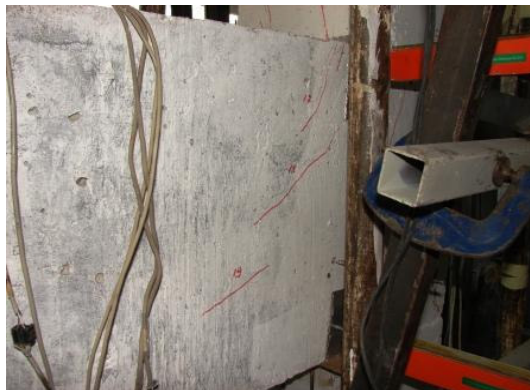
(c) Diagonal cracks at the backside of the transverse beam (2.75% drift level)

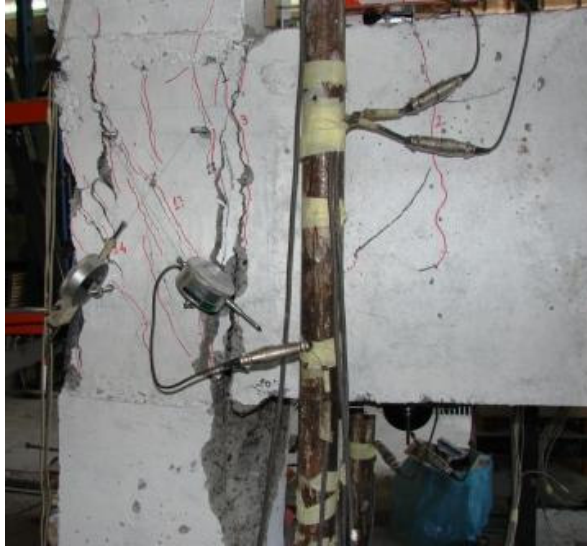
The main difference observed during the tests of the control specimens was the deformations occurred at the east side of the joint and transverse beam regions in US3-CS-Control (Figure 4.6). Diagonal cracks occurred at the east side of the transverse beam and vertical cracks occurred at the back side of the column in the joint region. As shown in Figure 4.6 (b), due to the slippage of the longitudinal beam top reinforcements, 90 degree bent region of the same reinforcements were deformed such that the east side of the joint concrete was pushed out and the concrete at this region spalled.

Figure 4.8. Failure pattern of US3-CS-Control

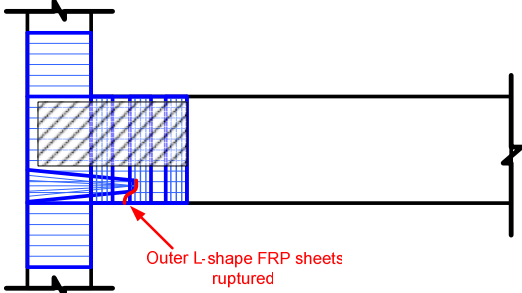
<p>Outer L-shape FRP sheets ruptured</p>

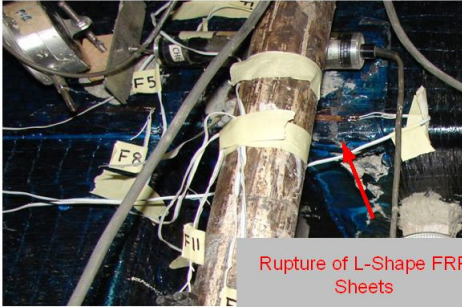
<p>Rupture of L-Shape FRP Sheets</p>

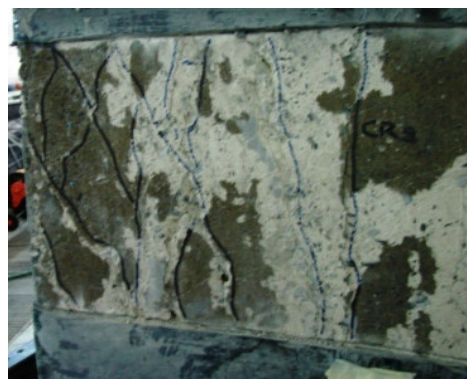
the concrete core spalled. Figure 4.11 shows the damage at the joint region under the FRP wraps. The joint shear deformation was critical for control specimens which caused the brittle failure of specimens in pull direction of loading. Therefore, one of the main objectives of CFRP retrofitting was to limit joint shear deformations. As it is shown in Figure 4.11, some diagonal shear cracks occurred at the joint region but they were not so remarkable.

Figure 4.11. Image of the joint after the removal of FRP wraps

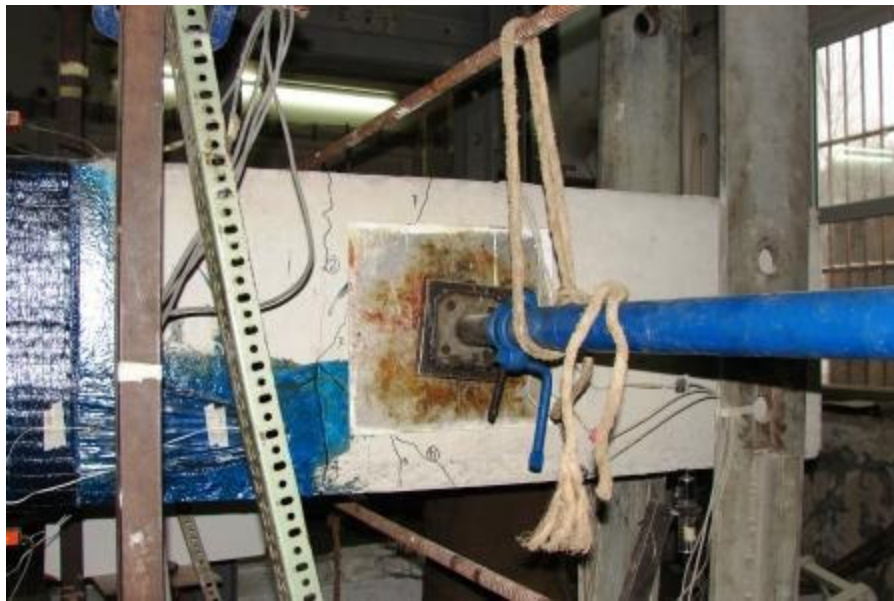
Figure 4.12. Crack pattern of US3-CS-FRP2 at the drift level of 1.40%

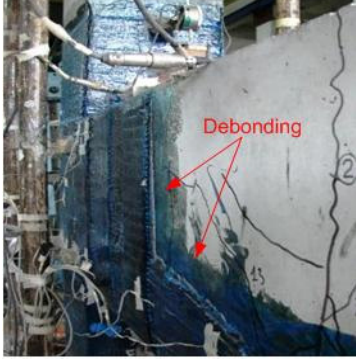
<p>(a) Debonding of the FRP belt and outer L-shape FRP sheets</p>

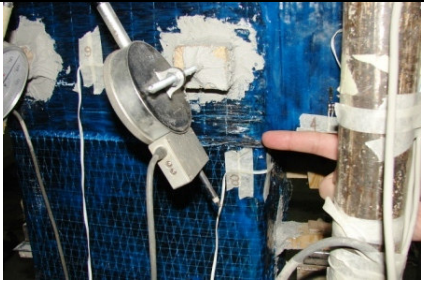
<p>(d) Rupture of outer L-shape FRP sheets and FRP belt</p>

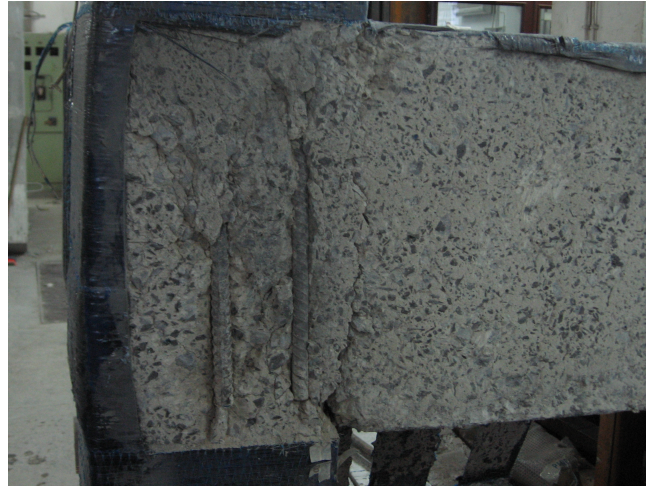
wraps. At the joint region, there were significant diagonal shear cracks and besides, the cover concrete was crushed. The damage at the joint region was more remarkable when it was compared with US3-CS-FRP1, as it can be seen in Figure 4.14.

Figure 4.14. Image of the joint after the removal of FRP wraps
