REHABILITATION OF THE DAMAGED BRICK INFILLED RC FRAMES BY CFRP  
OVERLAYS AND EPOXY INJECTION

Submitted to the Institute for Graduate Studies in  
Science and Engineering in partial fulfillment of  
the requirements for the degree of  
Master of Science

Graduate Program in Civil Engineering  
Boğaziçi University

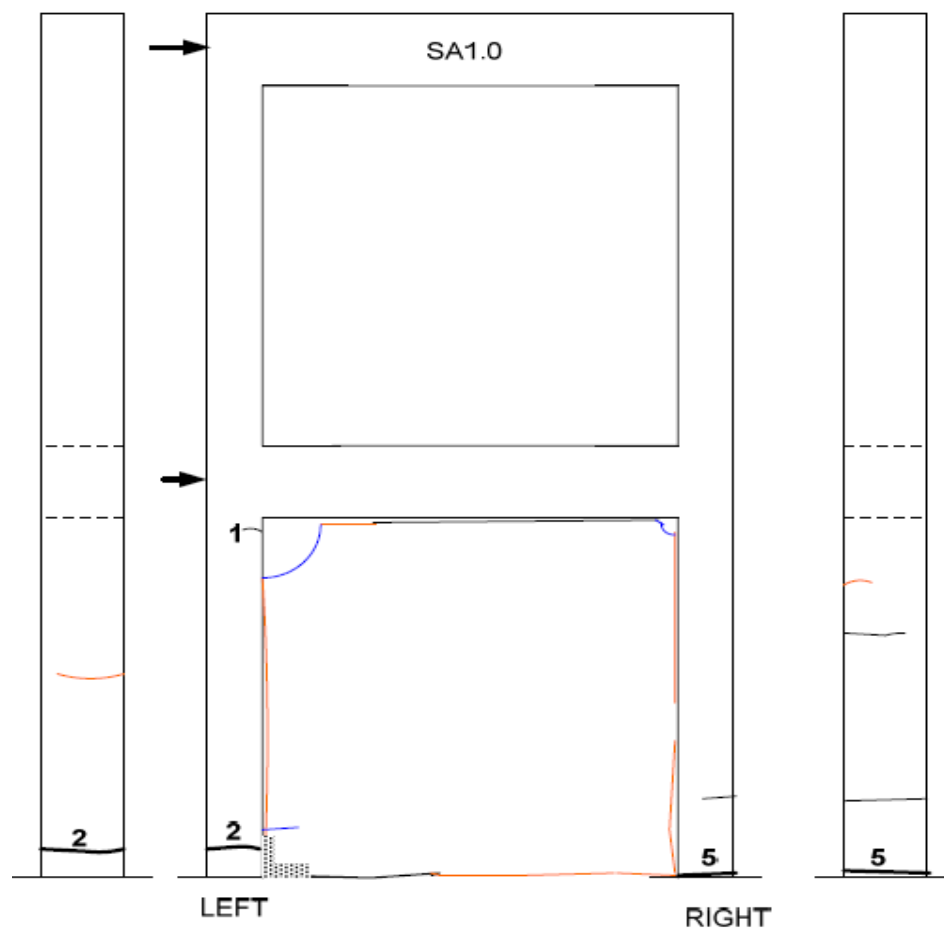
Second phase of the repairing works was the filling of the cracks on the column and beams. After the tests of Atmaca(2008), it is seen that cracks occurred especially at column beam joints and at the column foundation joints. Width of these cracks was approximately between 2 and 5 mm. Beside that there were lots of micro cracks smaller than the 0.5 mm which high strength epoxy injection method could not be used. However, these surface cracks were repaired with the help of repair mortar Sikadur 31.

Figure 3.9. Cracks distribution at specimen O1

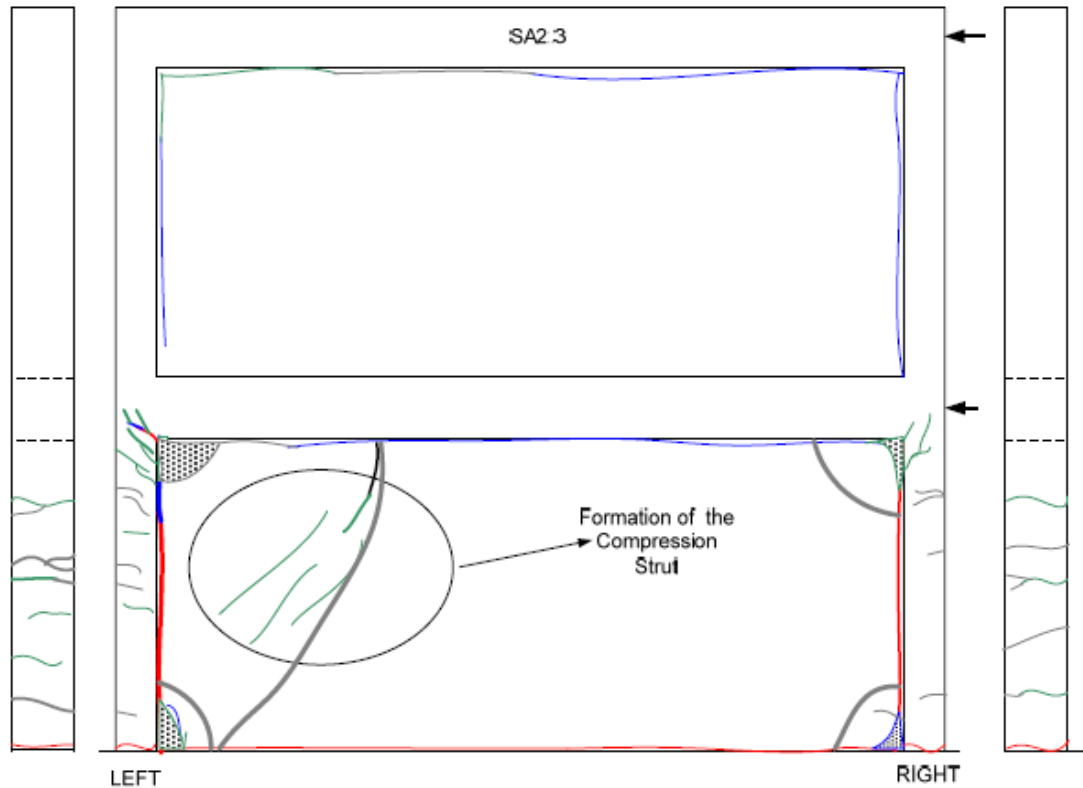
columns as illustrated at Fig 3.10. At this specimen critical cracks wider than 0.5 mm had been occurred at the first story column beam joints and foundation level of column. These 4 critical points were injected by high strength epoxy resin.

Figure 3.10. Cracks distribution at specimen O2

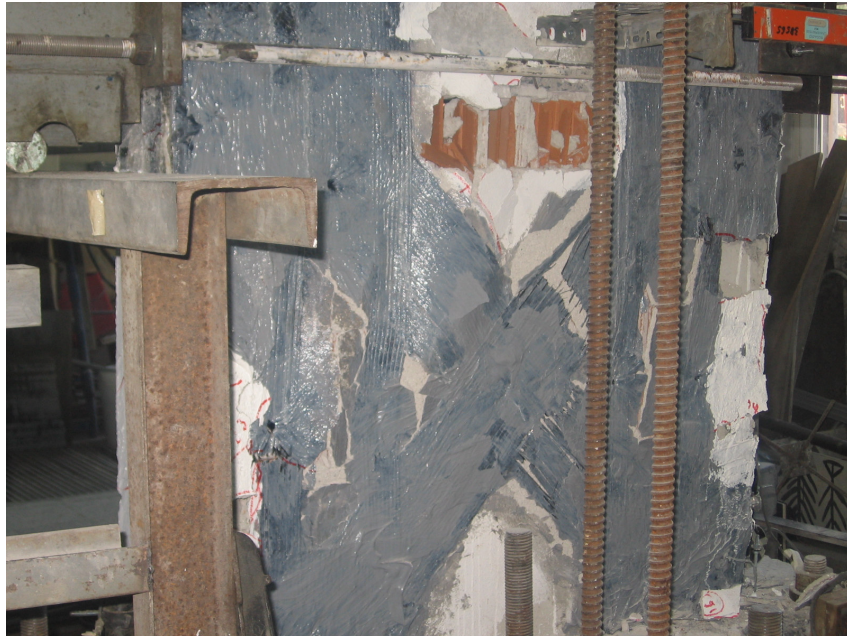
Figure 4.3. Rupture of diagonal and vertical FRP for specimen O1

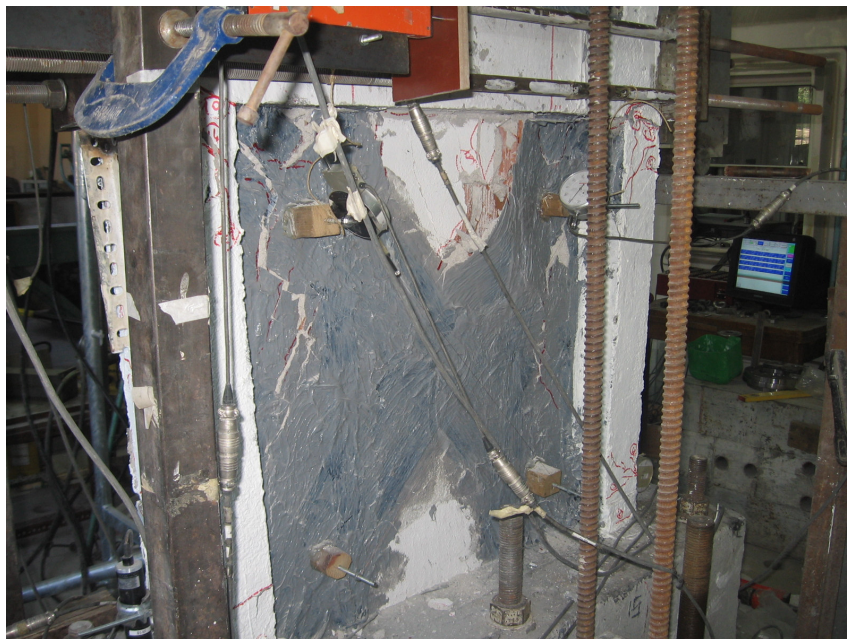
Figure 4.4. Debonding of diagonal FRP for specimen O1

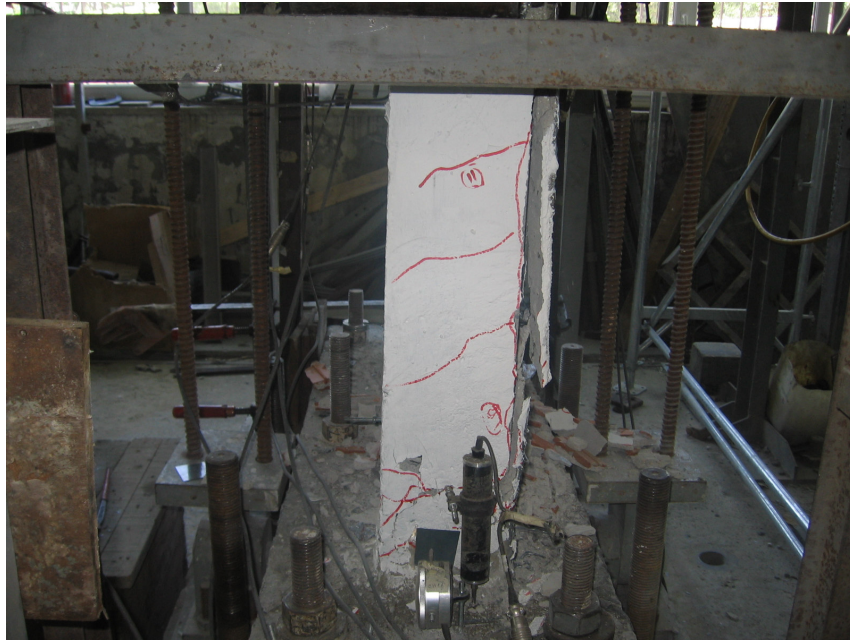
Figure 4.7. Tension cracks on right column of specimen O1

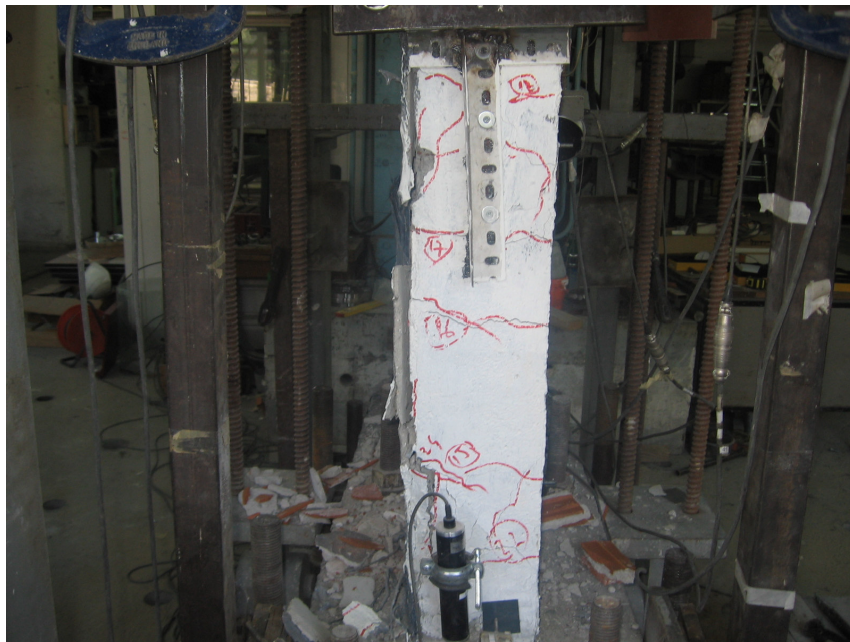
Figure 4.8. Tension cracks on left column of specimen O1

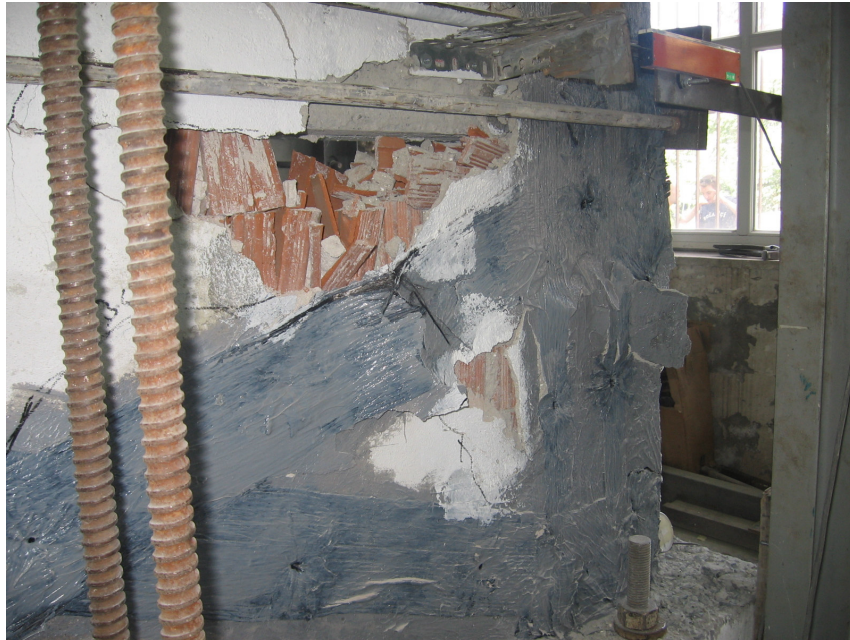
Figure 4.12. Rupturing of diagonal FRP for specimen O2

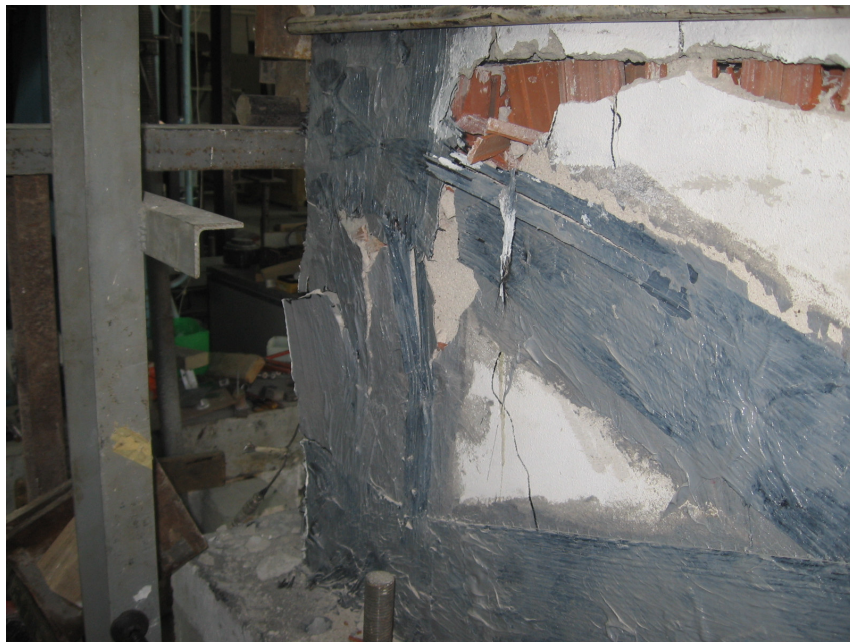
Figure 4.13. Rupturing of diagonal and vertical FRP for backside of specimen O2

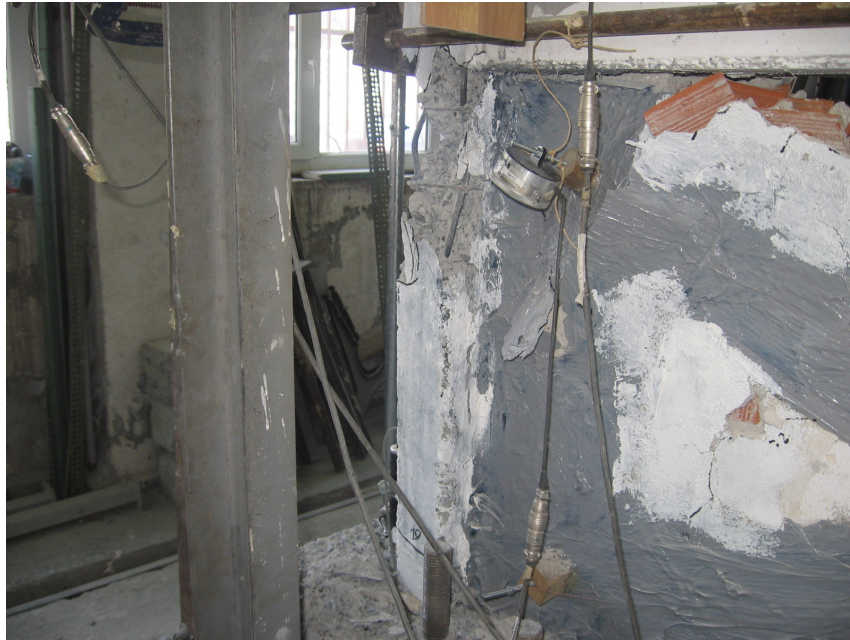
Figure 4.14. Beam-column joint failure for specimen O2

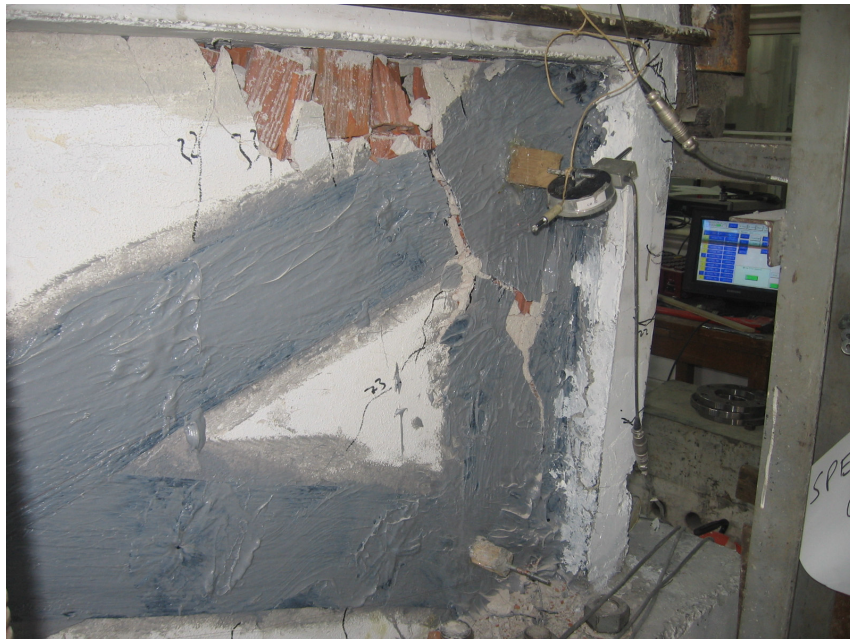
Figure 4.15. Rupturing of diagonal and vertical FRP for front side of specimen O2

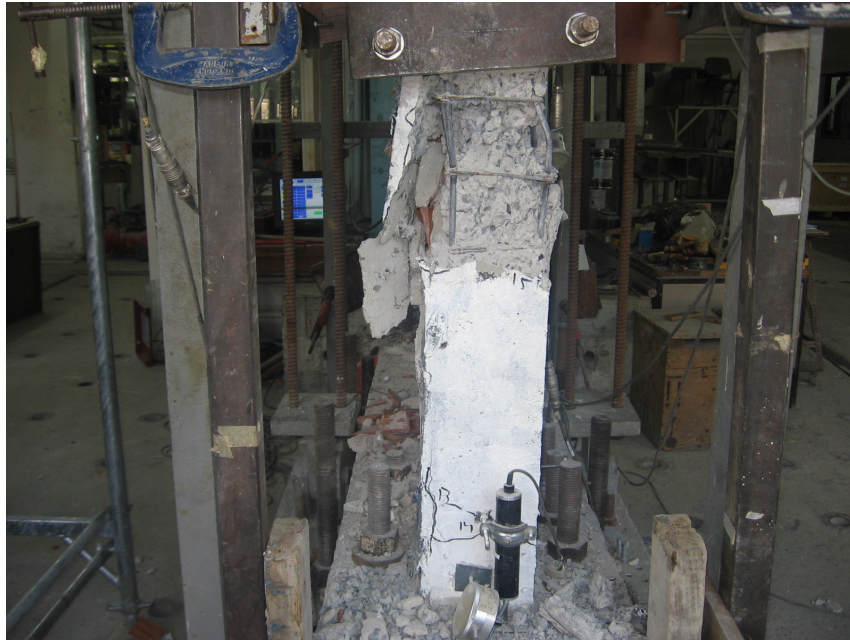
Figure 4.16. Spalling of concrete and buckling of reinforcement
