SEISMIC RETROFITTING OF RC BEAM – COLUMN JOINTS
USING COMPOSITE MATERIALS

Osman Kaya

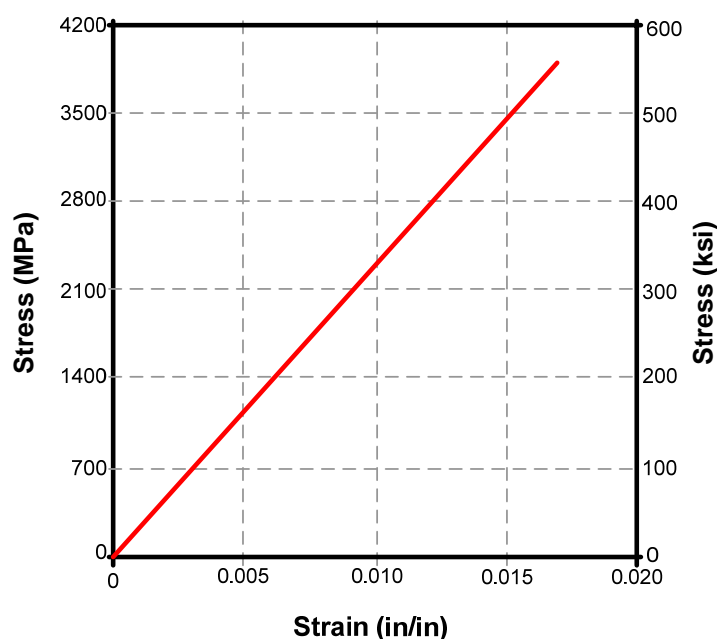
Figure 2.11. Stress-strain relations of CFRP sheets

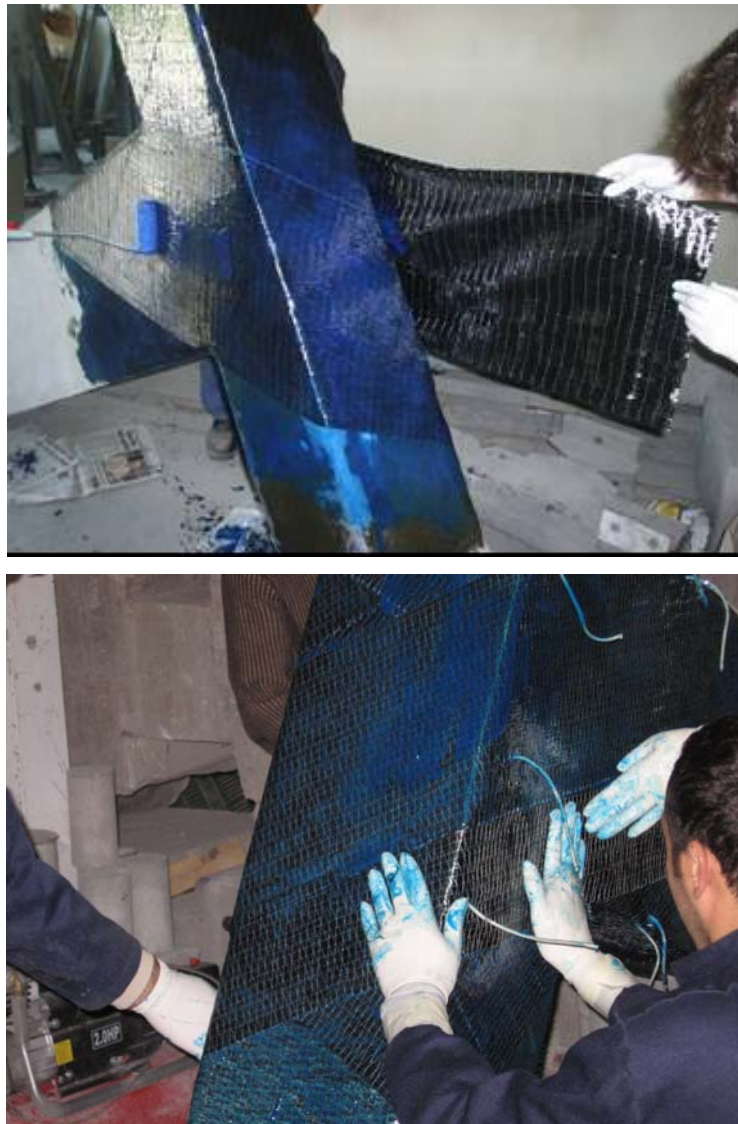
Figure 2.17. CFRP application

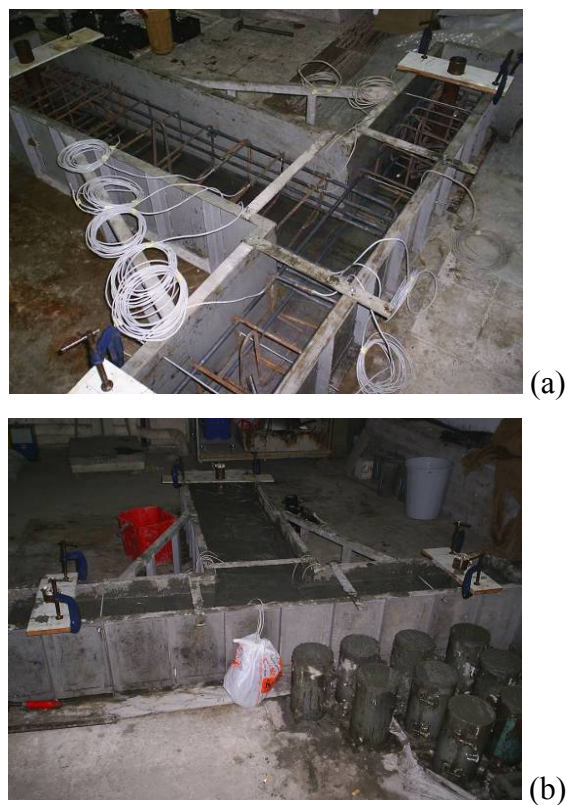
Figure 2.22. Pictures from production of Specimen TR-2 Control

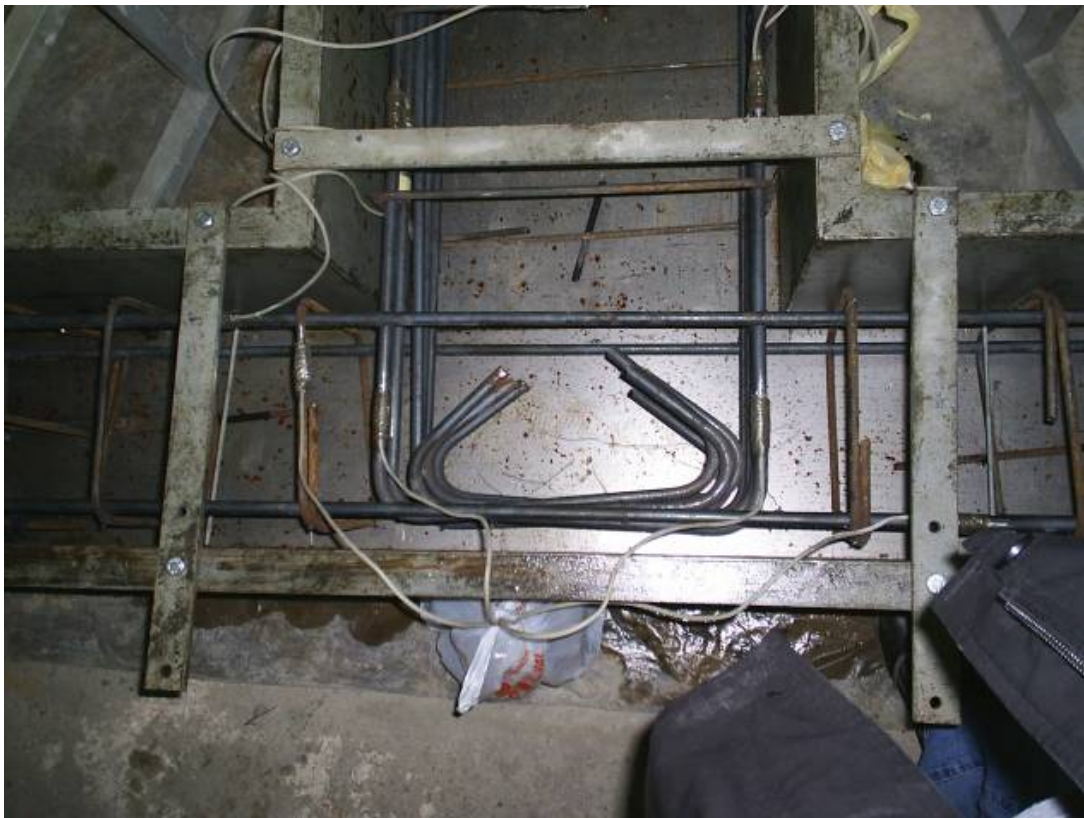
Figure 2.26. Picture of Specimen TR-4 Control produced at the laboratory

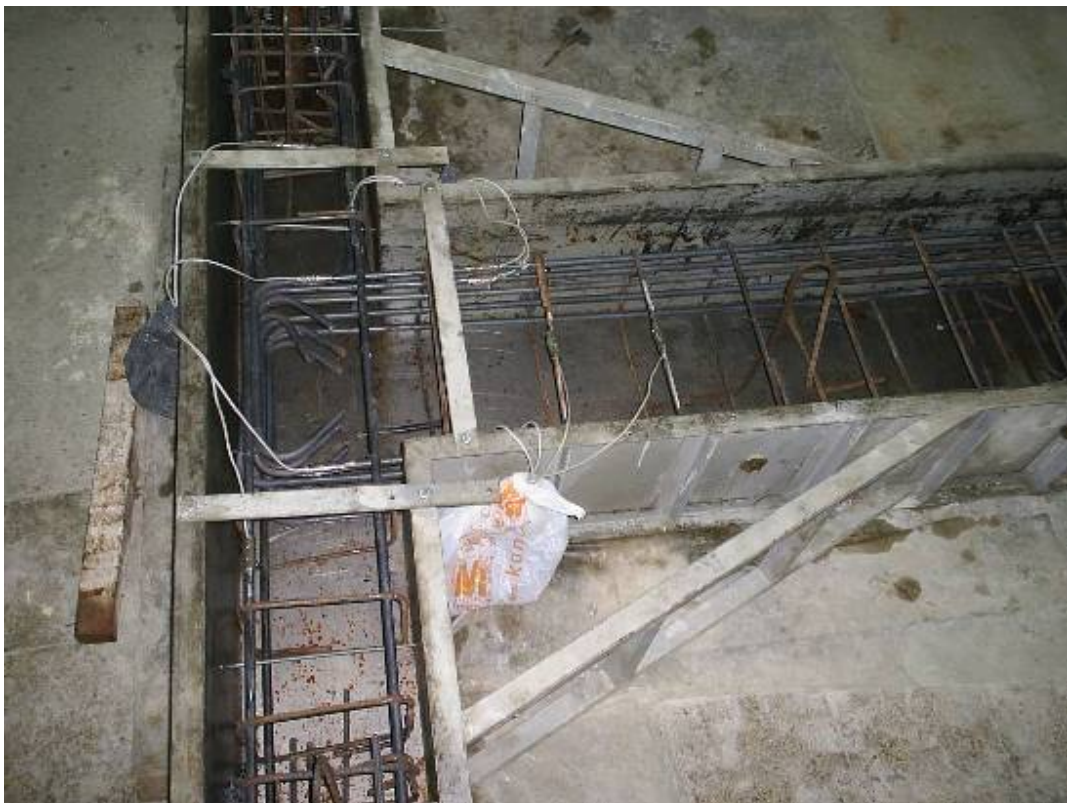
Figure 2.28. A Picture from Construction of Specimen TR-5 Control

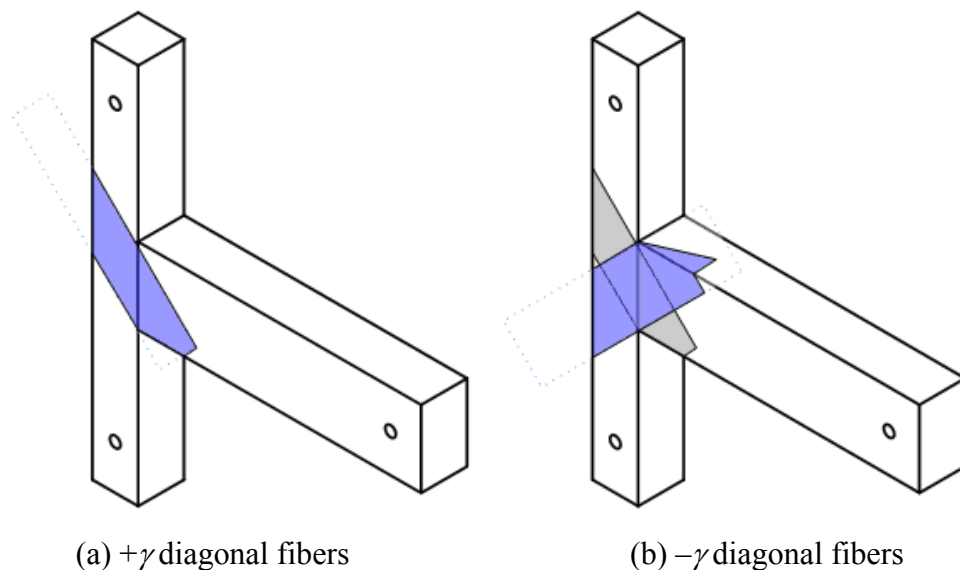
(a) $+\gamma$ diagonal fibers

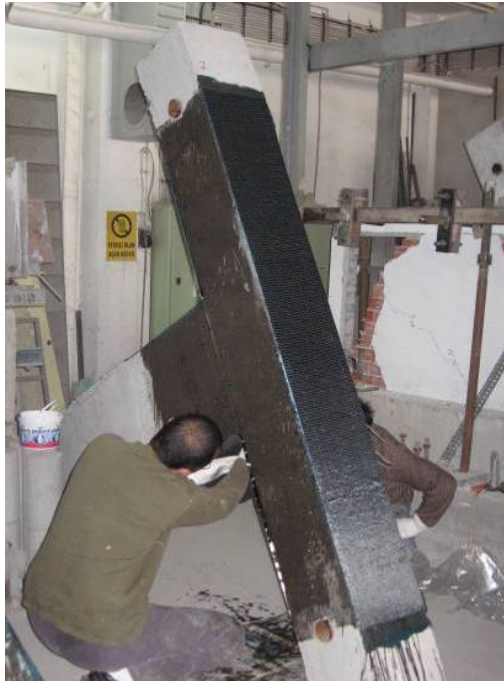
Figure 2.37. Application of L Shaped fibers

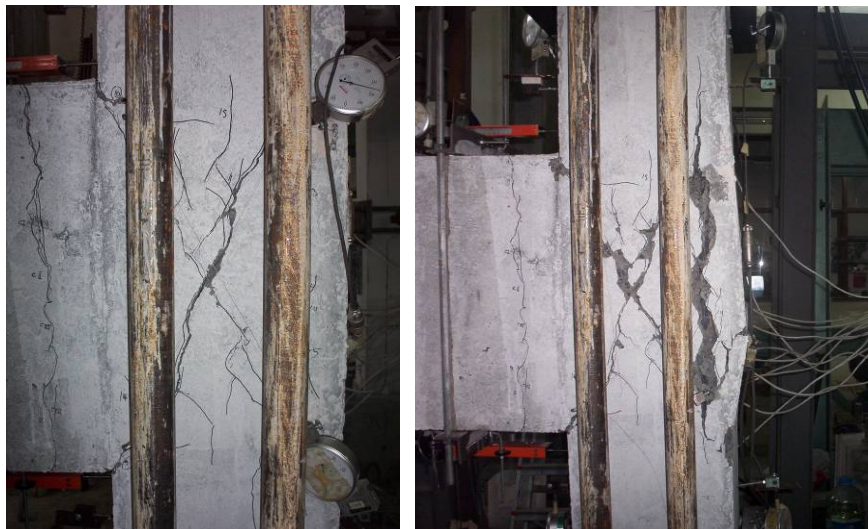
Figure 3.3. Crack pattern at 2.20% and 2.75% drift level

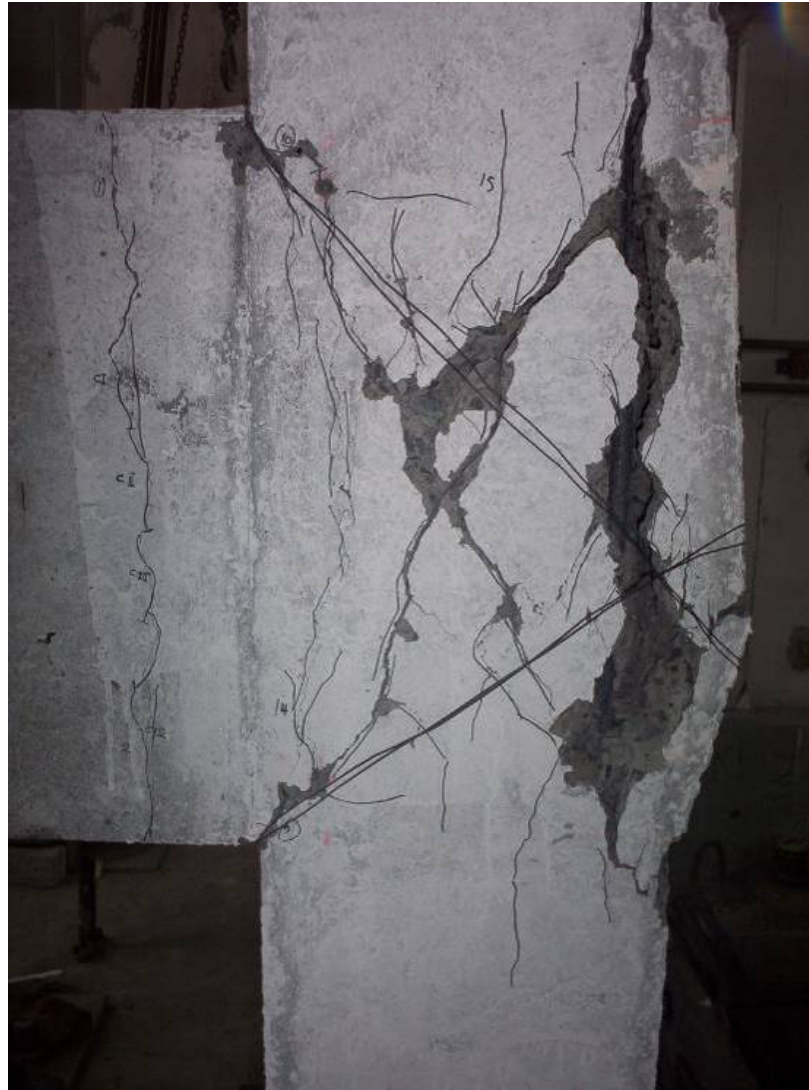
Figure 3.4. Final damage in the joint region

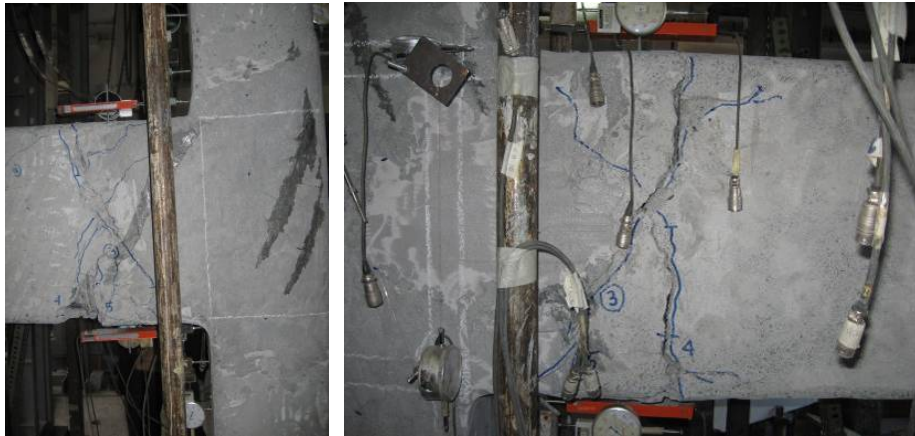
Figure 3.6. Final crack patterns of beam

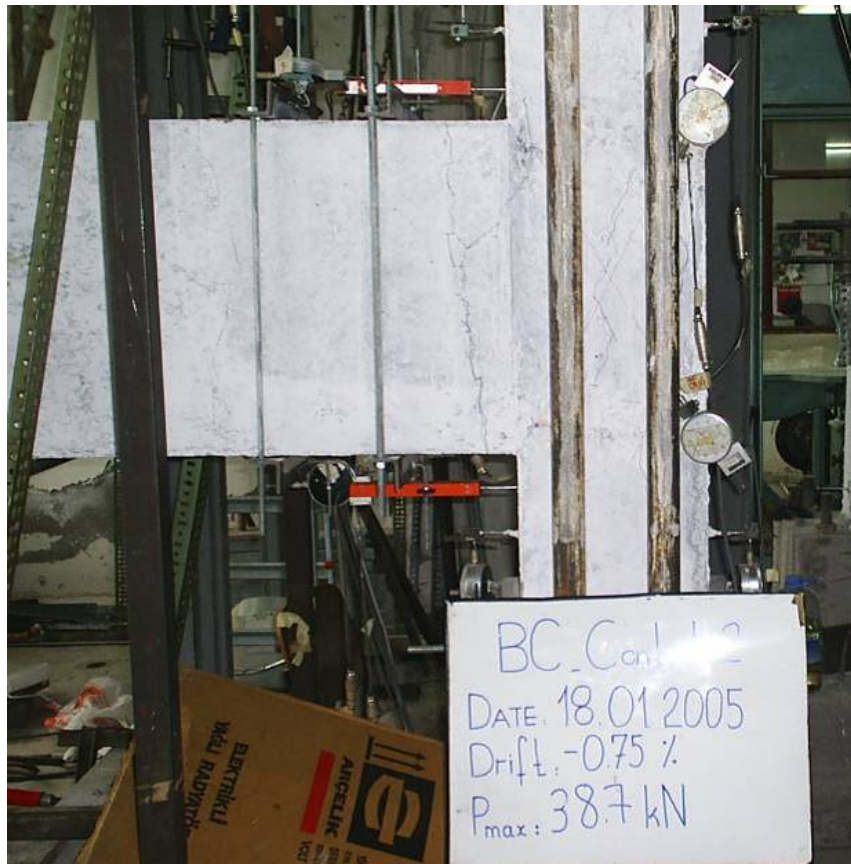
Figure 3.8. Flexural cracks up to the drift level of 0.75%

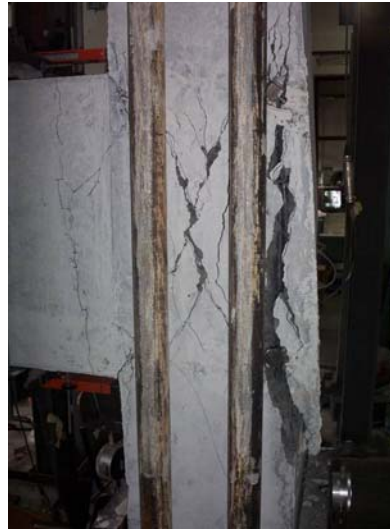
Figure 3.9. Failure mechanism of the specimen

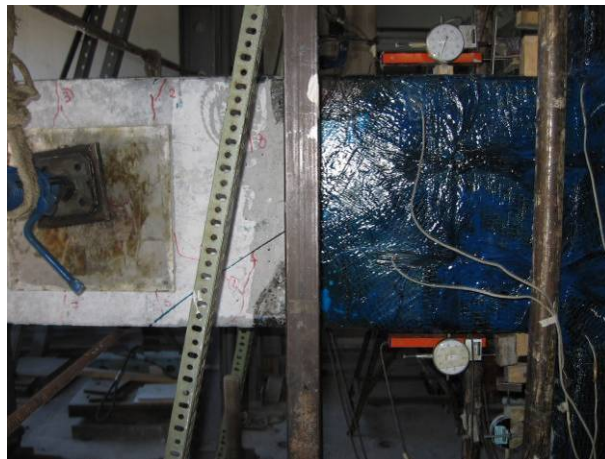
Figure 3.11. Cracks formed on the beam

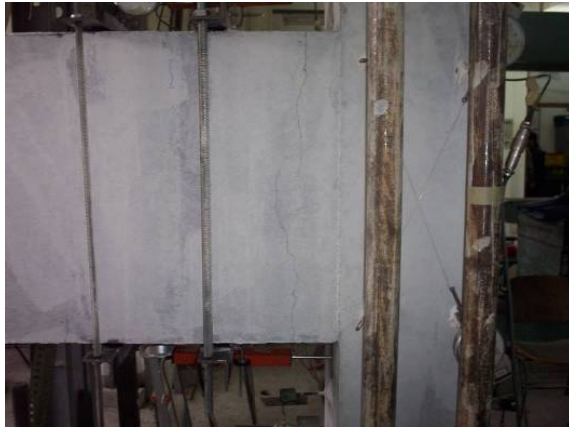
Figure 3.14. Flexural cracks up to the drift level of 0.35%

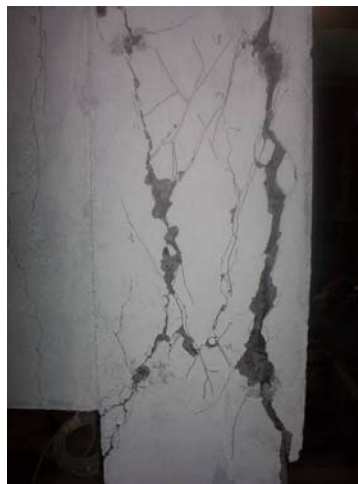
Figure 3.15. The cracks occurred in the joint region at the end of the test

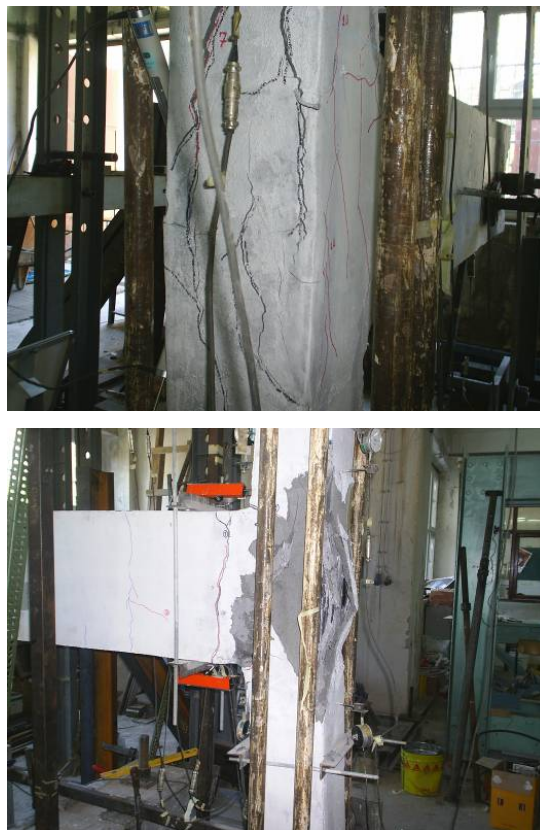
Figure 3.17. Cracking of joint region at the end of the test

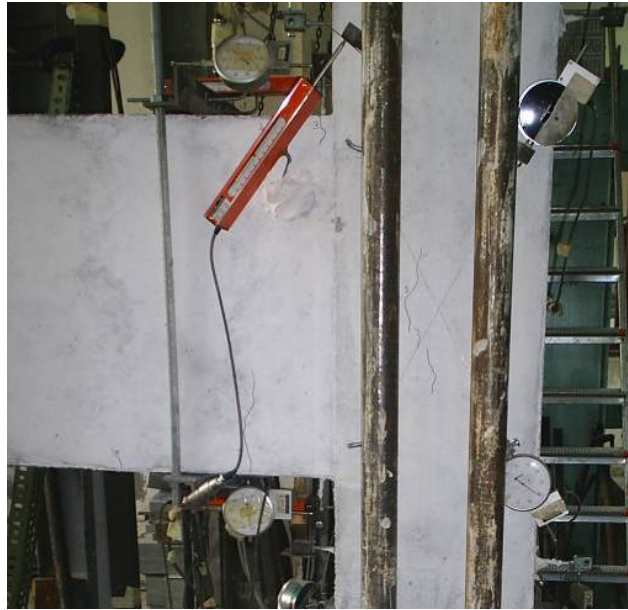
Figure 3.19. The first shear crack in the joint

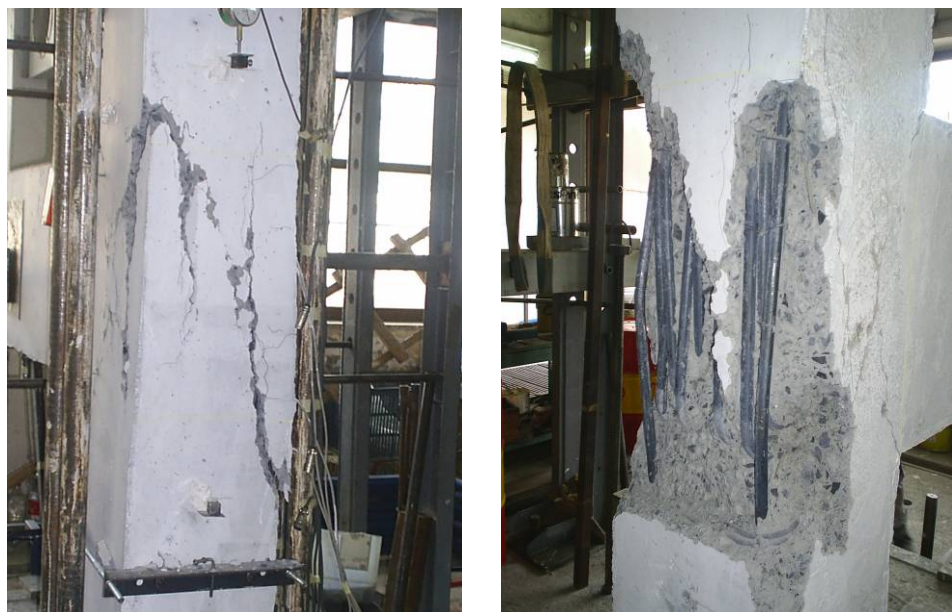
Figure 3.20. Buckling of column reinforcements

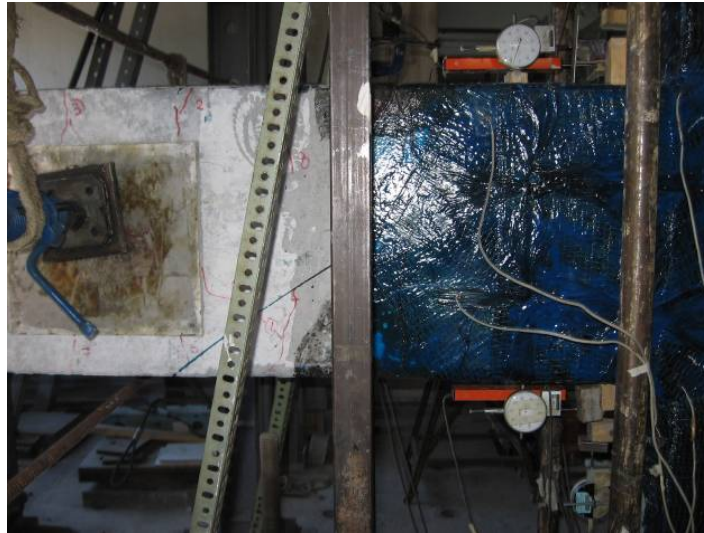
Figure 3.22. Cracks on the beam

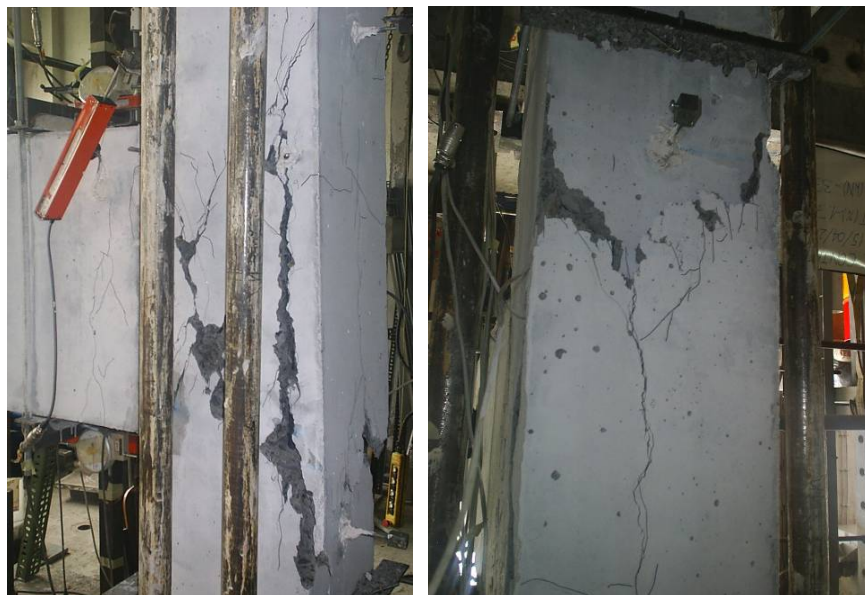
Figure 3.25. Final crack patterns of Specimen TR-5 Control

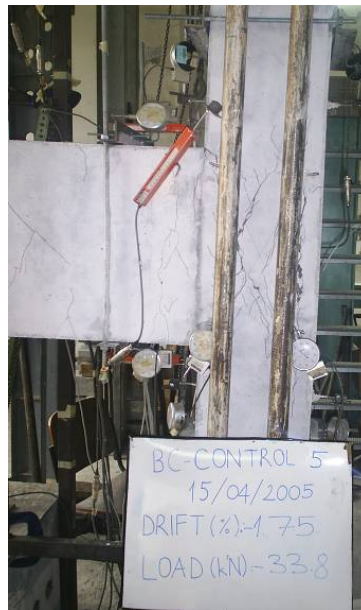
Figure 3.26. Final crack pattern of Specimen TR-5 Control

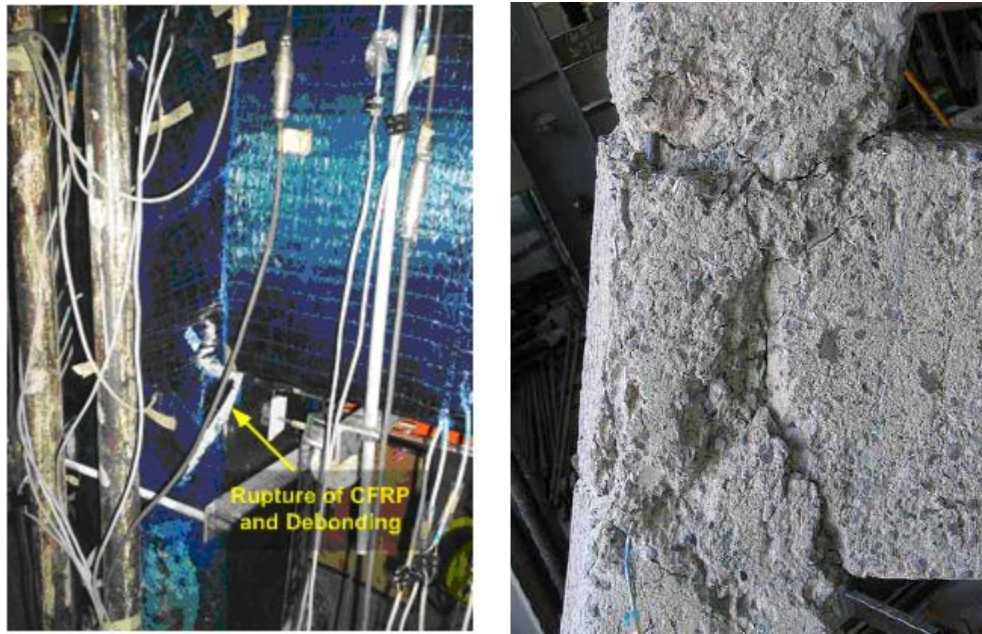
Figure 3.28. Rupture of CFRP and crack pattern of Specimen TR-5-FRP-1

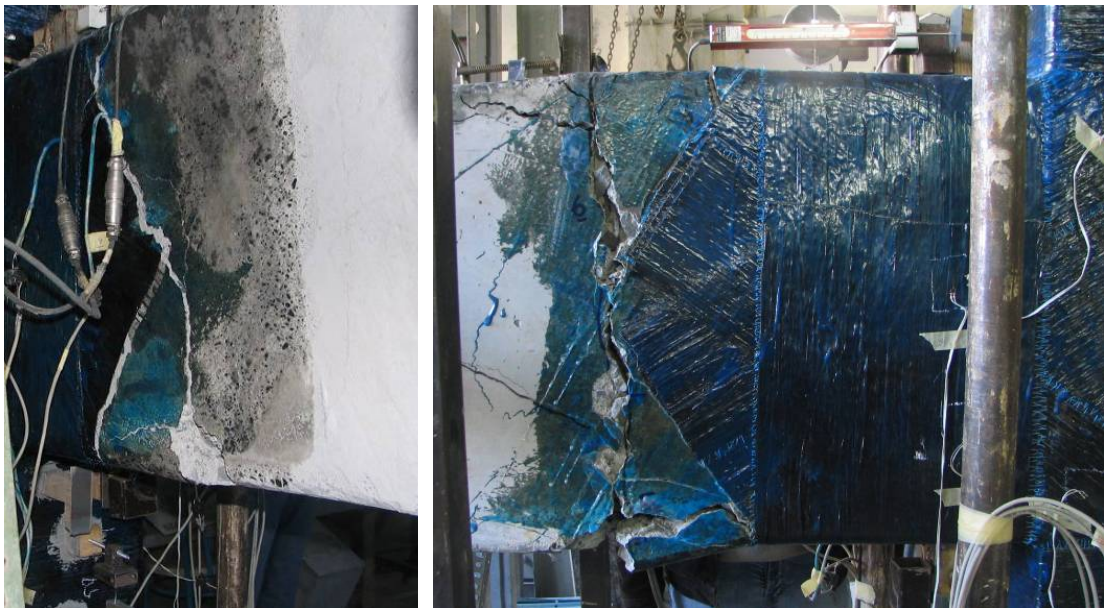
Figure 3.30. Debonding and beam hinging of Specimen TR-5-FRP-2

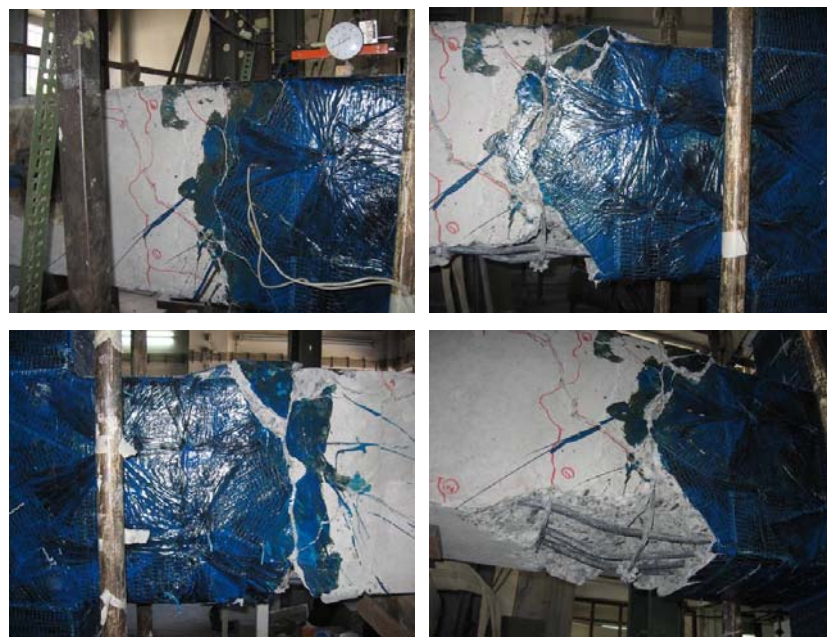
Figure 3.32. Debonding and beam hinging of Specimen TR-5-FRP-3

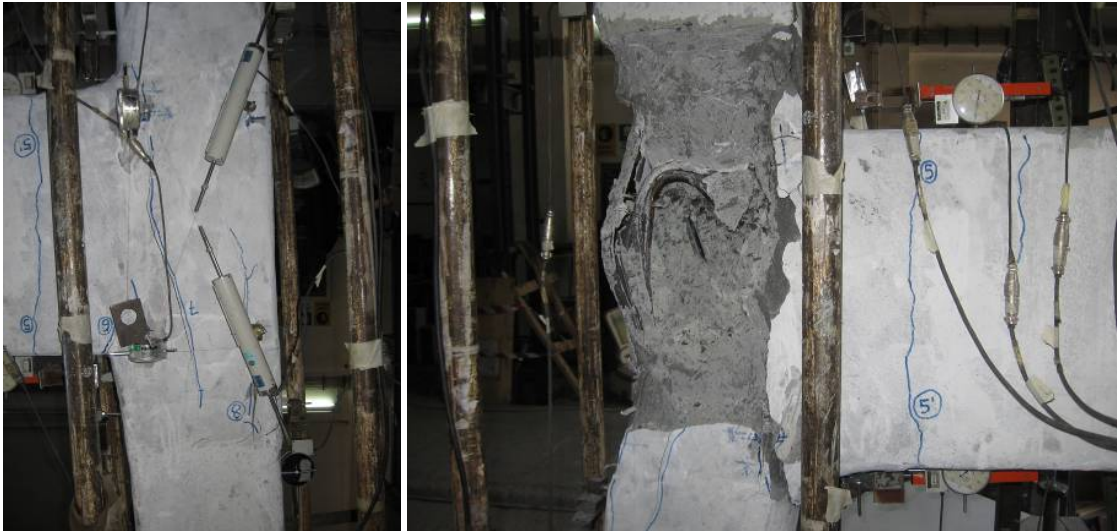
Figure 3.35. Damages of Specimen TR-5-R

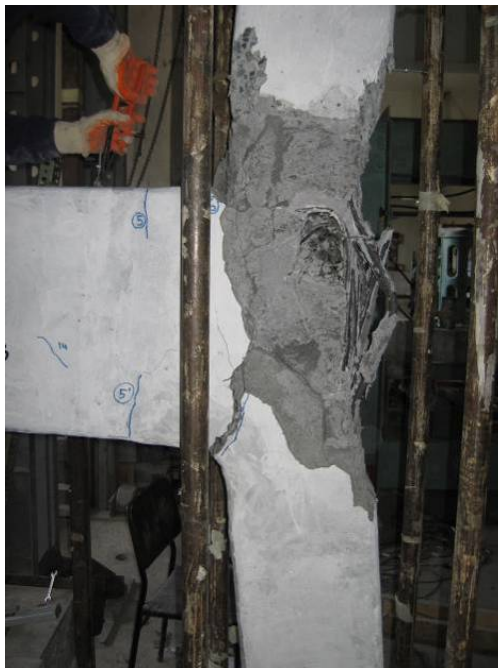
Figure 3.36. Damages of Specimen TR-5-R

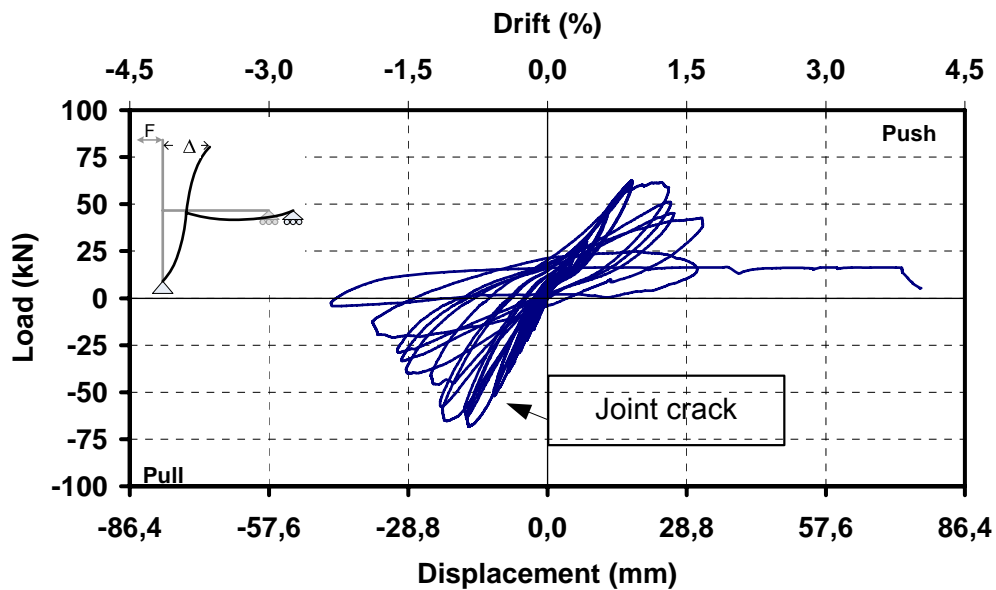
Figure 3.37. Lateral load versus top displacement for Specimen TR-5-R

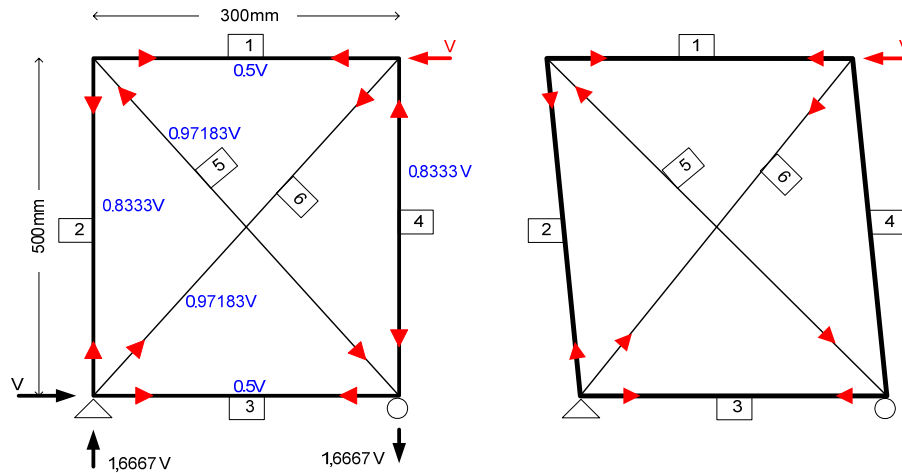
Figure 4.9. Forces acting on joint region and deformed shapes

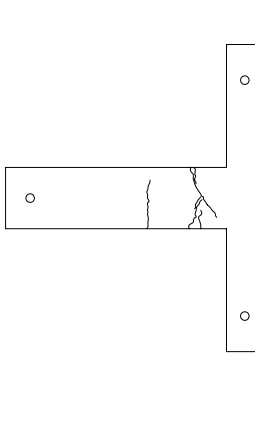
| Drift (%) | Observations | Crack Patterns |
|---|--|---|
| 1.00 | Max lateral load :(+) 54.16 kN (Push) :(-) 66.00 kN (Pull) Crack-3: extended about 100 mm. Crack-4: Flexural crack was formed at the bottom of the beam. It is located at about 290 mm away from the column face and its length was 100 mm. Crack-5: Flexural crack developed at the bottom of the beam. It is located at about 290 mm away from the column face and its length was 100 mm. | |

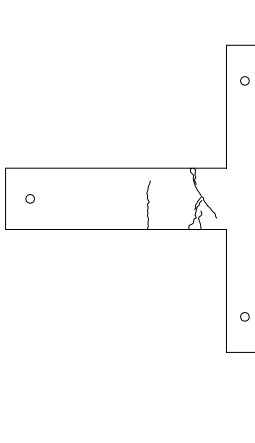
| Drift (%) | Observations | Crack Patterns |
|---|--|---|
| 1.40 | Max lateral load :(+) 70.08 kN (Push) :(-) 70.00 kN (Pull) Crack-3: doubled at the top of the beam. And extended from the bottom. Crack-5: doubled at the bottom. Crack-4 extended. Crack-2: the width of the crack was reached 5 mm. Spalling of concrete observed around Crack 2 and Crack 3. | |

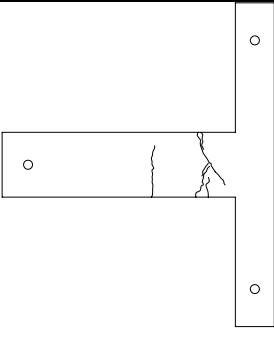
| Drift (%) | Observations | Crack Patterns |
|---|---|---|
| 1.75 | <p>Max lateral load :(+)75.85 kN (Push) :(-)69.00 kN (Pull)</p> <p>No new cracks observed. Existing cracks were extended.</p> | |

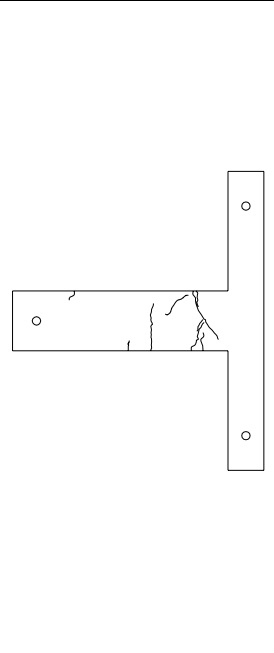
| Drift (%) | Observations | Crack Patterns |
|---|---|---|
| 2.20 | <p>Max lateral load :(+)81.00 kN (Push) :(-)66.00 kN (Pull)</p> <p>Crack-6: flexural crack was formed at the bottom, 920 mm away from the column face.</p> <p>Crack-7: Flexural crack developed in push direction at the end of the beam, near to the roller support.</p> <p>Crack-5: widened</p> <p>Crack-8: Diagonal crack appeared at the top side of the beam, 500 mm away from the column. And joined with Crack 3: Concrete crushing observed near to the Crack-7</p> <p>Crack-3: widened and the reinforcement can be seen from the crack</p> | |

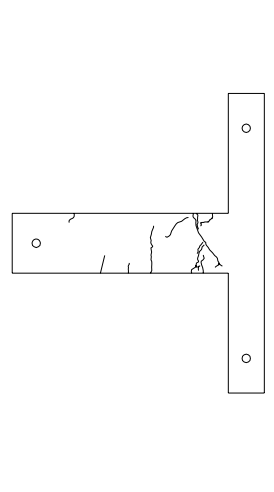
| Drift (%) | Observations | Crack Patterns |
|---|---|---|
| 2.75 | <p>Max lateral load :(+)80.00 kN (Push) :(-)63.20 kN (Pull)</p> <p>Repairing material was crushed at the joint region.</p> <p>Crack-3: Doubled and extended towards joint. Width of crack was 3.5 mm.</p> <p>Crack-7: Width of crack was 3 mm.</p> <p>The spalling of cover concrete observed at the region of roller support.</p> <p>Crack-9: Flexural crack occurred at bottom of the beam, 1020 mm away from the column.</p> | |

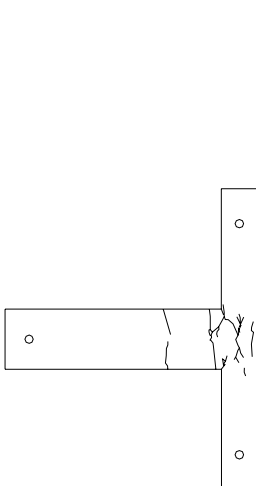
| Drift (%) | Observations | Crack patterns |
|---|--|---|
| 1.40 | <p>Max lateral load :(+)37.00 kN (Push) :(-)41.00 kN (Pull)</p> <p>Crack-8: crack width is 1.2 mm The width of crack at the core was 0.8 mm</p> <p>Crack-6: crack width is 1.2 mm The width of crack at the core was 1.2 mm</p> <p>Crack-13: crack width is 1.6 mm.</p> <p>Crack-6: crack width is 1.6 mm</p> <p>Crack-9: 85 mm extended towards the joint core</p> <p>Crack-15: extended 50 mm</p> <p>Cover spilled at the joint core</p> <p>Crack-18: formed at the right side of the column.</p> <p>Crack-13: crack width: 1.8 mm.</p> <p>Crack-8: crack width 1.6 mm.</p> | |

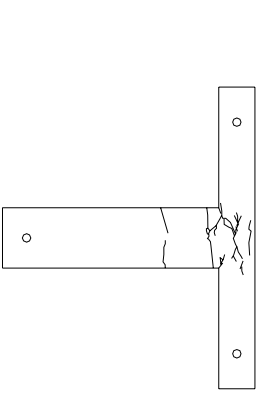
| Drift (%) | Observations | Crack patterns |
|---|--|---|
| 1.75 | <p>Max lateral load :(+)33.80 kN (Push) :(-)34.70 kN (Pull)</p> <p>Crack-6: crack width: 2 mm.</p> <p>Crack-13: crack width: 2.5 mm.</p> <p>Crack-19: vertical crack formed at the joint core</p> <p>Crack-13: doubled and extended 70 + 45 mm upward.</p> <p>Crack-6: 150 mm extended upward</p> <p>Concrete covers at the corner was spilled</p> <p>Crack-19 & Crack-12: joined</p> | |

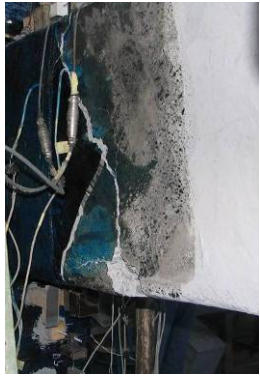
| Drift (%) | Observations | Pictures |
|---|--|---|
| 1.75 | Max lateral load :(+) 69.00 kN (Push) :(-) 91.70 kN (Pull) Debonding of diagonal fibers at the end of wrapped area. Crack-1: Diagonal cracks were formed at the bottom of the beam next to the Crack-1 , Diagonal cracks occurred between the Crack 1 and Crack 5. Crack-1 and Crack-8: are joined. | |

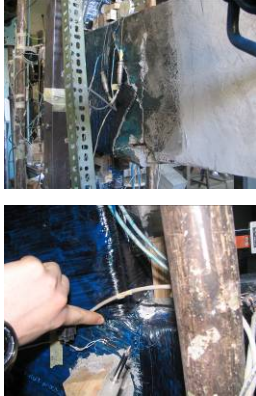
| Drift (%) | Observations | Pictures |
|---|---|---|
| 3.50 | <p>Max lateral load :(+) 69.70 kN (Push) :(-) 92.30 kN (Pull)</p> <p>CFRP sheets were ruptured at the top corner of beam column interface</p> <p>Concrete was totally crushed and beam bottom reinforcements were buckled at the hinged region.</p> | |

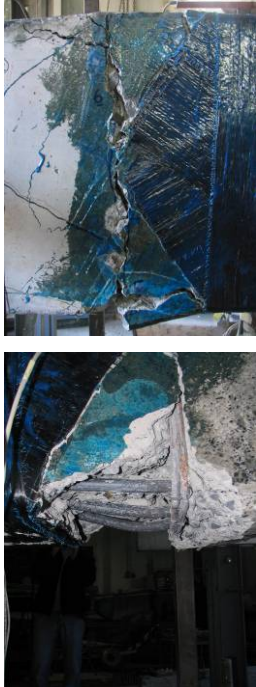
| Drift (%) | Observations | Pictures |
|---|---|---|
| 4.00 | <p>Max lateral load :(+) 67.00 kN (Push) :(-) 80.00 kN (Pull)</p> | |

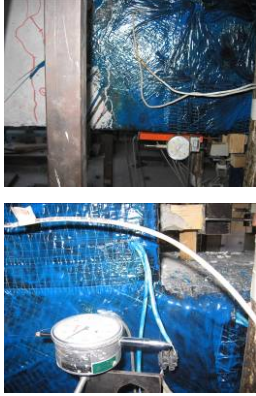
| Drift (%) | Observations | Pictures |
|---|---|---|
| 2.20 | Max lateral load :(+) 71.90 kN (Push) :(-) 98.00 kN (Pull) The crack width was reached almost 4mm at the bottom of the beam (Crack 1) The diagonal CFRP layers were started to rupture from the corner but due to patching they do not propagate. | |

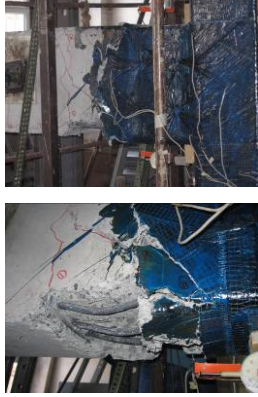
| Drift (%) | Observations | Pictures |
|---|---|--|
| 3.50 | Max lateral load :(+) 71.00 kN (Push) :(-) 94.10 kN (Pull) The concrete was spalled and the reinforcement were buckled at the bottom of the beam. | |
