STRENGTHENING OF BRICK INFILLED RC FRAMES WITH DIFFERENT ASPECT  
RATIOS BY MEANS OF CFRP OVERLAYS

Submitted to the Institute for Graduate Studies in  
Science and Engineering in partial fulfillment of  
the requirements for the degree of  
Doctor of Philosophy

Graduate Program in Civil Engineering  
Boğaziçi University

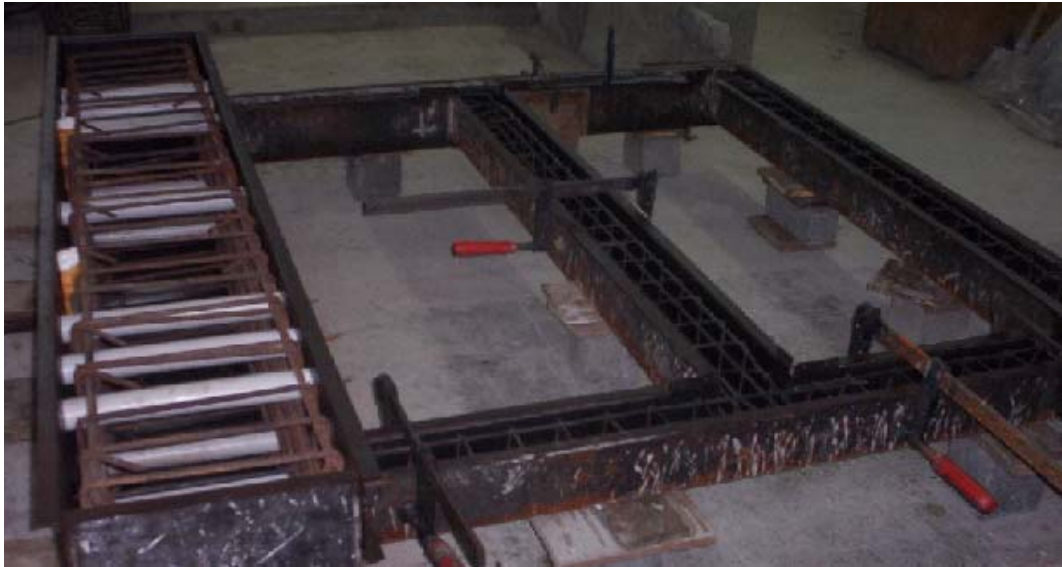
Figure 3.8. Picture of reinforcement cage prior to casting of concrete.

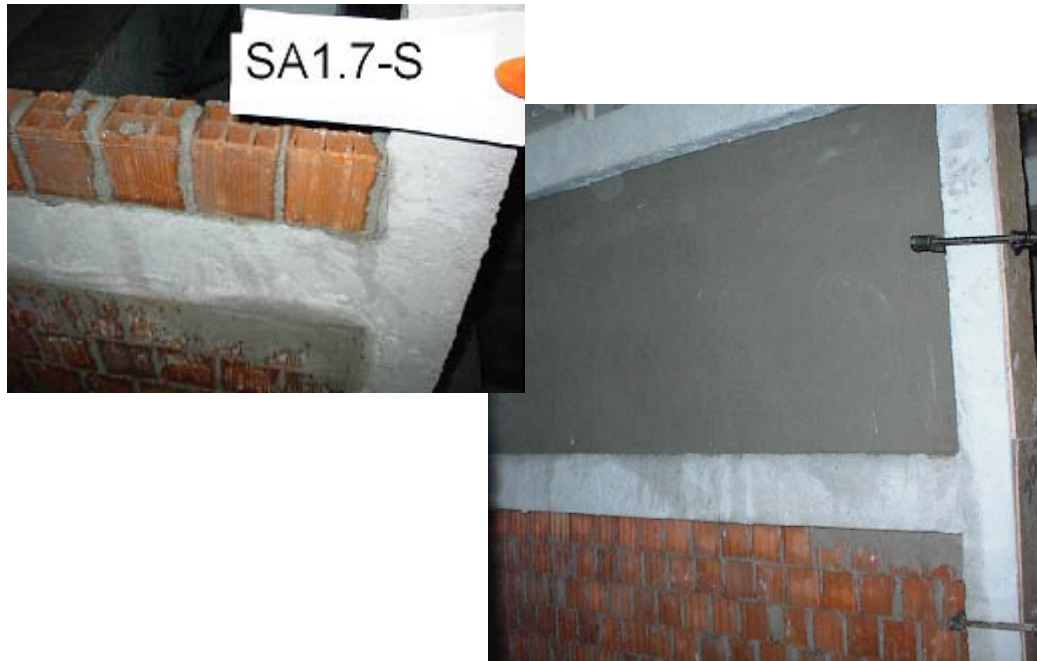
Figure 3.9. Laying of bricks and plastering of the brick wall

The third process was laying the bricks and plastering the specimen. Bricks were flush to one side of the specimens. While they were laying, the cores were kept vertical to the bed joints. A professional mason was hired to lay the bricks so they would correspond to brickwork laid in practice. The thickness of the bricks was about 70 mm. The pictures related to this phase are given in Figure 3.9. The thickness of the plaster was between 8.5 mm-10 mm. In order to have an identical plaster thickness, long narrow strips of wood were used.

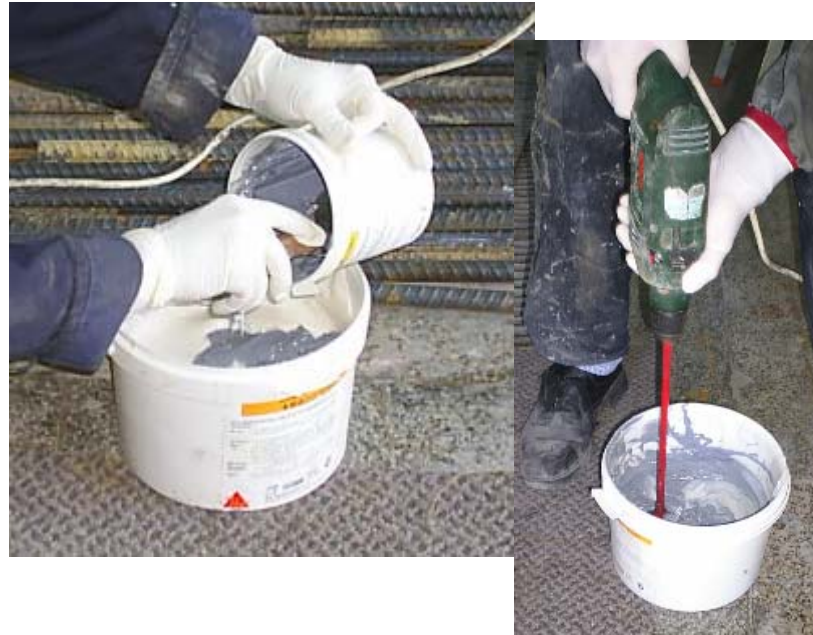
Figure 3.11. Preparation of the epoxy resin

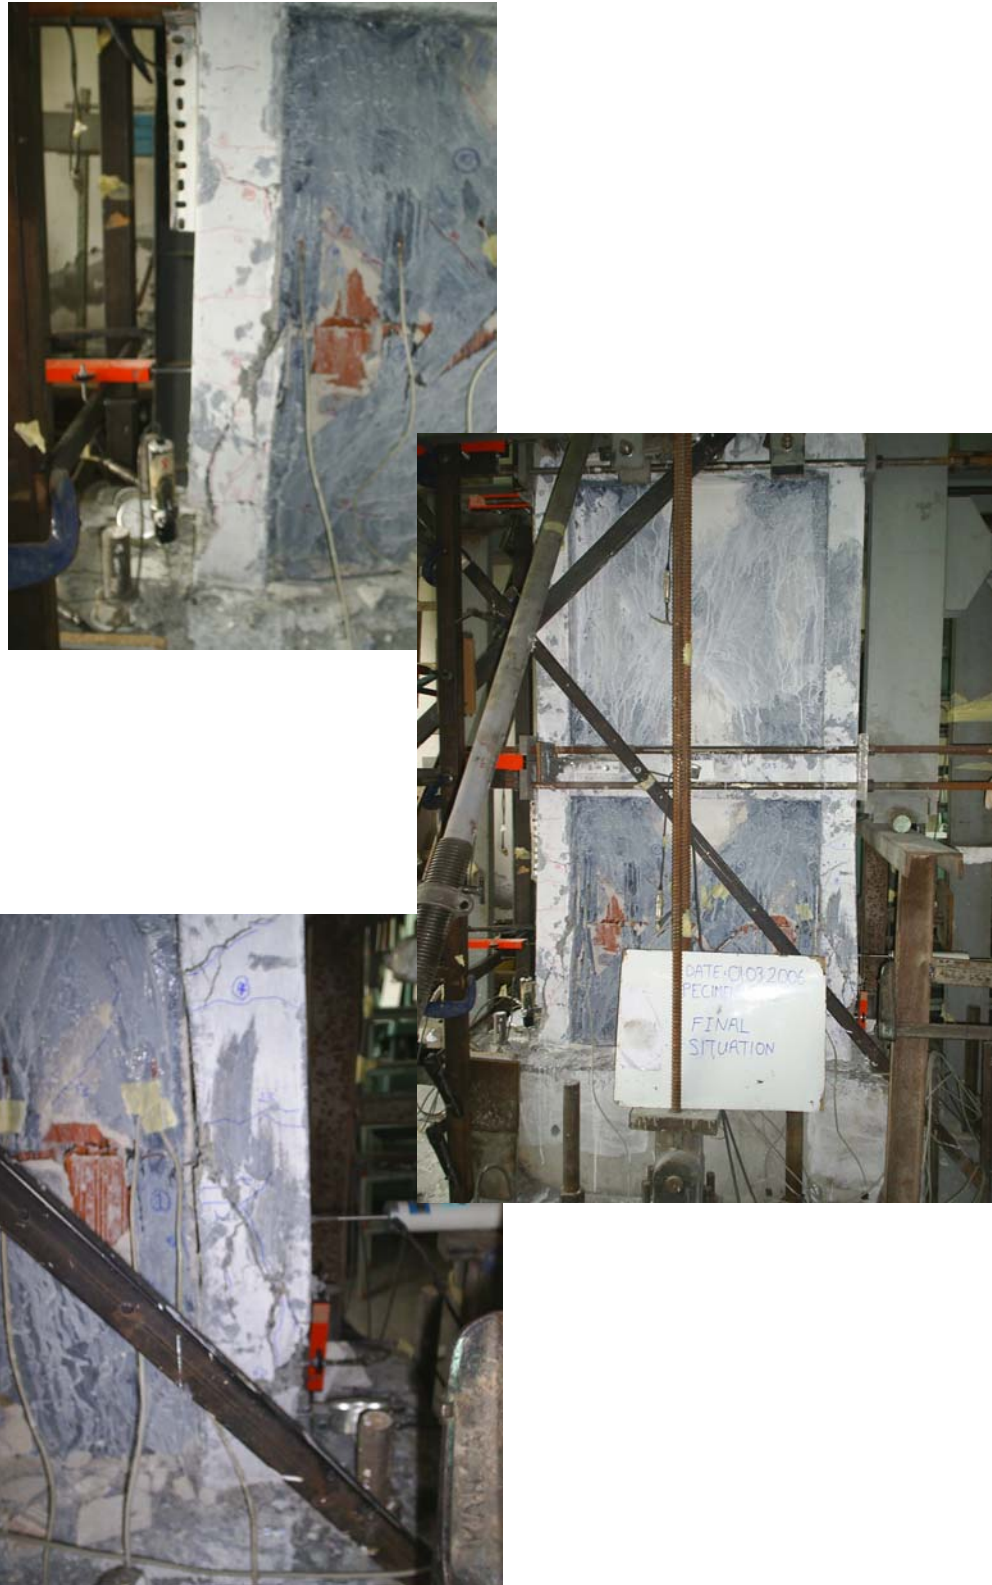
Figure 4.18. Specimen SA1.0-C2V at the end of the test

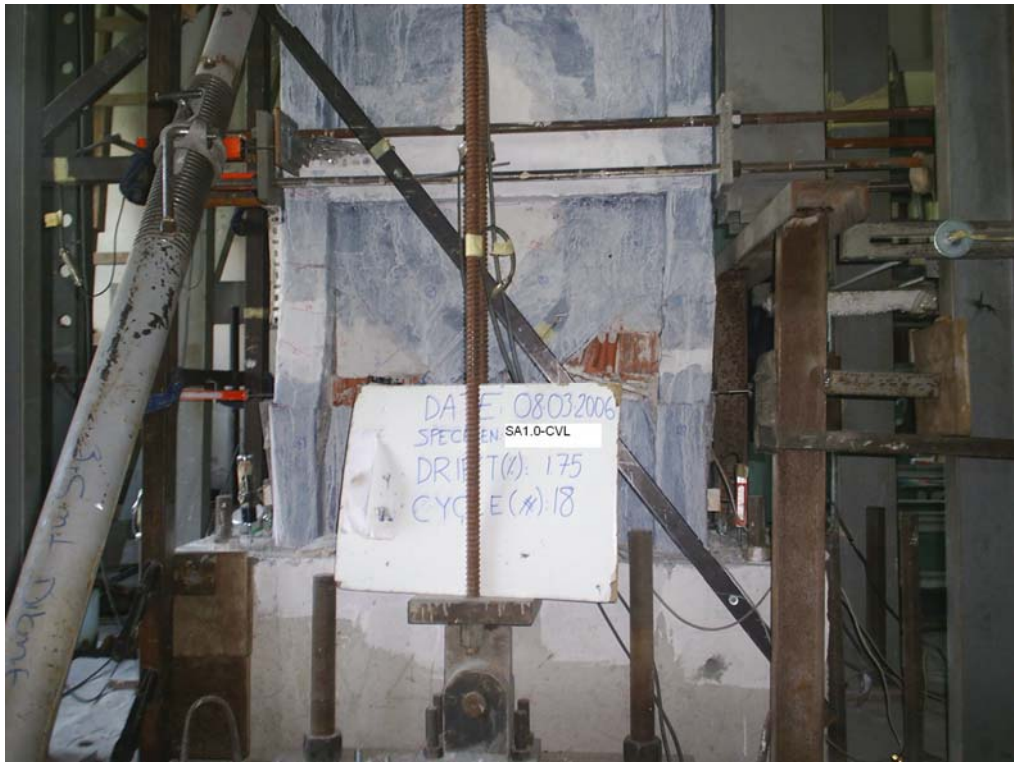
Figure 4.23. Front view of specimen SA1.0-CVL at the 18th cycle

Test was terminated at a drift level of 0.0177 at the end of the 18<sup>th</sup> cycle. Front view of the specimen and close-ups of the right and left columns were illustrated in Figures 4.23, 4.24 and 4.25. Failure was due to shear sliding failure with rupturing of cross diagonals under the combined action of axial tension and shear (Figure 4.23). Debonding of cross diagonals was observed. Formation of plastic hinges on the left and right column upper ends were observed due to block movement of infills (Figures 4.24 and 4.25). Vertical strips around columns prevented lap splice failure induced damage to a certain load level. It is observed that the load transfer between column lap splices through the vertical CFRP strips bonded on columns failed at a drift level of 0.0030. This observation was shown in the forward half cycle clearly. After that point minimal sliding observed. Hence, the cross FRP diagonals are stretched resulting load capacity enhancement. It was believed that these vertical strips around column lap splices helped to transfer failure plane on the masonry towards mid-height part of the first story panel. Loss of core concrete which implied gravity load collapse was not observed. Base shear-top drift diagram revealed that pinching behavior took place due to opening and closure of cracks especially after the failing of vertical strips around the lap splice region of the columns.

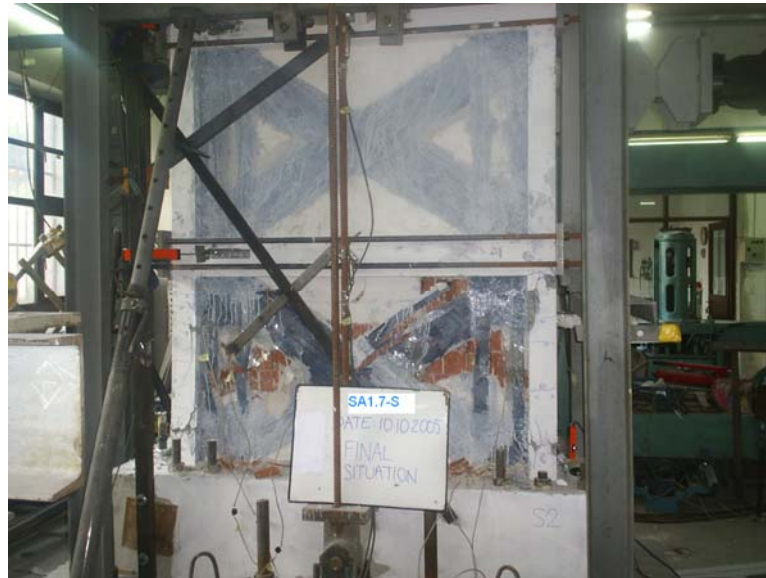
Figure 4.39. Front view of specimen SA1.7-S at the final state

Failure could be attributed to the formation of lap splice failure of column longitudinal bars along with the axial tension failure of the vertical FRP strips (Figures 4.39 and 4.40). Flag FRP configuration at the corners of the masonry impeded the crushing remarkably. On the other hand failure of vertical strips let the specimen to a rocking and sliding type of movement resulting high distress on diagonal FRP strips. Sliding of specimen was observed after the failure of vertical strips and before the failure of diagonal ones. On the other hand sliding was not predominant on the failure. This sliding is observed as a so-called ductility on the pull part of hysteretic curve. The observations done after the test illustrated that FRP anchorages on the columns caused cone failure cracks which were vertical as shown in Figure 4.41. This cone failure cracks and dowel cracks, which were formed by different sliding surfaces on the masonry panel and RC columns, could be among the possible reasons of spalling of the cover concrete. The close-up of the right column upper end is depicted in Figure 4.42. Sliding, shear failure of the right column (Figure 4.42) and lap splice failure of the columns' bottom ends (Figure 4.39) may be listed as the reasons of pinched hysteretic behavior of the specimen especially after 0.5% - 0.6% drift level.

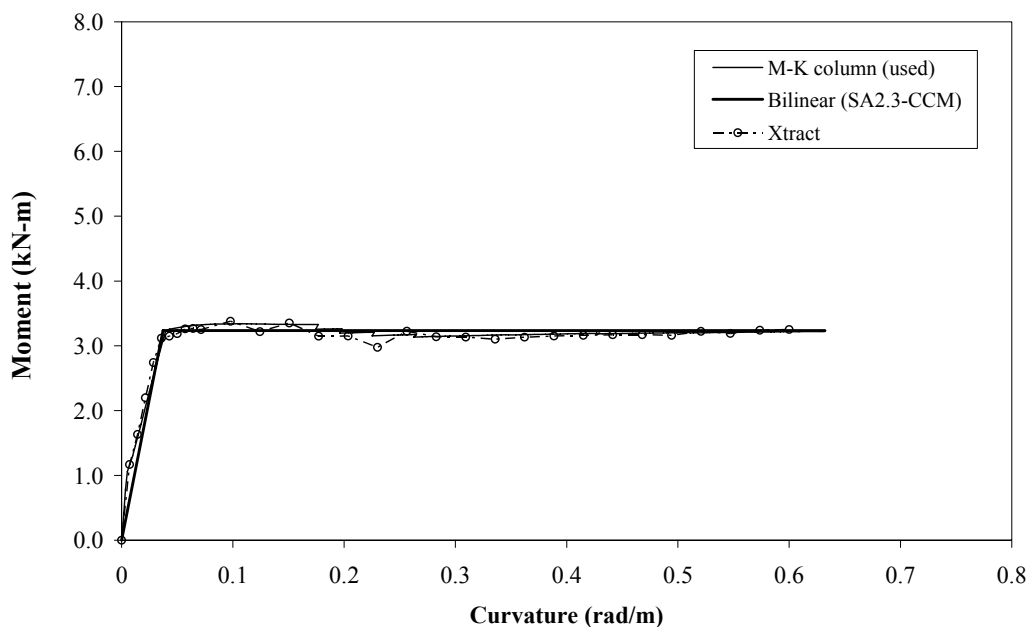
Figure 6.5. Moment Curvature Diagram of the column of specimen SA2.3-CCM

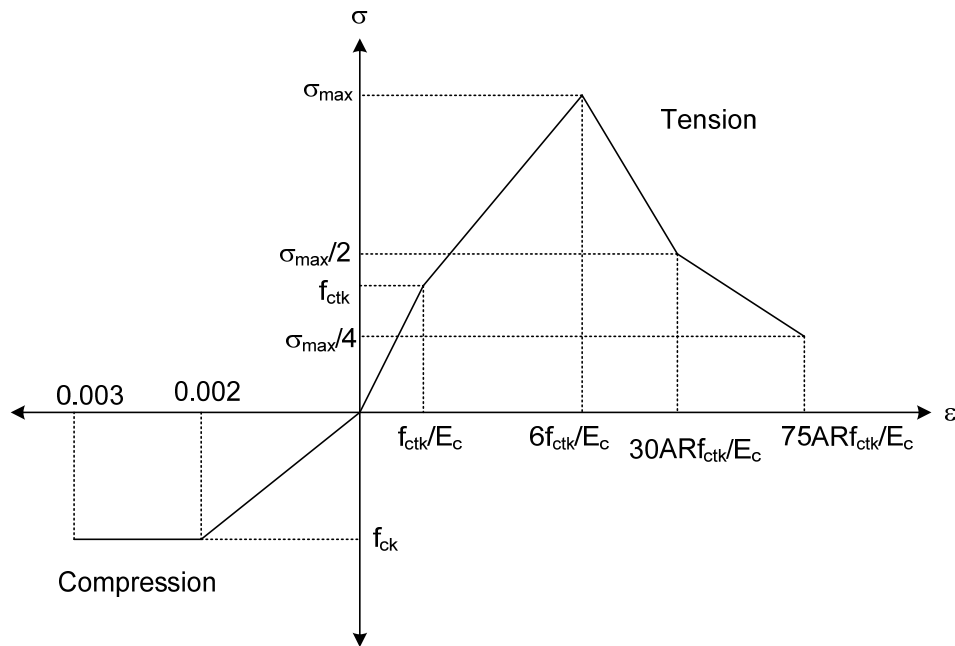
Figure 6.7. Description of tension-compression hinge for the columns (P hinge)

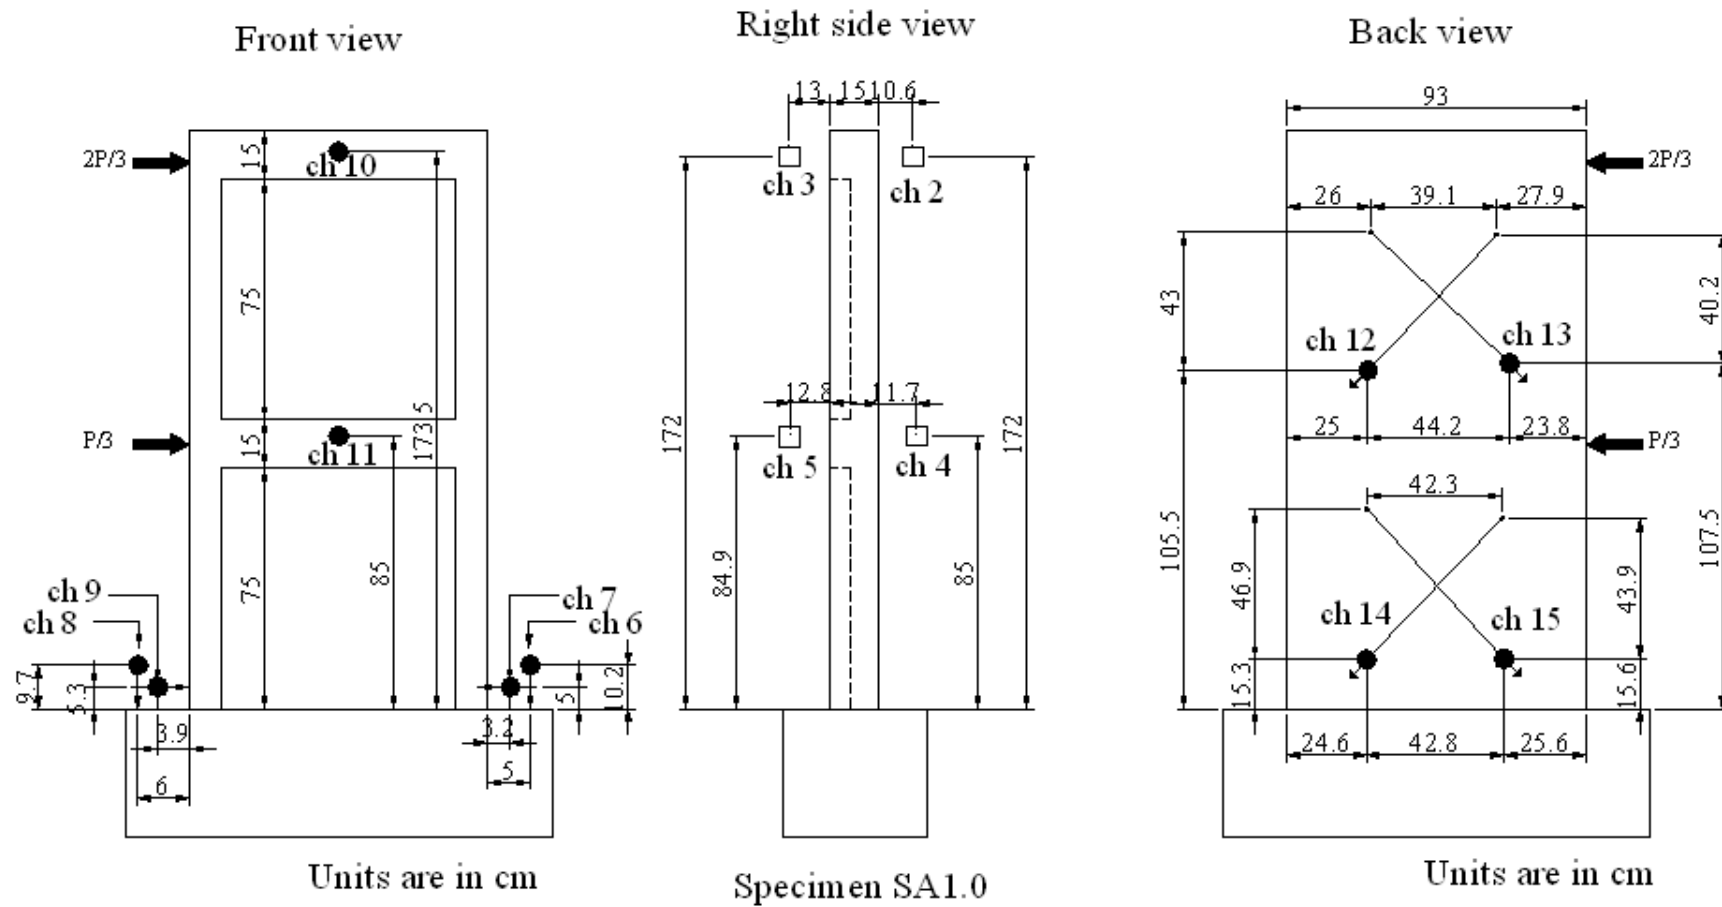
Figure A.1. Position of measuring sensors of specimen SA1.0
