EXPERIMENTAL INVESTIGATION AND 3D CYCLIC FINITE ELEMENT
SIMULATION OF R/C EXTERIOR BEAM-COLUMN JOINTS RETROFITTED WITH
CFRP COMPOSITE MATERIALS

Graduate Program in Civil Engineering

Boğaziçi University

2010

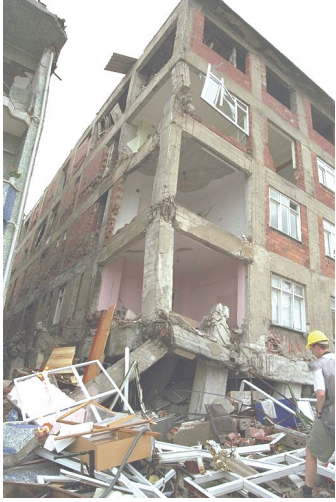
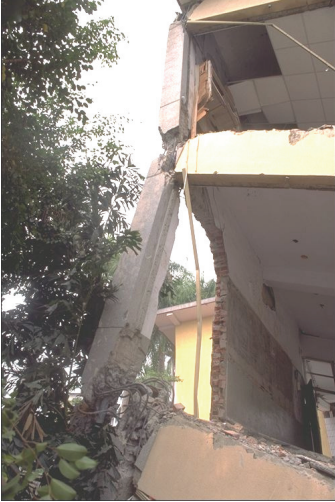
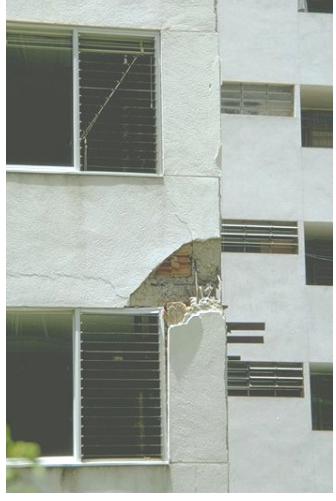
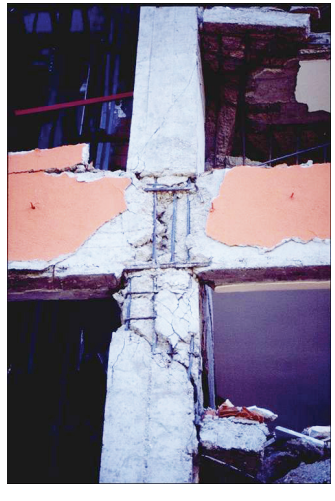
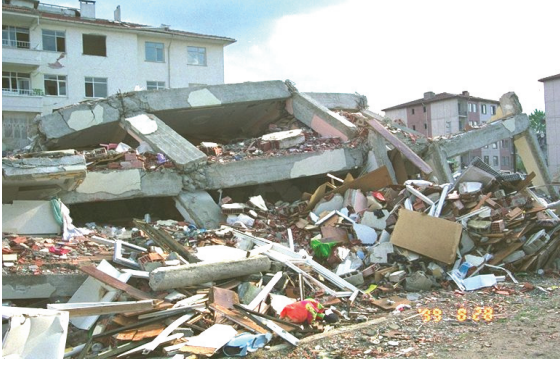
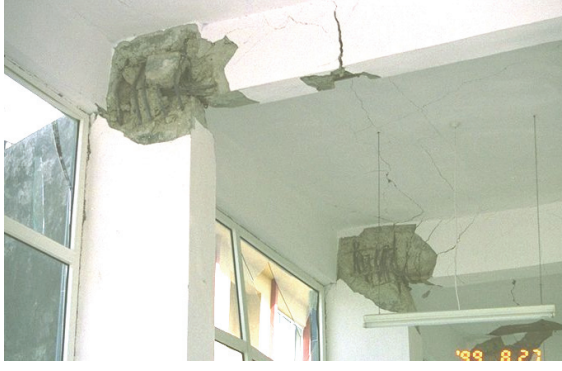
Figure 1.1. Beam-column joint failure

<p>Izmit, Turkey earthquake, Aug. 17, 1999. Photo by Sezen, Halil</p>	<p>Chi-Chi, Taiwan earthquake, Sept. 21, 1999. Photo by Mahin, Stephen A.</p>

<p>Caracas, Venezuela earthquake, July 29, 1967. Photo by Steinbrugge, Karl V.</p>	<p>Izmit, Turkey earthquake, Aug. 17, 1999. Photo by Whittaker, Andrew S.</p>

<p>Izmit, Turkey earthquake, Aug. 17, 1999. Photo by Sezen, Halil</p>	<p>Izmit, Turkey earthquake, Aug. 17, 1999. Photo by Sezen, Halil</p>

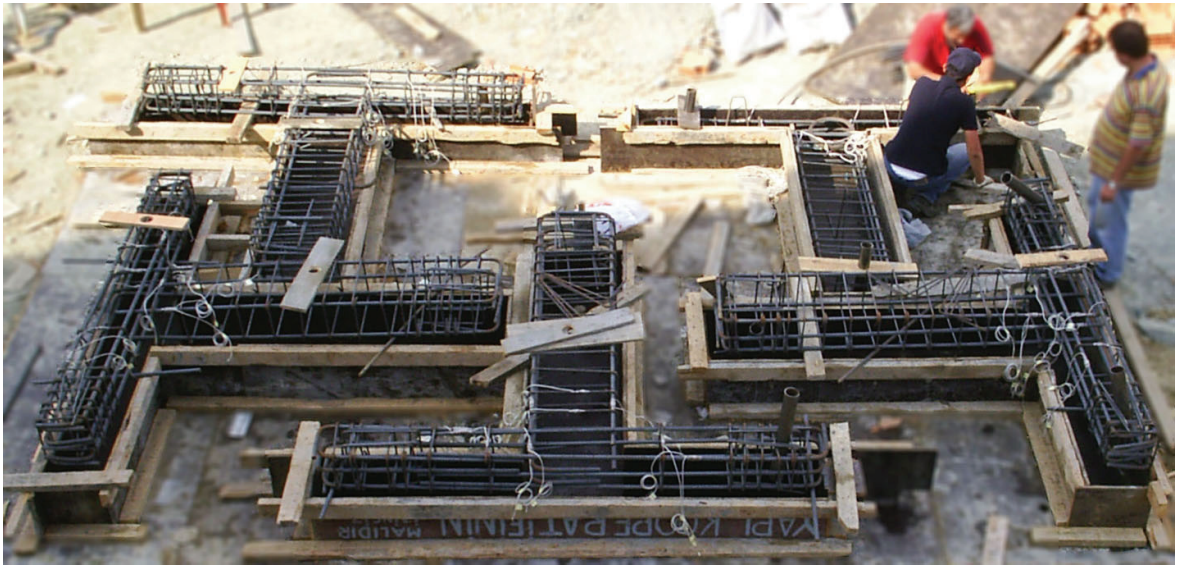
Figure 3.2. Construction of the specimens

The beam column joint specimens were produced at the construction side in a horizontal position as shown in Figure 3.2. Reinforcement and formworks were prepared by actual construction workers. First, formworks were erected and then reinforcing cages were placed inside the formworks. Strain gauges were mounted on desired locations of the reinforcing steel. In order to keep away water contact, strain gauges were coated with silicon and wrapped with tape. After that, ready mix concrete was ordered from a local concrete plant. The concrete was cast such that the subassemblies were in a horizontal position. During the casting, concrete samples were taken in 150 x 300 mm cylinder

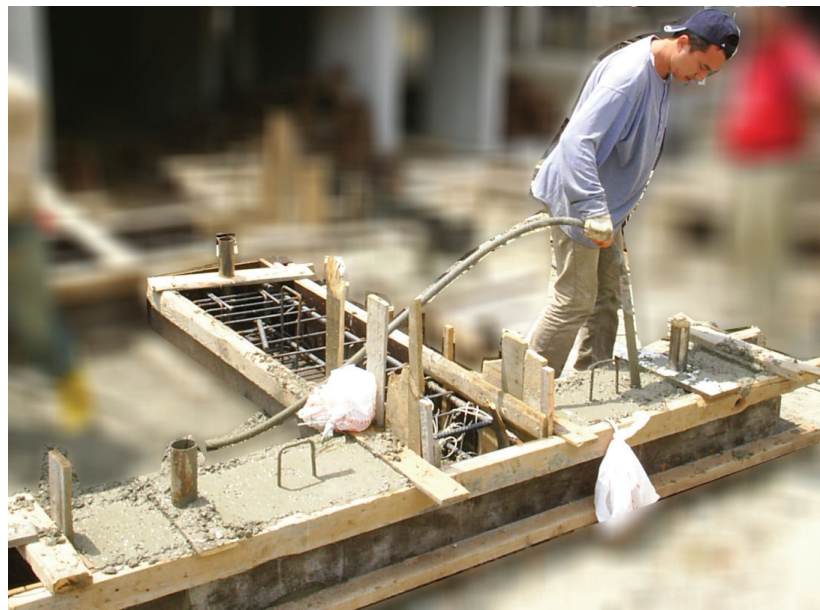
Figure 3.3. Use of immerse vibrator

formworks. As illustrated in Figure 3.3, immerse vibrator was used to prevent air voids inside the concrete. In order to represent an actual construction application, concrete was poured in two different days such that construction joints form between the columns and the beam as shown in Figure 3.4. Since the specimens were under the sun-exposed area, all specimens were covered with burlap and were cured with water spraying. After a week all formworks were removed.

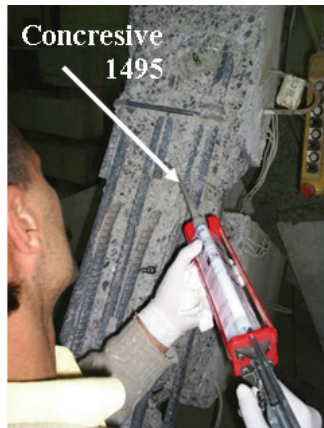
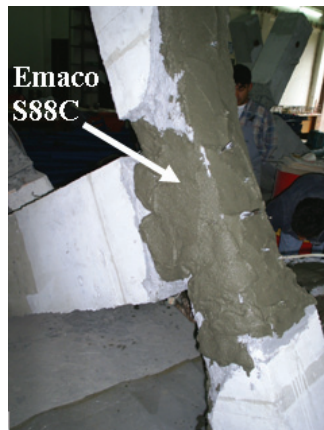
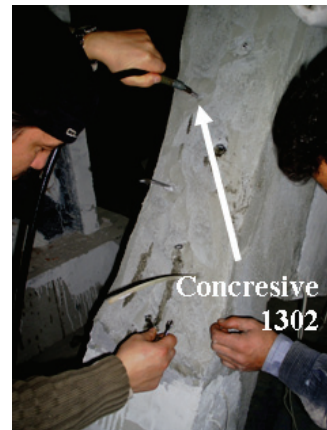
Figure 3.27. Repairing procedure

The repair procedure started with the removal of the loose concrete from the damaged region of a specimen. The surface and the cracks were cleaned using wire brush. Before the epoxy injection, the damaged area was blown by high-pressure air until it was free from dust particles. Several holes were drilled along the cracks. Then, check valve nipples were placed into the holes. Large cracks were filled with epoxy-based high strength repair material, Concrevice 1495. All remaining voids were filled with epoxy based material Concrevice 1406. Next, the surface was smoothed with the cement based repairing material Emaco S88C. Then the specimen was left for curing of the materials. After a week low viscosity epoxy, Concrevice 1302 was injected with 200-bar pressure through the nipples via special pumps as shown in Figure 3.27. Epoxy injection process was continued until leakage of the epoxy was observed from the nipples placed on the other sides of the specimen.

Epoxy injection of large cracks

Replacement of loose concrete voids

High-pressure epoxy injection

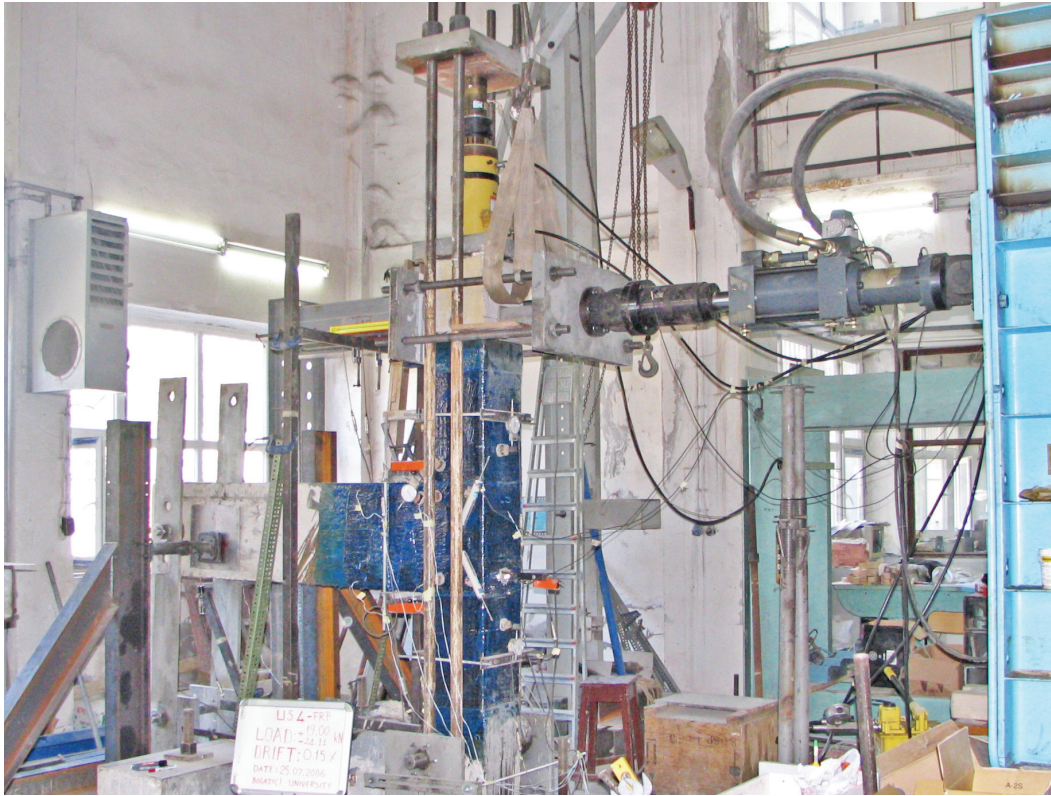
Figure 3.29. General view of the test setup

A general view of the test setup is shown in Figure 3.29. The specimens were tested in beam horizontal position with a hinge at the end and the columns in vertical position supported by a pin at the bottom end as shown Figure 3.30. The top of the column is free to move and rotate and the hinged end of the beam can easily rotate and translate horizontally. Hence the point of contraflexure for both the beam and the column can be modeled within the loading setup. A constant load is applied through the use of 1000 kN hydraulic cylinder on the axis of the column. In order to restrict any out of plane actions, an out of plane frame was mounted on the two sides of the specimens as seen on the bottom left in Figure 3.29. A closed loop double acting dynamic actuator with a load capacity of 250 kN and 200 mm stroke capacity was used in the testing. The available capacity of the reaction wall was 2000 kN.

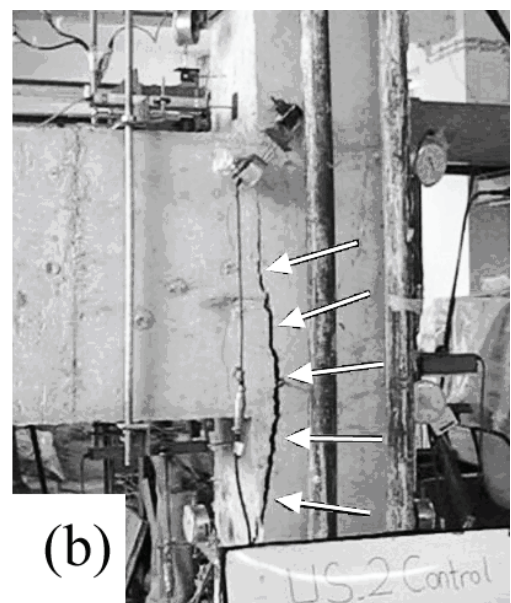
Figure 4.3. Failure modes; (a) pull, (b) push direction of loading

In pull direction, the mode of failure and the behavior was different than in push direction of loading. Load applied to the top of the specimen in the direction of pull caused a negative moment in the beam which created a tension force in the beam top longitudinal reinforcement. The tensile force in the rebar was transferred to the joint region which created shear force in the joint core. Since the joint was not reinforced for shear, diagonal shear cracks at the joint core were observed as shown in Figure 4.3. Maximum lateral load recorded in pull direction of loading was 77 kN and the drift level corresponding to maximum load was 1.00%.

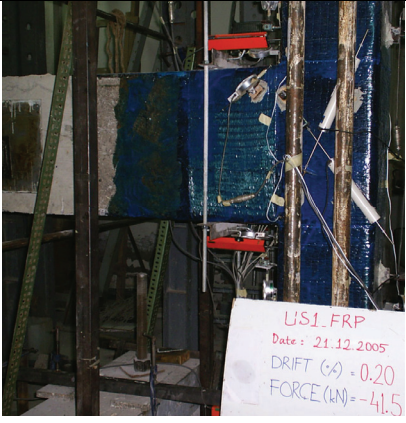
0.25	<p>Maximum load: + 23 kN (push) - 46 kN (pull)</p> <p>CR1: A single flexural crack was observed at the top of the beam where U-shaped CFRP sheet ends.</p>

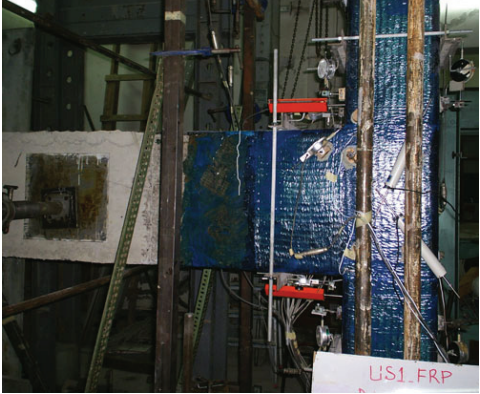
0.35	<p>Maximum load: + 29 kN (push) - 58 kN (pull)</p> <p>CR2: A flexural crack was observed at the bottom of the beam where U-shaped CFRP sheet ends.</p>

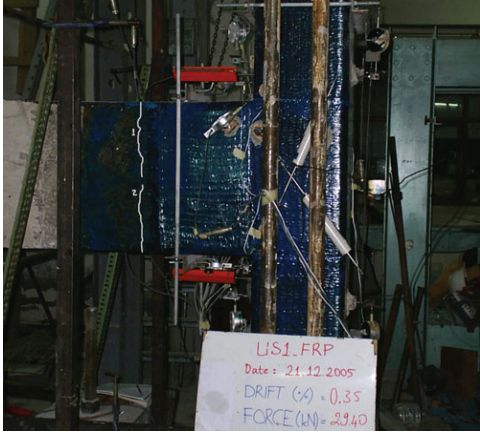
0.50	<p>Maximum load: + 38 kN (push) - 73 kN (pull)</p> <p>CR3: A flexural crack was observed at the top of the beam approximately 48 cm away from the column face.</p>

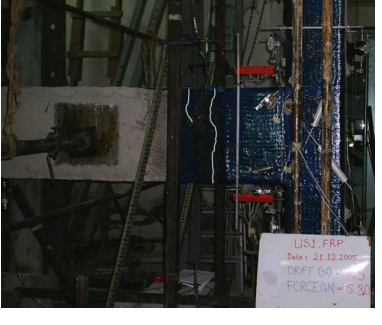
1.00	<p>Maximum load: + 76 kN (push) - 113 kN (pull)</p> <p>Several flexural cracks were observed at the beam as seen in the figure on the right.</p>

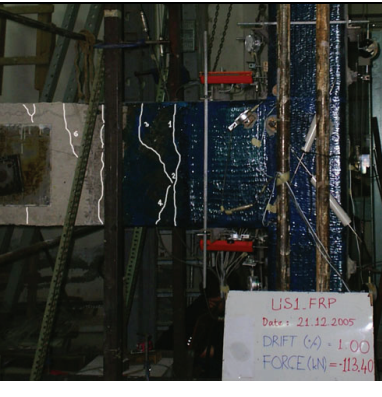
1.40	<p>Maximum load: + 91 kN (push) - 128 kN (pull)</p> <p>No additional cracks were observed. Crack widths of the existing cracks increased.</p>

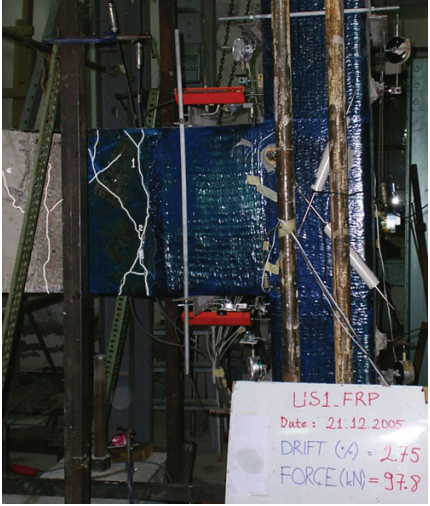
2.75	<p>Maximum load: + 96 kN (push) - 140 kN (pull)</p> <p>No additional cracks were observed.</p> <p>Plastic hinging at the beam was observed as seen in the figure on the right.</p>

After test	The damage was observed at the beam

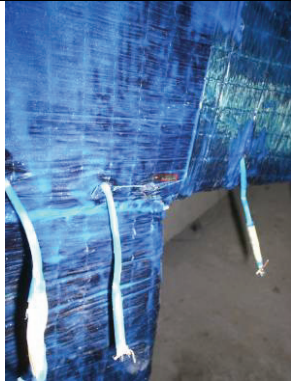
After test	Rupture of CFRP was formed at the bottom corner of beam column intersection

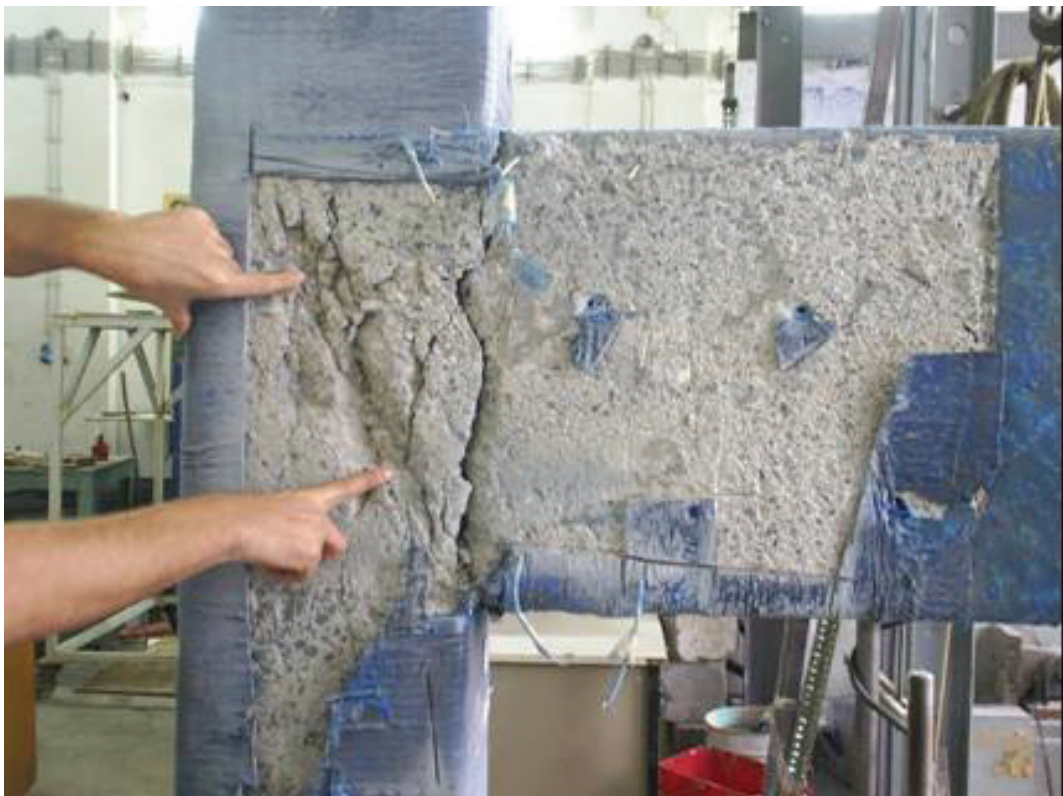
Figure 4.15. Damage at the joint region after removal of the CFRP sheets

At the end of testing the CFRP wraps were removed from the concrete surface for visual inspection. Several hairline cracks on the beam were observed. The main crack (the most wide and deep crack) was at the core of the joint region as shown in Figure 4.15. This crack indicated a shear failure at the joint but only in pull direction of loading since the crack was formed in only one diagonal of the joint. After the rupture of the CFRP sheets, inadequately embedment beam bottom longitudinal reinforcement slipped again as it the case of the control specimen US3. Tension force in the bottom rebar was not transferred to the joint, and thus it was unable to create shear forces within the joint.

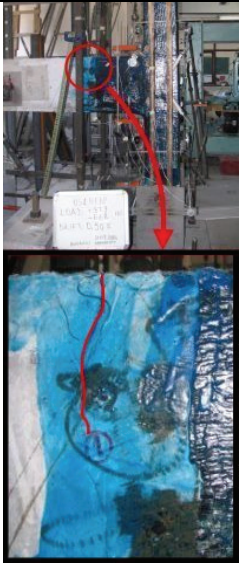
Drift (%)	Observations	Crack patterns & CFRP failure
0.50	<p>Maximum load :(+)37.90 kN (Push) :(-)68.80 kN (Pull)</p> <p>CR1: Flexural crack formed at the top, 110 cm away from the east face of the column. The length of the crack was 16.5 cm.</p>

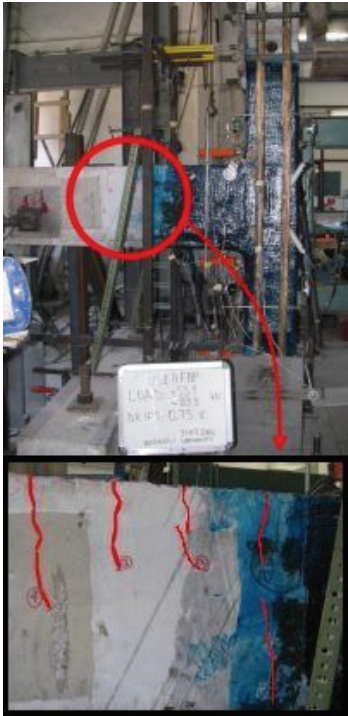
0.75	<p>Maximum load :(+)59.10 kN (Push) :(-)89.34 kN (Pull)</p> <p>CR2: Flexural crack formed at the top, 80 cm away from the east face of the column. The length of the crack is 17 cm.</p> <p>CR3: Flexural crack formed at the top, 65 cm away from the east face of the column. The length of the crack is 16 cm.</p> <p>CR4: Flexural crack formed at the top, 94 cm away from the east face of the column. The length of the crack is 24 cm.</p> <p>CR5: Flexural crack formed at the top, 110 cm away from the east face of the column. The length of the crack is 16 cm.</p>

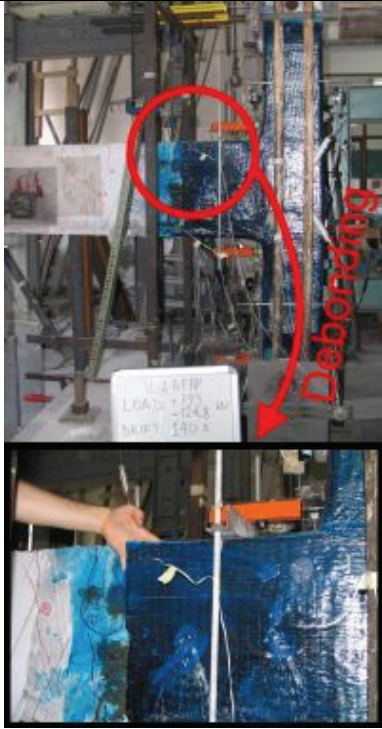
Drift (%)	Observations	Crack patterns & CFRP failure
1.40	<p>Maximum load :(+79.50 kN (Push) :(-124.80 kN (Pull)</p> <p>CR9: Flexural crack formed at the bottom, approximately 1 cm away from the east face of the column. This crack was only observable from the beam bottom face.</p> <ul style="list-style-type: none"> In pull direction of loading top portion (17 cm within the height of the beam) of the U-shape CFRP sheet debonded from the concrete of the beam.

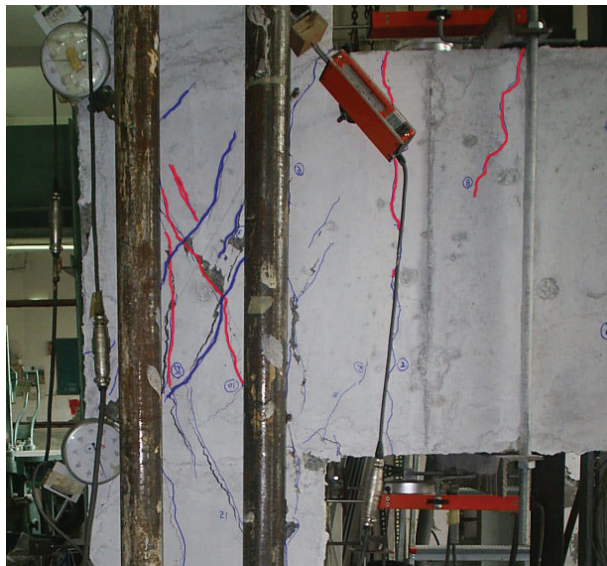
Figure 5.22. Shear failure at the joint core

In the experimental testing of specimen US1, heavy damage at the joint region was observed due to excessive shear deformations at joint core. The FE simulation of specimen US1 showed very similar failure mode as seen in Figure 5.21.
