EXPERIMENTAL RESEARCH ON PREVENTING DEBONDING PROBLEM IN
RETROFITTED RC BEAM – COLUMN JOINTS USING COMPOSITE MATERIALS

Submitted to the Institute for Graduate Studies in
Science and Engineering in partial fulfillment of
the requirements for the degree of
Master of Science

Graduate Program in Civil Engineering
Boğaziçi University

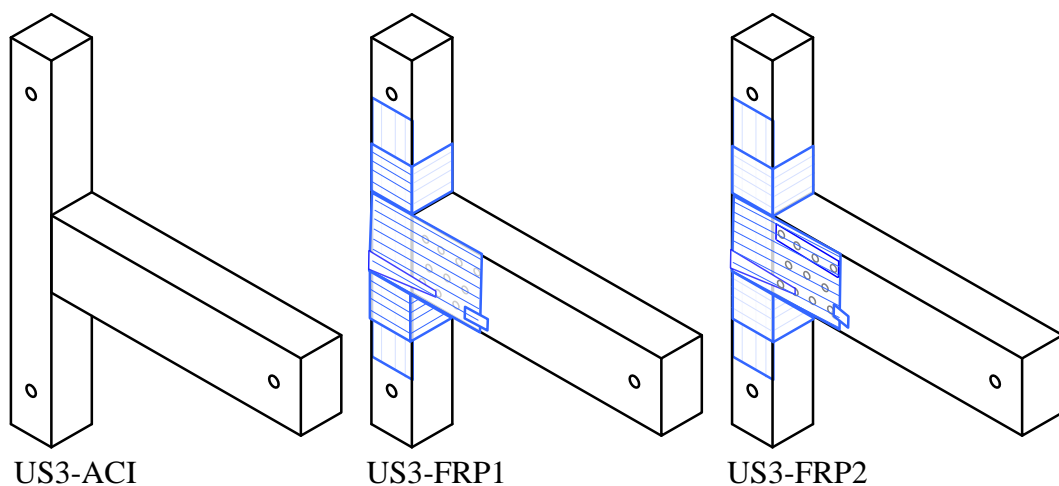
Figure 2.1. Testing Specimens

In this series of tests, prevention of debonding of CFRP sheets from concrete surface parameter was intended to be investigated. One specimen with proper current ACI 318-2002 and 352R-20 code provisions was prepared (US3-ACI). Other two specimens were exactly as same as previously-tested US3 (US3-FRP1 and US3-FRP2). Both retrofitted specimens were strengthened with CFRP as like in Altay's study in which three layers of CFRP were used for retrofitting, however they had different anchorage application techniques.

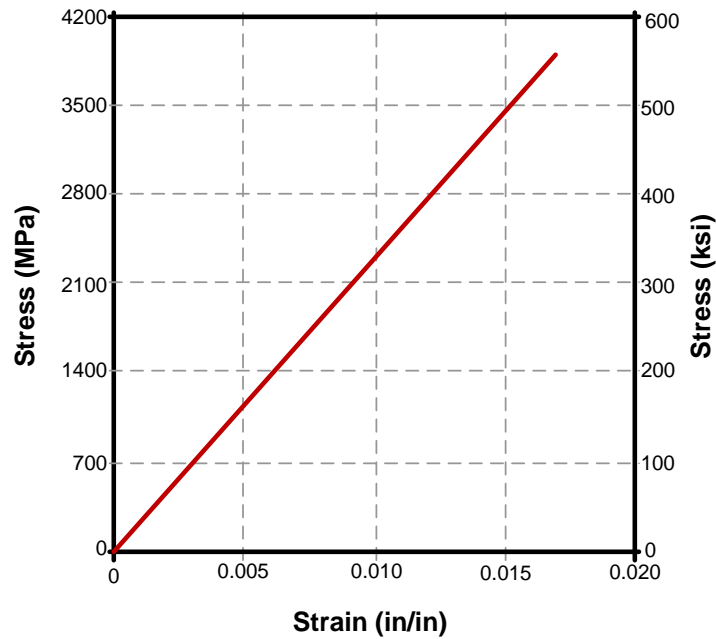
Figure 2.7. Stress-Strain Relations of CFRP sheets

Nominal Thickness	0.33 mm/ply
Ultimate Tensile Strength (0°)	3800 MPa
Tensile Modulus (0°)	227 GPa
Ultimate Rupture Strain (0°)	1.67 %
Weight	330 g/m ²
Density	1.70 -1.80 t/m ³

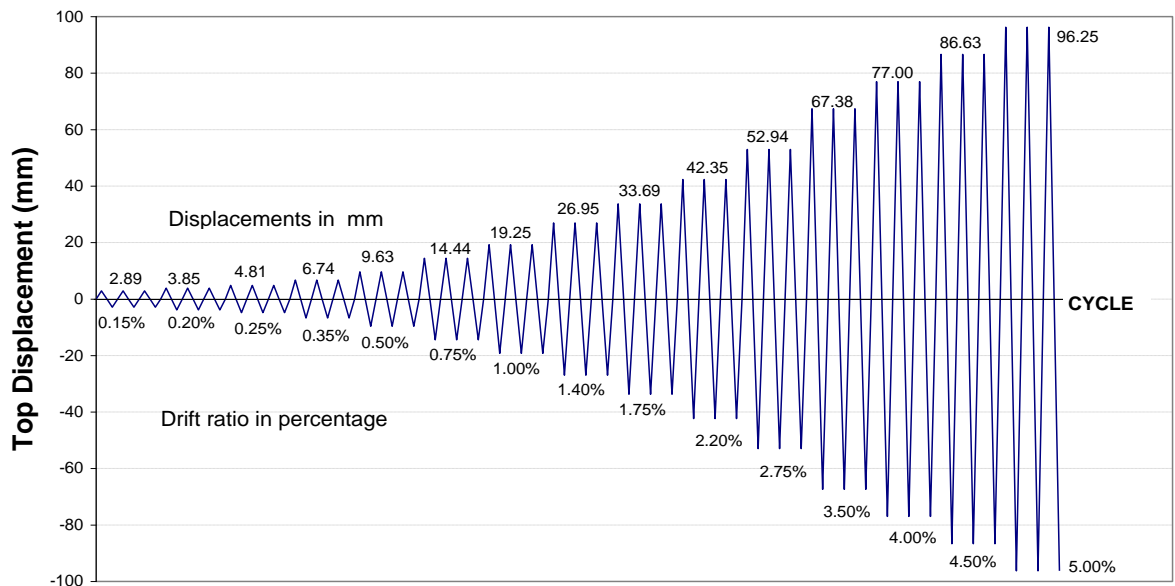
Figure 2.24. Loading Pattern based on ACI protocol

The lateral load was applied based on the displacement control criteria. In any quasi-static cyclic loading, the specimens were subjected to predetermined numbers of displacement-controlled loading cycles as shown in Figure 2.25, and these load reversals were applied slowly in order to eliminate the effects of material strain rate (Sin 2004). Approximately 35-40 reversed cycles were applied throughout the test. All data were using TML 602 50 Hz. 50 channel data acquisition box. Crack propagation, CFRP fractures, debonding and other failures were recorded.

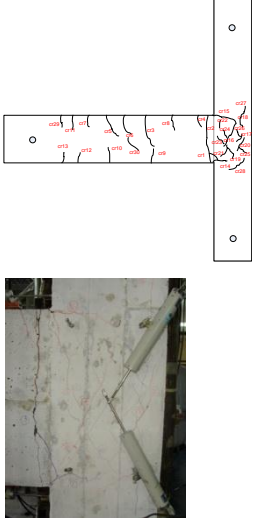
Drift (%)	Observations	Crack pattern
1.75	<p>Max lateral load : (+) 74.10 kN (Push) : (-) 103.90 kN (Pull)</p> <p>CR2: extended bifurcated CR15 & CR16: joined CR23: occurred in the joint length is 110 mm CR24 : occurred in the joint length is 90 mm CR25: occurred in the joint length is 100 mm. CR26 : occurred in the joint length is 120 mm. CR27 : occurred in the joint length is 150 mm. CR28 : occurred in the joint length is 110 mm. CR27 & CR18: joined CR29: flexural crack in the beam. CR30 : flexural crack in the beam. CR1 : crushed and widened.</p>

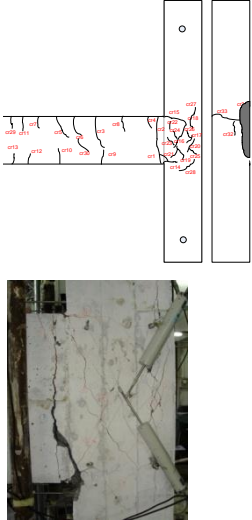
Drift (%)	Observations	Crack pattern
3.50	Max lateral load : (+) 42.30 kN (Push) : (-) 75.50 kN (Pull) CR1 & CR2: has widened and crushing has started. CR27 & CR18:has widened and crushing has started.

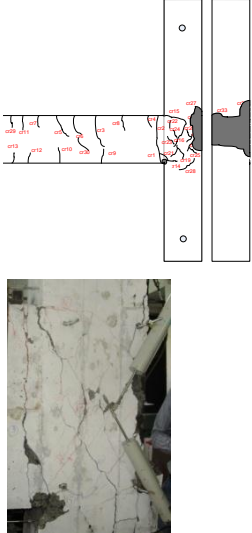
4.00	Max lateral load : (+) 29.10 kN (Push) : (-) 62.50 kN (Pull) CR27 & CR18:has crushed. Joint is crushed.

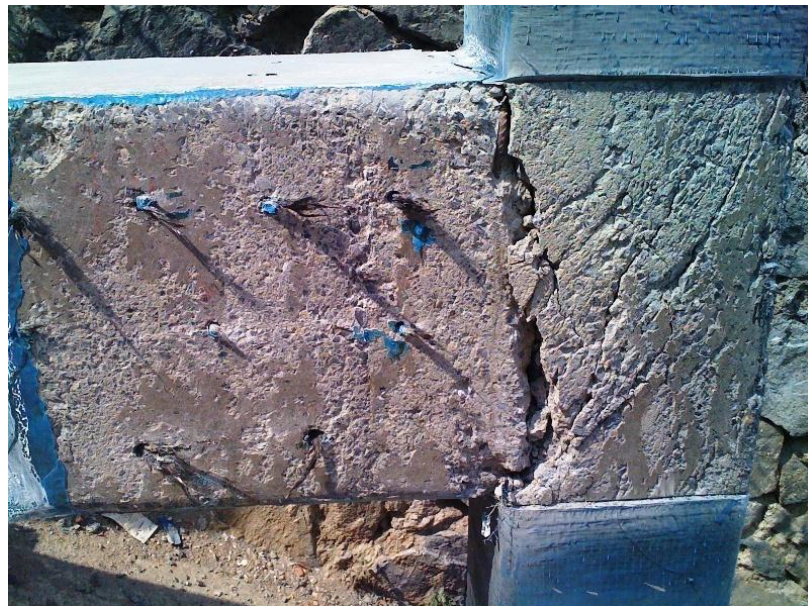
Figure 3.2. Main cracks after removing the CFRP sheets

After the completion of the experiment, the CFRP wraps were removed from the concrete surface for visual inspection and it has been observed that the concrete in the joint was crushed to some extent and the crack pattern was different from the US3-ACI specimen. The detailed crack propagations for US3-FRP1 are given in Table 3.2.

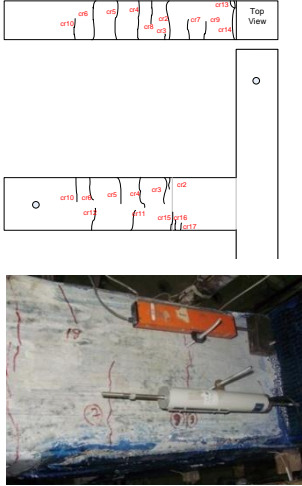
Drift (%)	Observations	Crack pattern
1.75	<p>Max lateral load : (+) 69.80kN (Push) : (-) 138.60 kN (Pull)</p> <p>Debonding increase was observed. It can be said that anchorages are handling with the stress. U shape almost dont have any bond on the surface of beam. Load has started to decrease in push direction.</p> <p>CR15 : A flexural crack occurred on the surface of the beam on FRP side. The distance from the face of the column is 460 mm and its length is 150 mm.</p> <p>CR16 : A flexural crack that has a 130 mm length and a 430 mm distance from the column, occurred at the bottom of the beam.</p> <p>CR17 : A flexural crack occurred. The distance from the face of the column is 40 mm and its length is 100 mm.</p>

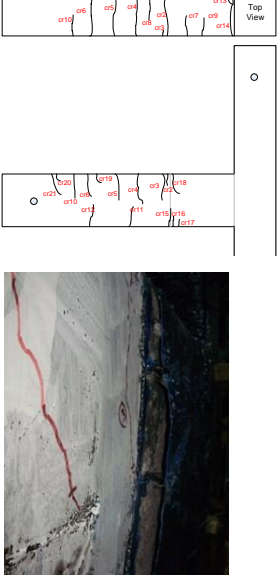
Drift (%)	Observations	Crack pattern
3.50	<p>Max lateral load : (+) 57.10 kN (Push) : (-) 114.70 kN (Pull)</p> <p>FRP strip, which surrounds the column as belt, and U shape FRP that extends to the beam totally ruptured</p> <p>It can be said that it is totally debonded and Anchorage failures were started.</p>

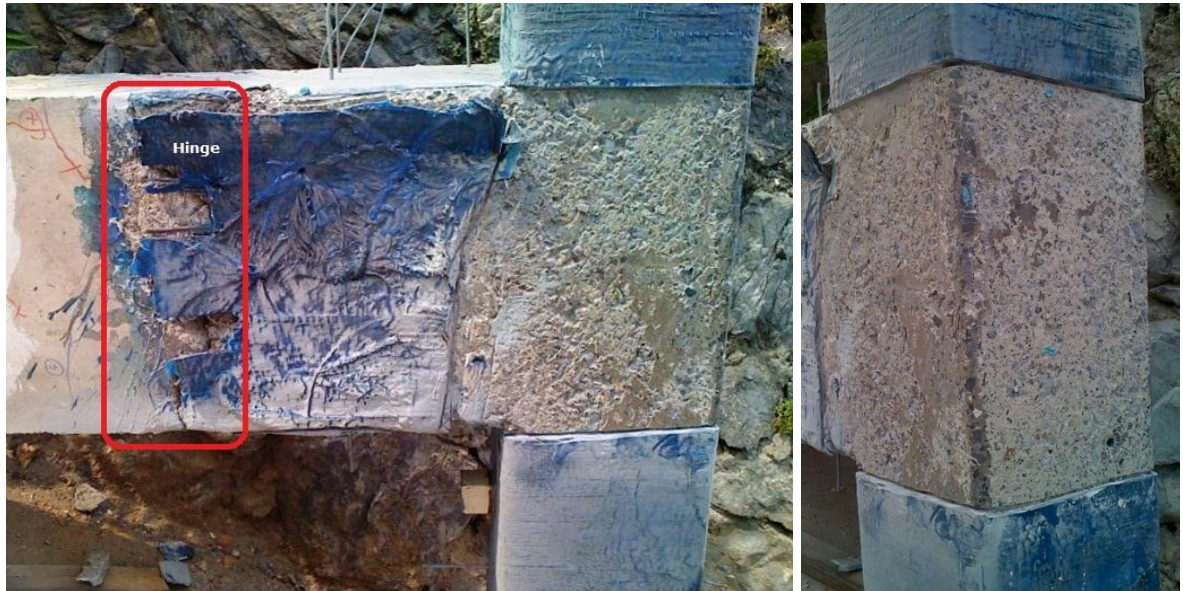
Figure 3.3. Hinge occurred in the beam and joint didn't crushed

observed in the bottom part of the beam. After this drift level the lateral load decreased rapidly in the push direction and a hinge occurred in the bottom part of the beam at the end of U shape as shown in Figure 3.3.

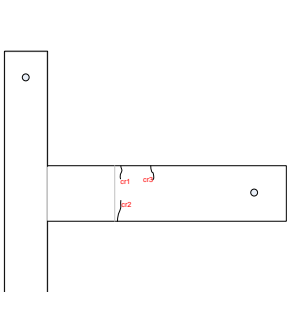
0.50	Max lateral load : (+) 41.20 kN (Push) : (-) 73.30 kN (Pull) CR2 : Flexural crack occurred at the bottom of the beam, 530 mm away from the column with a length of 140 mm. CR3 : Flexural crack occurred at the top of the beam, 850 mm away from the column with a length of 120 mm. CR1 : has extended and widened.

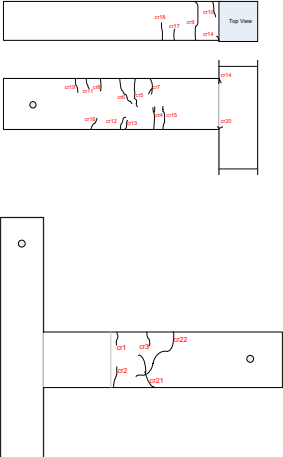
2.20	<p>Max lateral load : (+) 103.10kN (Push) : (-) 153.50 kN (Pull)</p> <p>CR21 : Flexural crack occurred at the bottom of the beam, 850 mm away from the column with a length of 350 mm.</p> <p>CR22 : Flexural crack occurred at the top of the beam 1010 mm away from the column with a length of 460 mm.</p> <p>CR1 : has widened to 3 mm.</p> <p>Debonding has started between middle and bottom anchorages.</p> <p>CR1 & CR18 : has joined.</p> <p>CR1 & CR2 : has joined.</p> <p>CFRP debonded.</p>

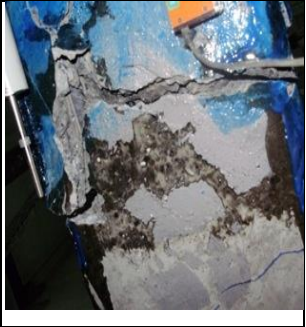
3.50	<p>Max lateral load : (+) 15.60 kN (Push) : (-) 135.30 kN (Pull)</p> <p>Slip and crushing occurred at hinge location.</p>

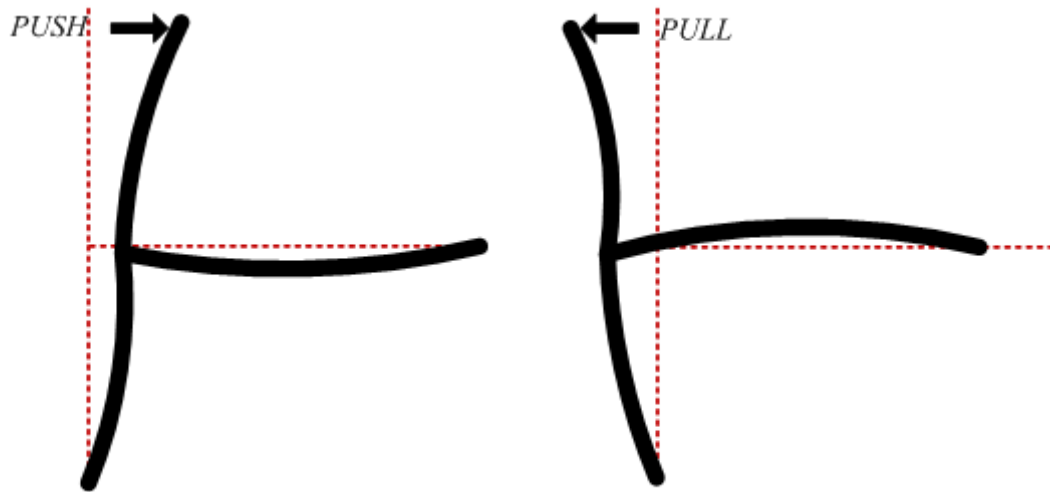
Figure 3.4. Push and Pull Directions of Loading

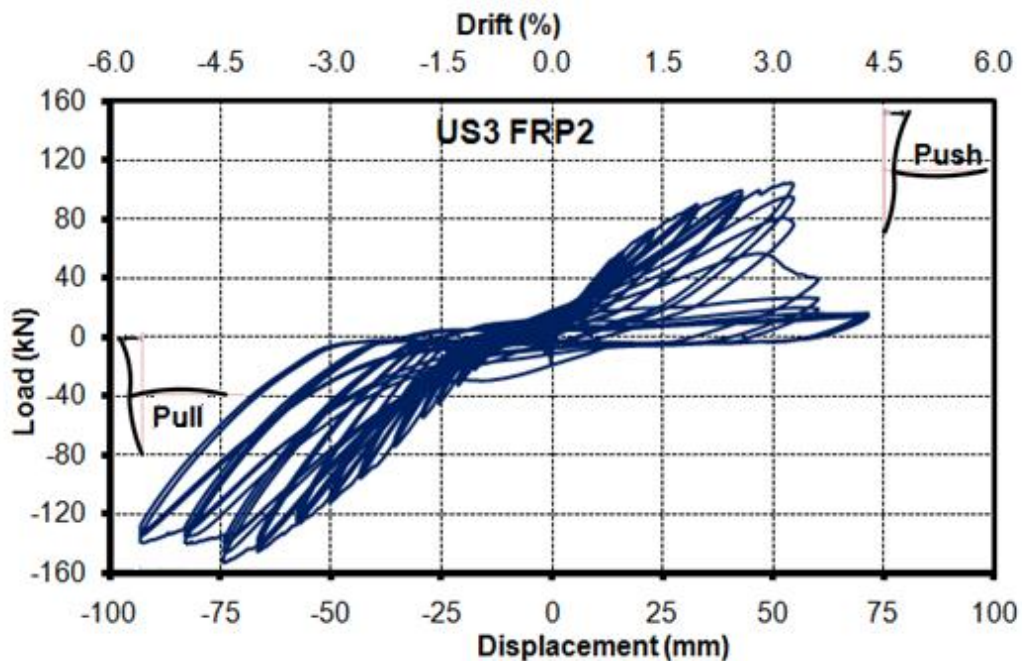
Figure 3.7. Lateral Load vs. Top Displacement

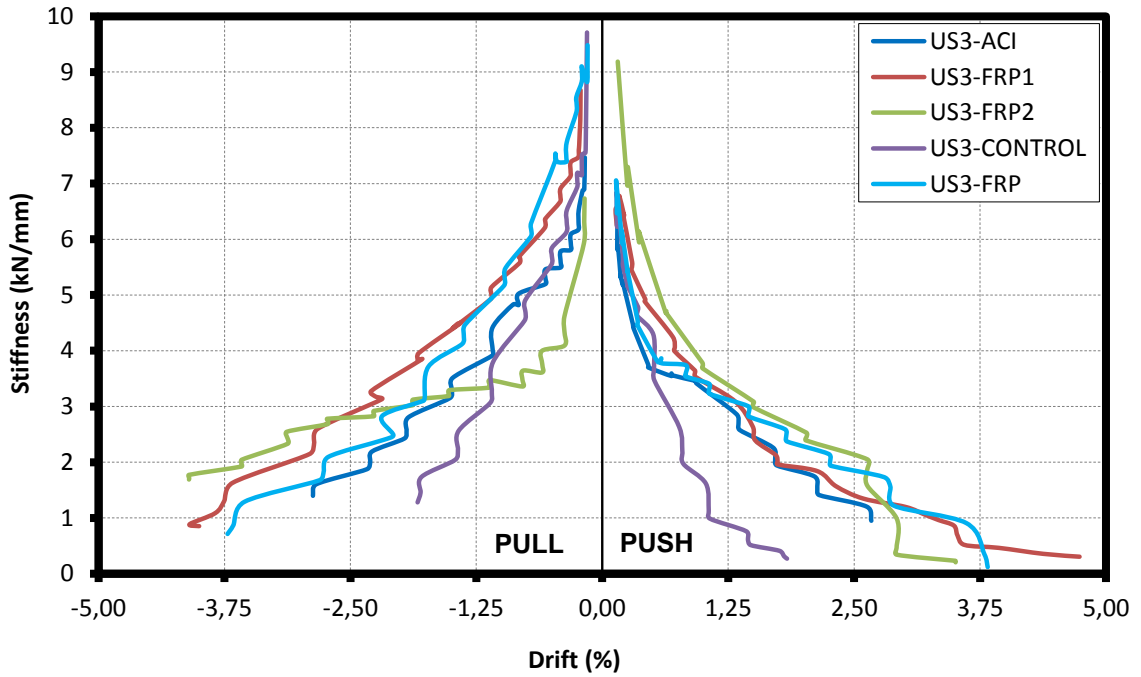
Figure 3.35. Stiffness vs. Drift relationship comparison with previous tests

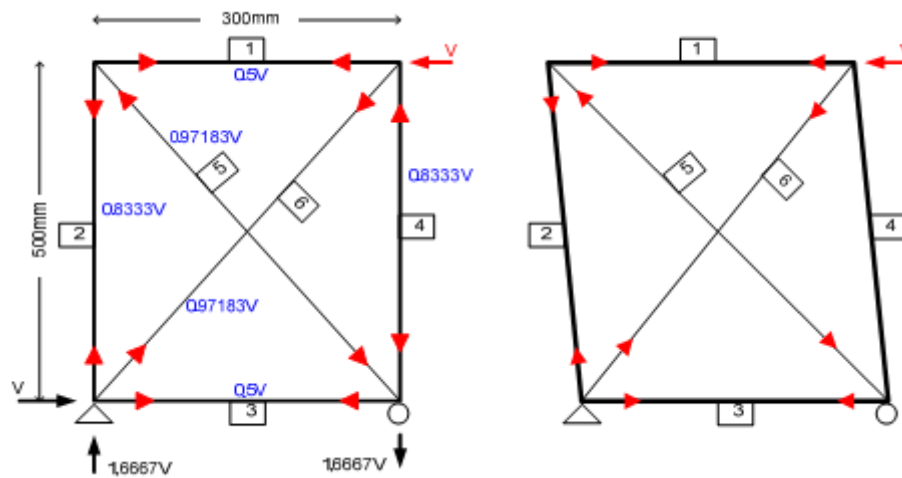
Figure 3.40. Proposed truss system
