EXPERIMENTAL RESEARCH ON SEISMIC RETROFITTING OF R/C EXTERIOR
BEAM-COLUMN-SLAB JOINTS UPGRADED WITH CARBON FIBER REINFORCED
POLYMER (CFRP) SHEETS

Master of Science

Graduate Program in Civil Engineering

Boğaziçi University

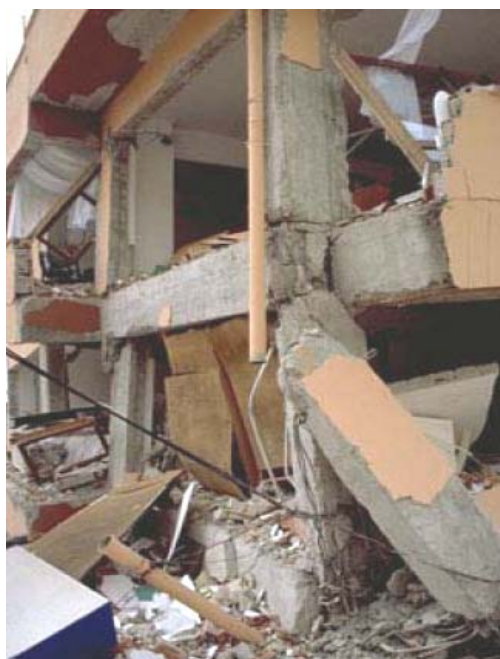
Figure 1.1. Joint failure from 1999 Kocaeli EQ (Sezen *et al.*, 2000)

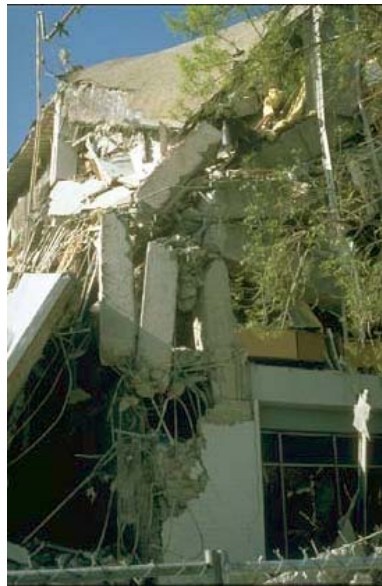
a) Typical Column Failure

b) Typical Joint Failures

c) Typical Slab-Column
Connection Failure

Figure 2.8. Failure Types of Buildings (Moehle, 2000)

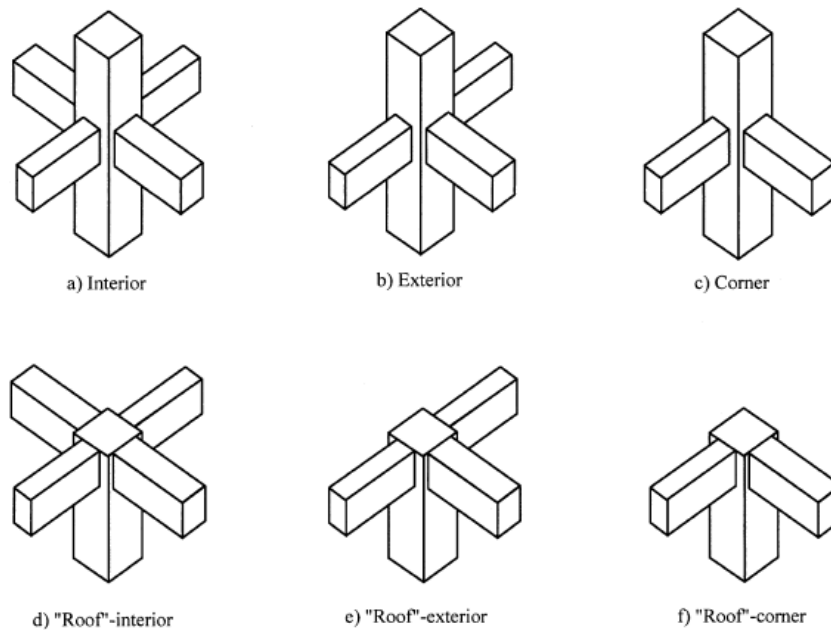
In the current ACI 352R-02 (Recommendations for Design of Beam-Column Connections in Monolithic Reinforced Concrete Structures), this subassembly was also named as “exterior beam to column connection”. Figure 3.2 illustrates the typical beam-column connections (slabs not shown for clarity) in ACI 352R-02.

Figure 3.2. Typical beam-column connections.

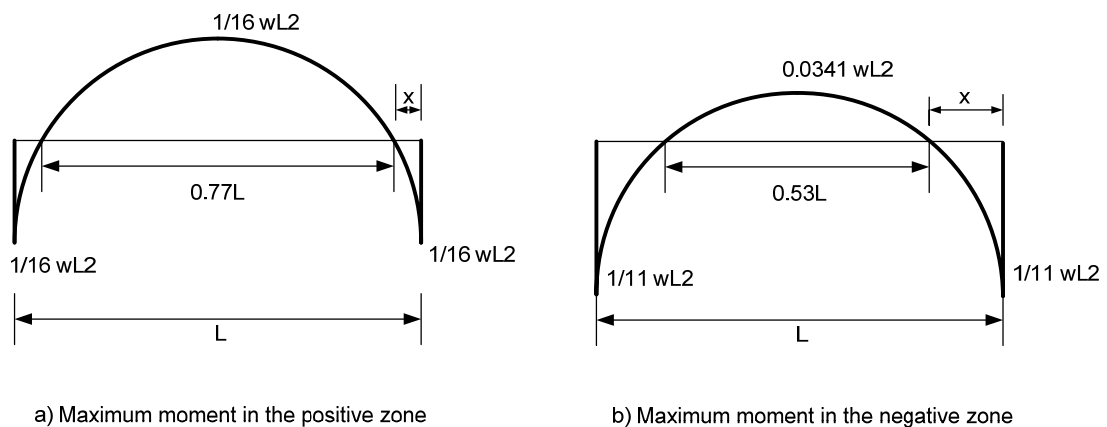
Last important concern is the moment diagrams of the beam under gravity loads. Figure 3.5 illustrates the approximate moment diagrams given by ACI 318, Section 8.3.3. The distance x is assumed as the point of inflection (zero moment point) of the beam. In this approach, the length of transverse beam was calculated between 265 mm and 700 mm in calculation of moment for positive and negative zones.

Figure 3.5. ACI approximate moment diagrams

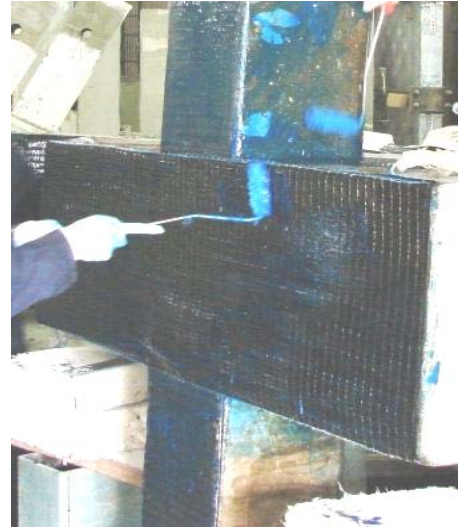
After application of column flexure sheets, 6 layers of 500 mm width CFRP sheets were applied to the north side of the transverse beams and joint core in order to increase the shear and torsion capacity of the transverse beam and to prevent the spalling of joint core (see Figure 3.13).

Figure 3.13. Application of CFRP on backside of the specimen

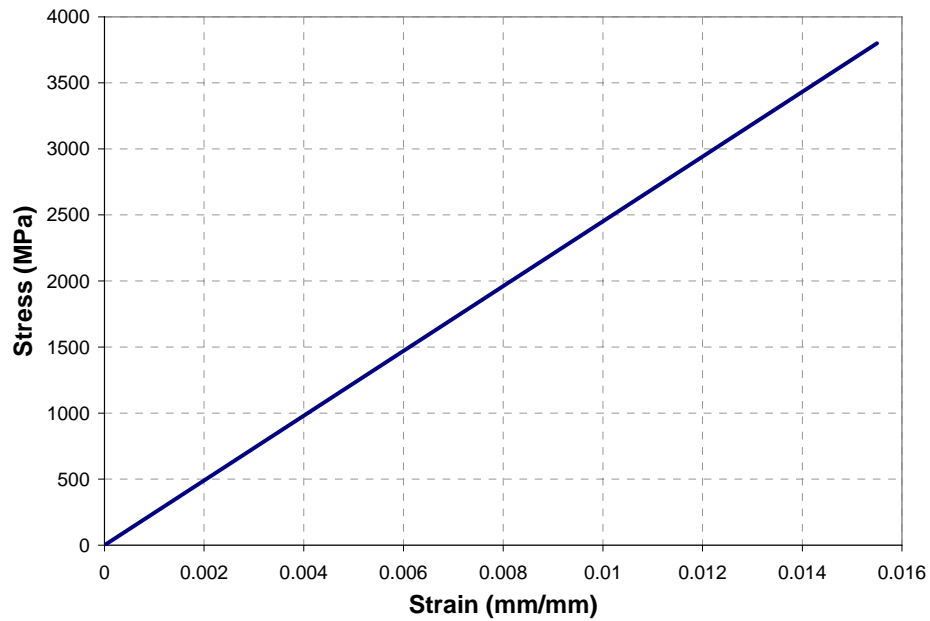
Nominal Thickness	0.176 mm/ply
Ultimate Tensile Strength (0°)	3800 MPa
Tensile Modulus (0°)	240 GPa
Ultimate Rupture Strain (0°)	1.55 %

Figure 3.23. Stress-Strain Relations of CFRP

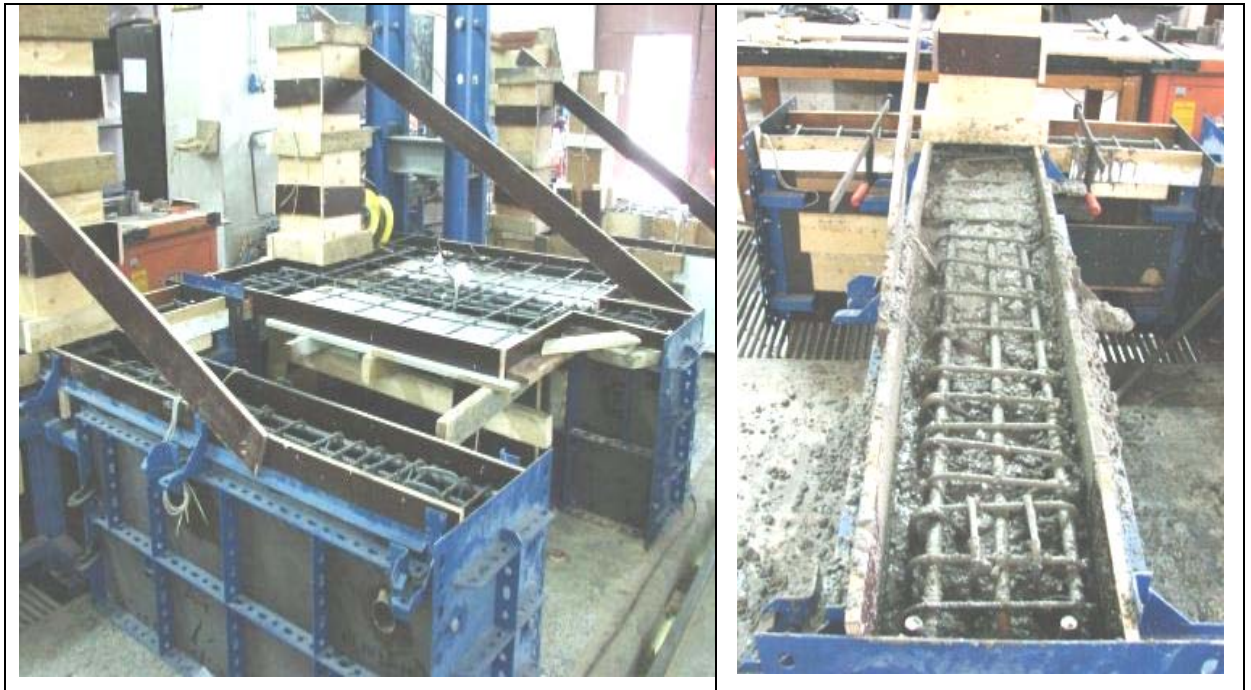
Test specimens were constructed in the Structure Laboratory of Boğaziçi University. Steel and wooden formworks were used to cast the subassemblies and all formworks were produced at once, and therefore all specimens were constructed at the same time. The forms were greased prior to concrete casting, to prevent concrete moisture loss and to help in the process of formwork removal. All longitudinal and transverse reinforcement steel bars of beam, column and floor slab were prepared in the laboratory according to shop drawings. The strain gauges were installed at key positions on the reinforcing bars after the bars assembled into steel cages and before placing into the formwork. Strain gauge wires were carefully arranged and protected during concrete pouring. 70 mm diameter steel pipes were installed on specified locations of the formwork to maintain proper support conditions on the test setup. The concrete was placed in the upright position of the form, as in field construction. The concrete was carefully vibrated with electric vibrators for proper consolidation. For each subassembly, all members were cast at once, using concrete from a local ready-mix concrete supplier. Figure 3.24 illustrates the pictures taken during production of the test specimens.

Figure 3.24. Construction of specimens

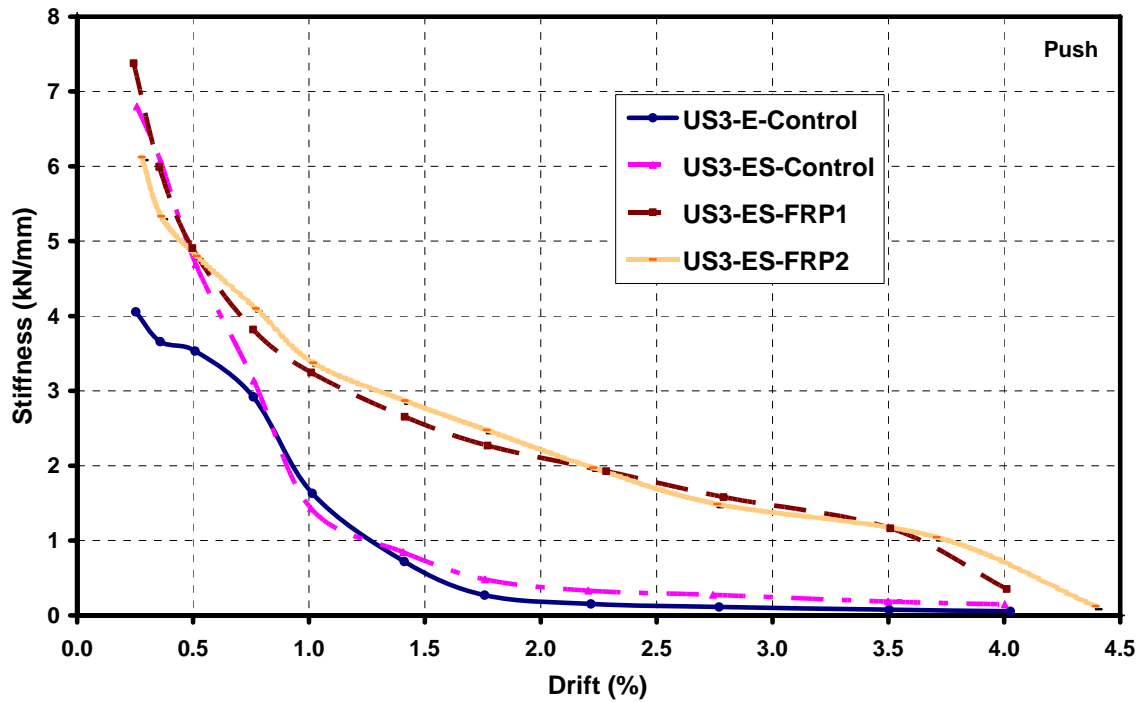
Figure 4.15. Comparison of stiffness degradation in push direction

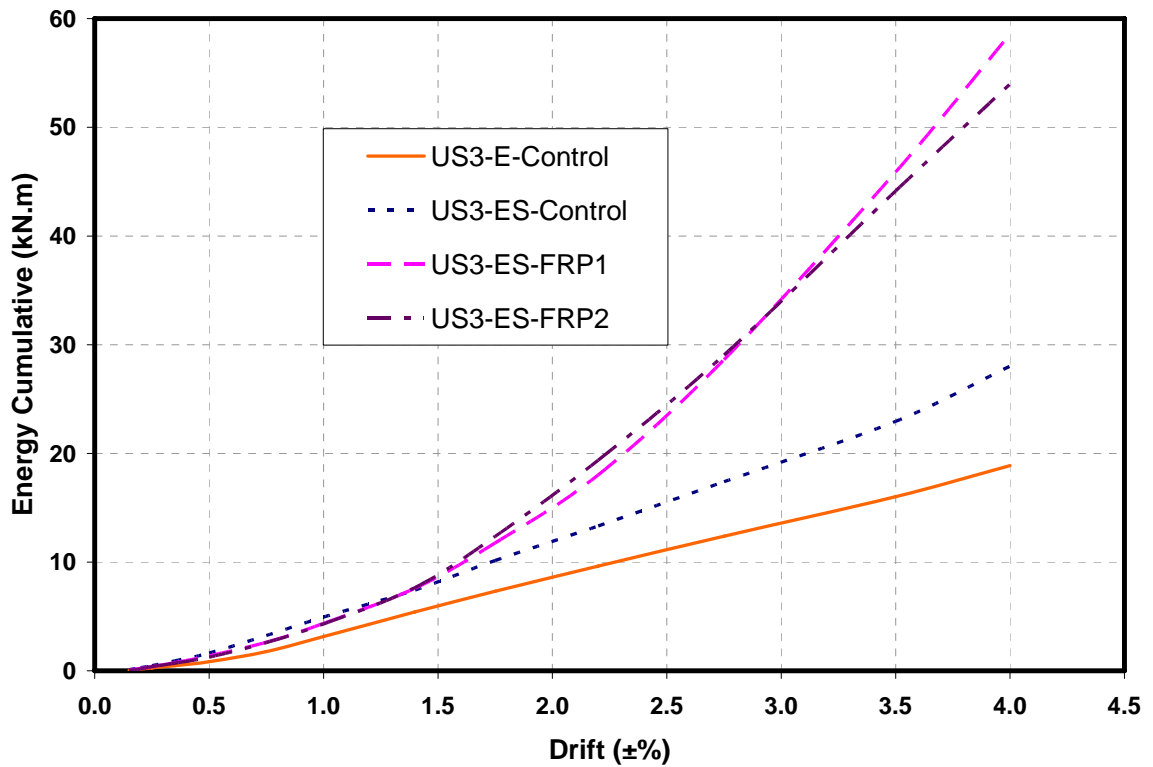
Figure 4.25. Comparative graph of cumulative energy dissipation

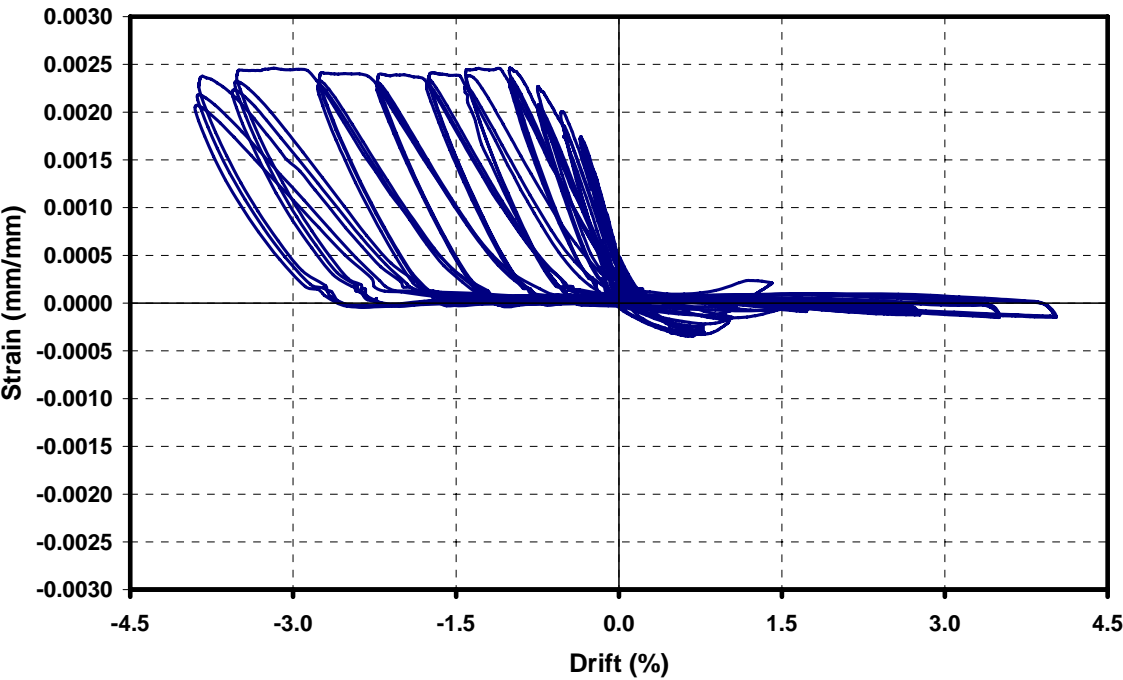
Figure 4.36. Strain versus drift graph of gauge #5 for US3-E-Control

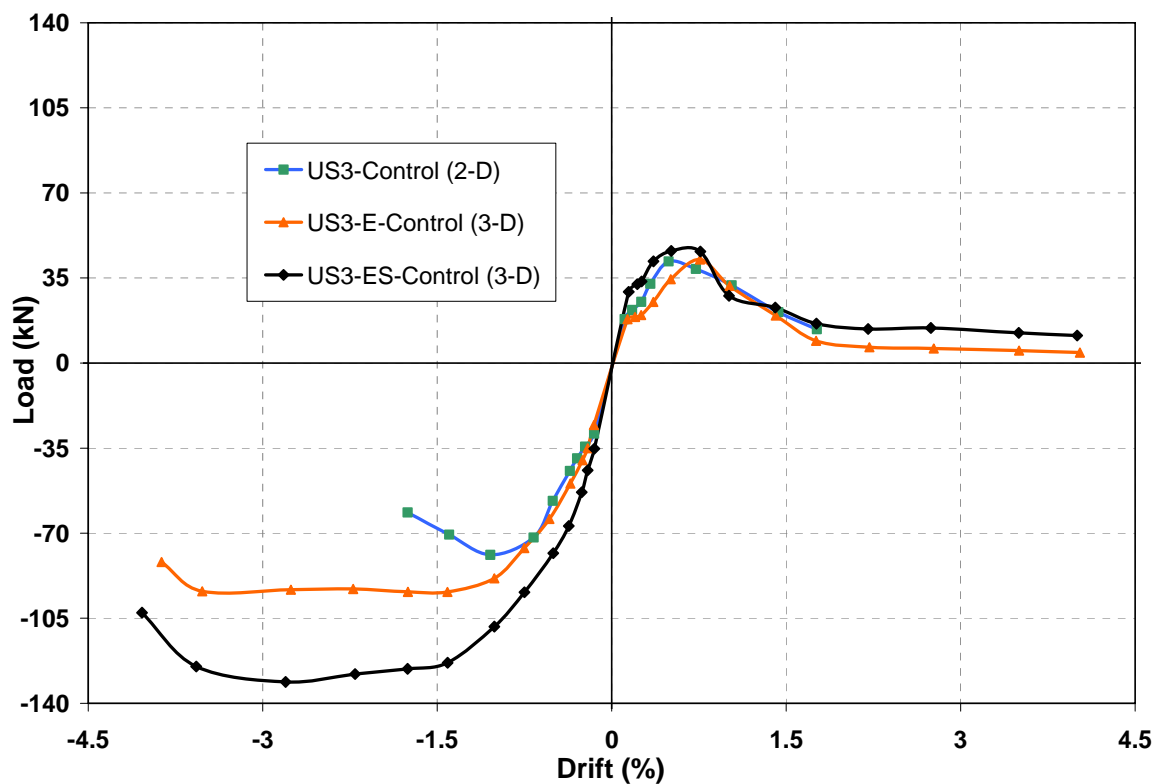
Figure 4.67 Comparison of test results of 2-D and 3-D specimens
