SEISMIC RETROFITTING OF R/C FRAMES WITH DEFICIENT LAP SPLICES

Master of Science

Graduate Program in Civil Engineering

Boğaziçi University

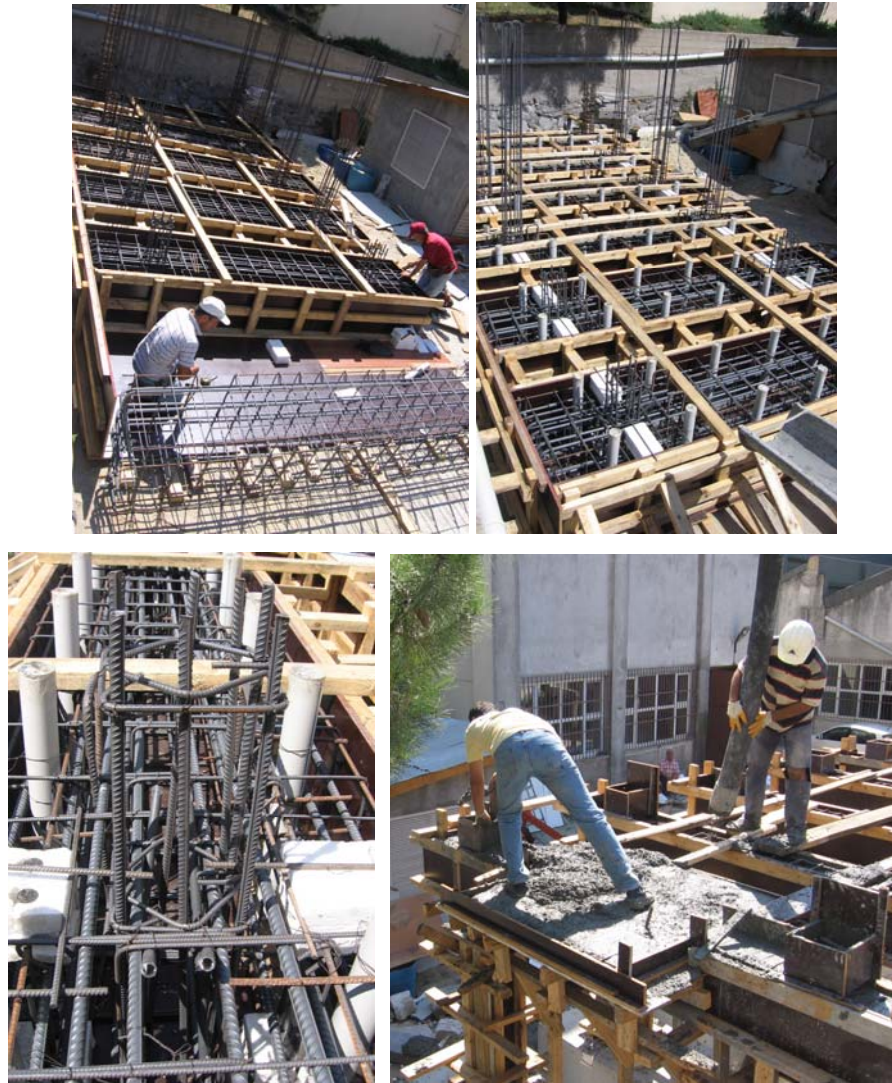
Three reinforced concrete frame specimens were constructed at the Structures Laboratory of Boğaziçi University. The pedestals of the specimens were first constructed, followed by construction of the columns and the beams. Figure 2.13 shows various stages of construction of the test specimens.

Figure 2.13. Production of Test Specimens

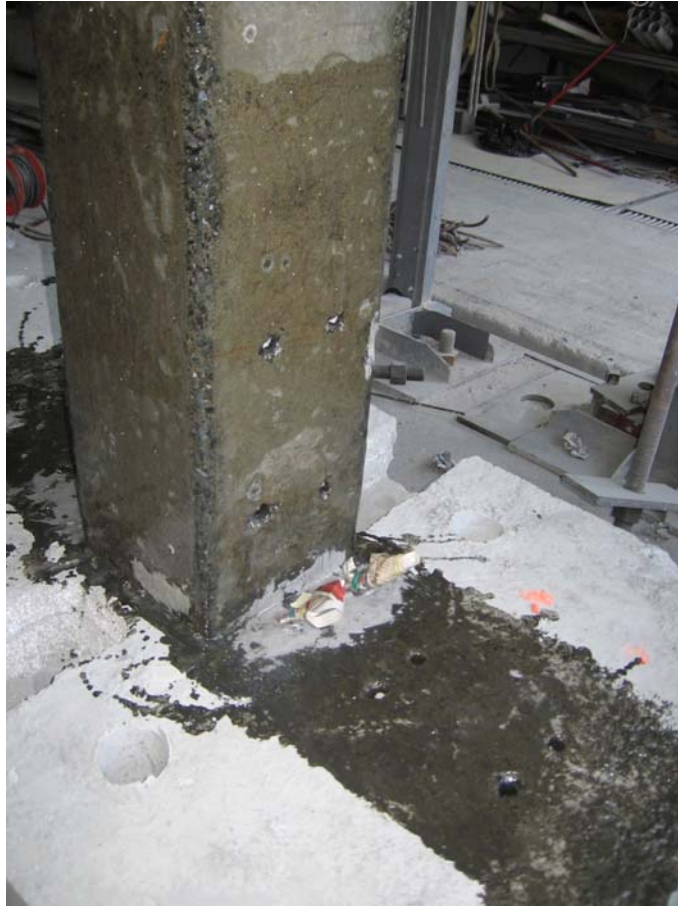
A primer (*MBrace Primer*), which helps the adhesion of the CFRP to the concrete, was applied to the surfaces with roll brush. A 24-hour curing time was passed prior to application of the CFRP (Figure 2.17).

Figure 2.17. Primer Application

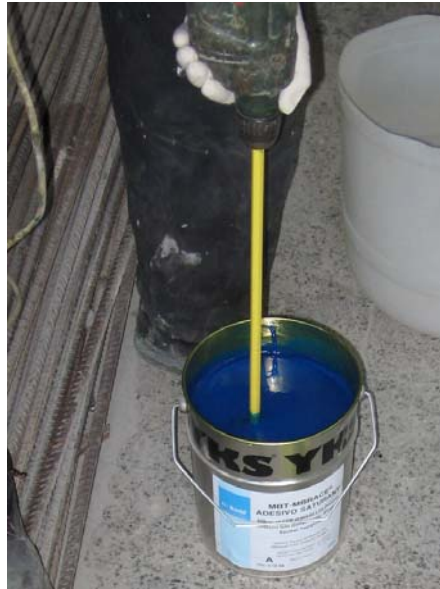
After the primer was cured, the two components- epoxy adhesive of CFRP, *MBrace Adesivo (Saturant)*, was prepared and CFRP fabrics were installed on the lap spliced region. It was made sure that, no air pockets remained under the CFRP sheets. It should be noted that the epoxy mix has approximately 30 minute working time before it gets hot and dense (Figure 2.18)

Figure 2.18. Epoxy Matrix

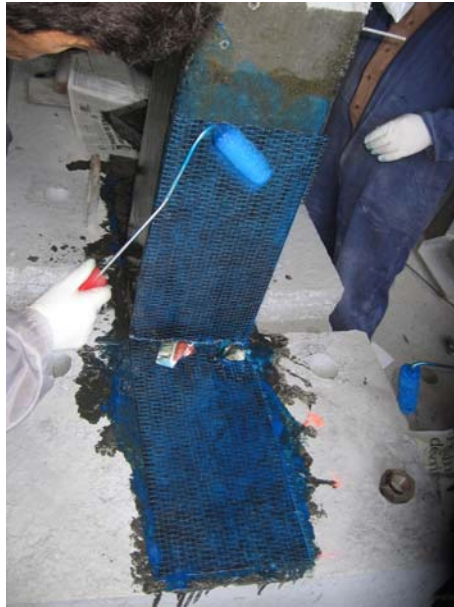
For increasing the flexural capacity of the columns, in the deficient lap splice region, three layers of “L shaped” CFRP sheets were applied on the exterior and the interior surfaces of the column - footing intersections. These “L shaped” CFRP sheets were intended to act as supplemental longitudinal reinforcement for the columns in the splice region. Application of the “L shaped” CFRP sheets are shown in Figure 2.21.

Figure 2.21. "L Shaped" CFRP

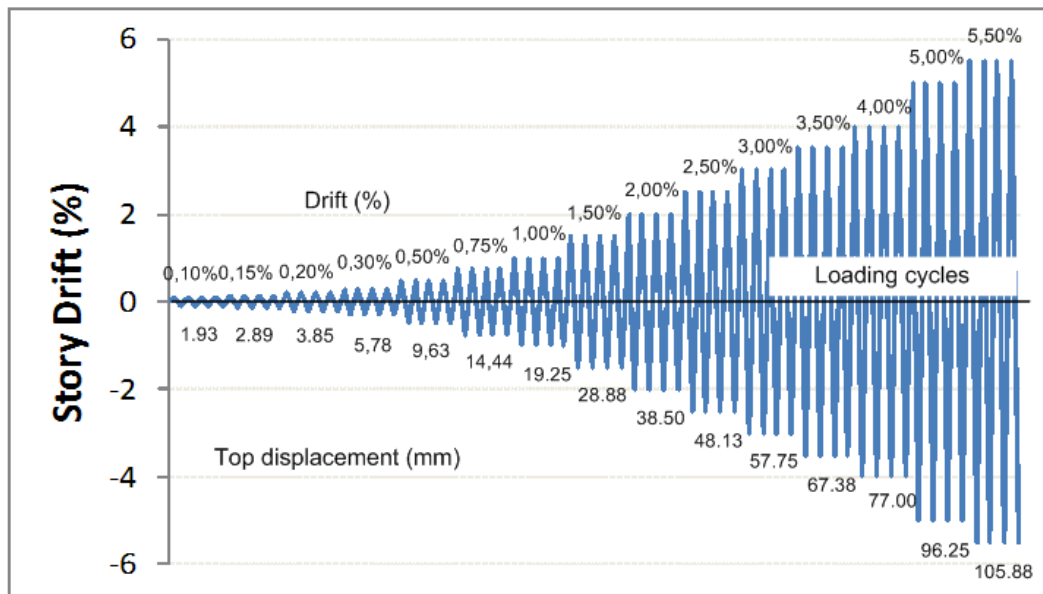
The lateral load was applied based on the displacement control criteria. The loading cycles are shown in Figure 2.25. Approximately 35-40 reversed cycles, depending on the behavior of the specimen, were applied throughout the test. All data was collected with a TML 602, 50 Hz. and 50 channel data acquisition system. Observations on cracks on concrete surface, CFRP fractures and debonding, and failure modes were recorded in each of 3-cycle loading set.

Figure 2.25. Loading Protocol

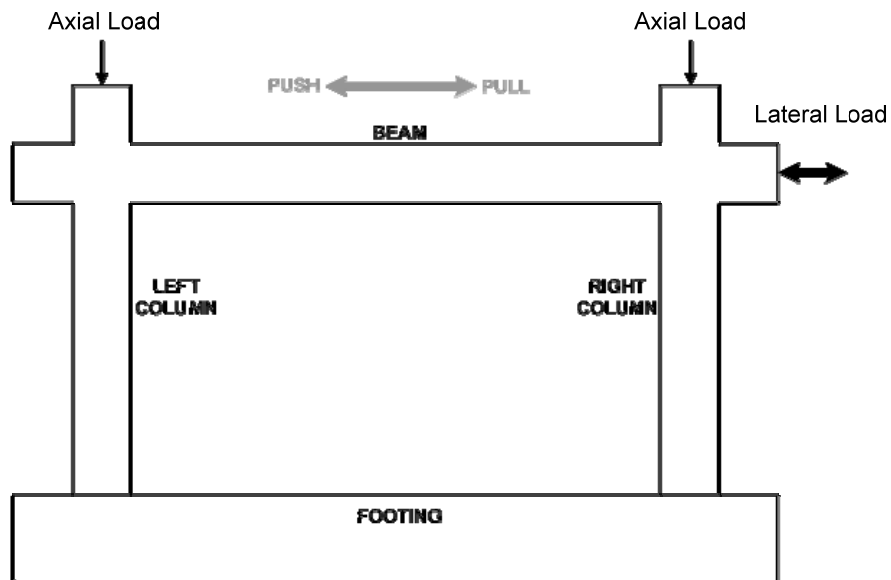
This chapter describes the observed behavior of the specimens tested and presents the data obtained from the experiments. In the explanation of the behavior of the specimens, the location of the cracks and observations are referenced according to the nomenclature depicted in Figure 3.1.

Figure 3.1. Nomenclature of the Structural Members

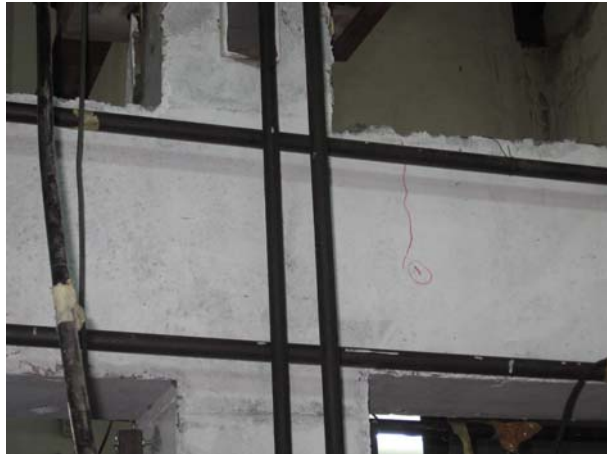
At the first drift level, which is 0.10 %, when the specimen was forced in the pull direction with a peak force of 35.5 kN, a 200 mm long- flexural crack formed at the top of the beam, at 90 mm distance from the right column (Figure 3.2). The second flexural crack developed symmetrically at the top of the beam, at a distance of 180 mm from the left column. The length of the crack was measured at about 90 mm. During subsequent drift levels, up to 0.30 %, existing flexural cracks were extended and new cracks were formed on the beam.

Figure 3.2. The first Flexural Cracks on Beam in Control Specimen

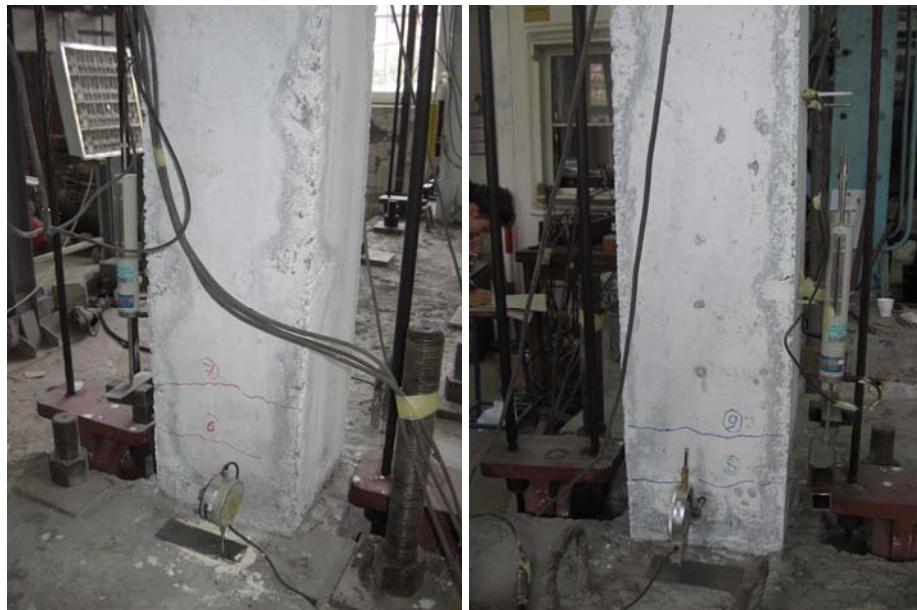
The first column flexural cracks were observed during the cycles of 0.30 % drift levels when the applied load was 66 kN in the push direction. The locations of the cracks were 150 and 240 mm from the footing on the exterior face of the right column. Similar cracks were observed on the interior face of the same column in the pull direction of loading (Figure 3.3). A vertical crack on the column was observed at the right joint region at this drift level. Vertical cracks were observed on both left and right beam joint interfaces.

Figure 3.3. Column Flexural Cracks (exterior and interior)

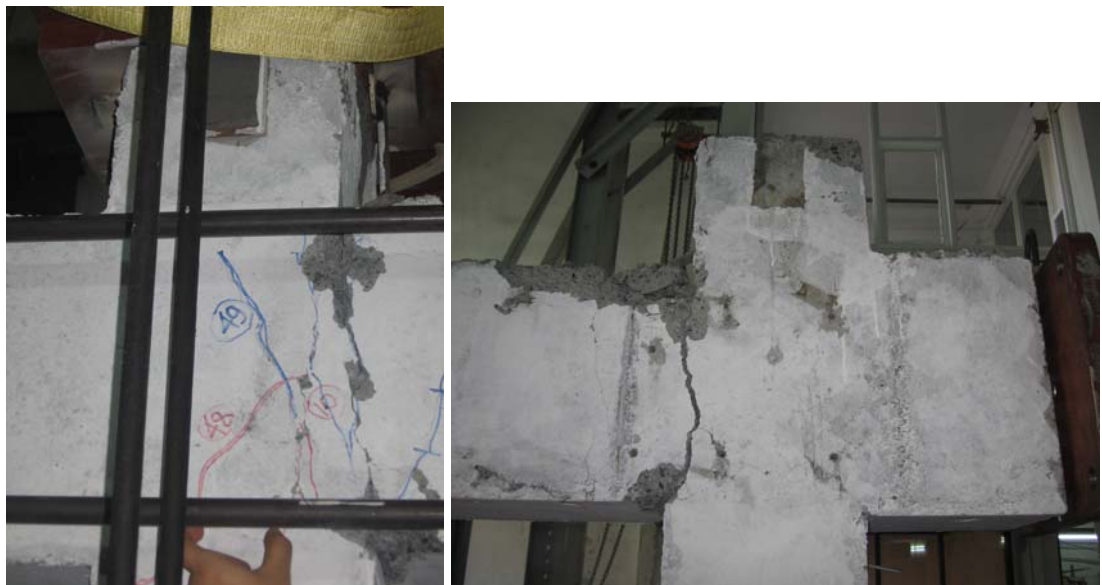
The first joint shear cracks were formed at a drift level of 5.00 % at the right beam-column joint region (Figure 3.4). Also, beam longitudinal reinforcement buckled at the maximum moment region. During the final cycles to 5.00 % drift level, the top longitudinal reinforcement of the beam fractured.

Figure 3.4. Joint Shear Cracks and Beam Crushing

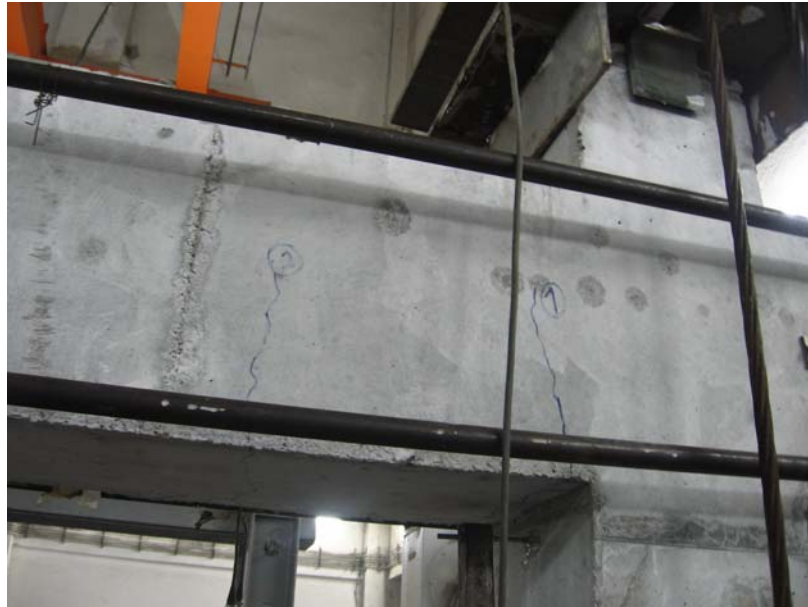
length of both cracks was almost 200 mm. During loading to cycles to 0.20 % drift, symmetrical flexural cracks observed on the right column side of the beam.

Figure 3.7. The First Flexural Cracks on the Beam in Specimen LS

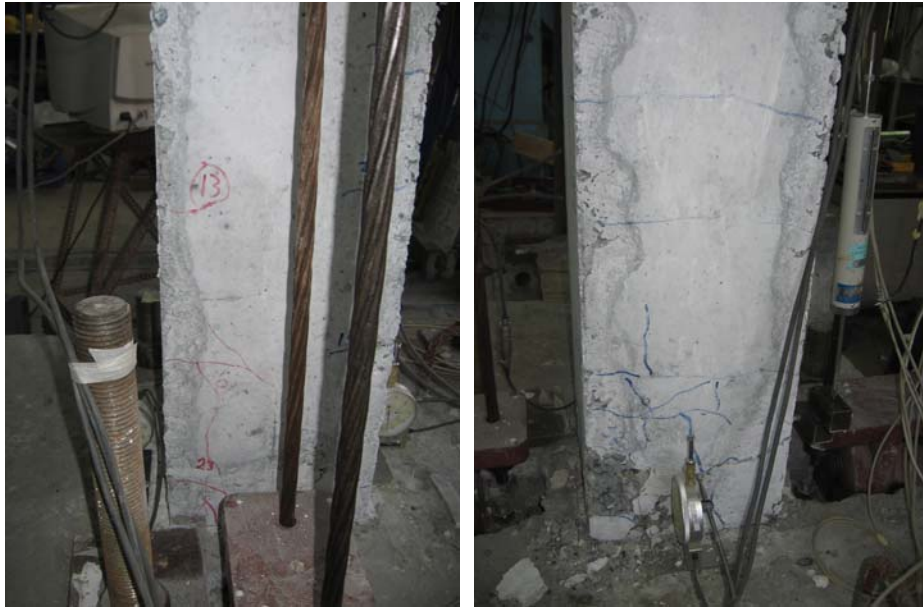
A vertical crack was formed at the beam column joints during the 3.00 % drift cycles. The crack initiated from the bottom interior corner of the right joint. A flexural crack also formed at the bottom region of the right column, at a distance of 260 mm from the footing.

Figure 3.8. Column Cracks of Specimen LS

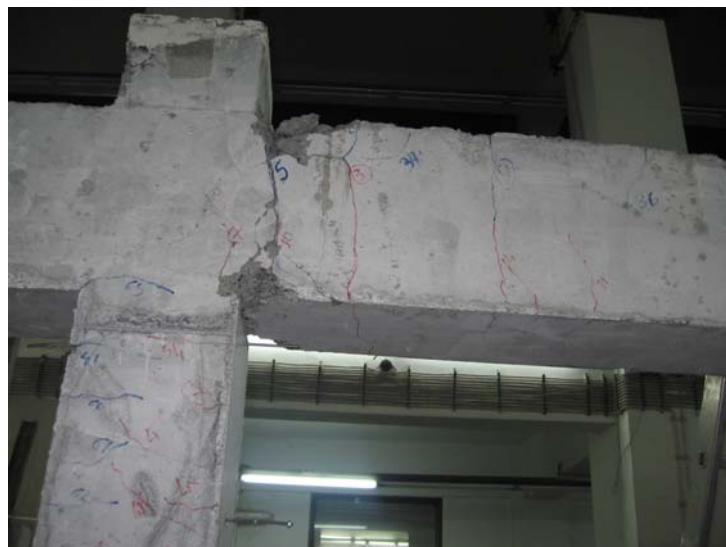
During loading to 3.00 %, 3.50 % and 4.00 % drift levels, the new vertical cracks developed in the columns lap splice regions. The horizontal cracks at the column - footing interfaces widened up to 8 mm, which also indicated significant bond-slip deformation. The width of the cracks on the beam reached 3.0 mm (Figure 3.9). The lateral load capacity, which was 140 kN for both the push and pull directions of loading was reached at a drift level of 3.00 %. The lateral load vs. top displacement and lateral load vs. story drift relationships for the specimen are shown in Figures 3.10 and 3.11 respectively.

Figure 3.9. Crackings of Beam and Column at the end of the Test for Specimen LS

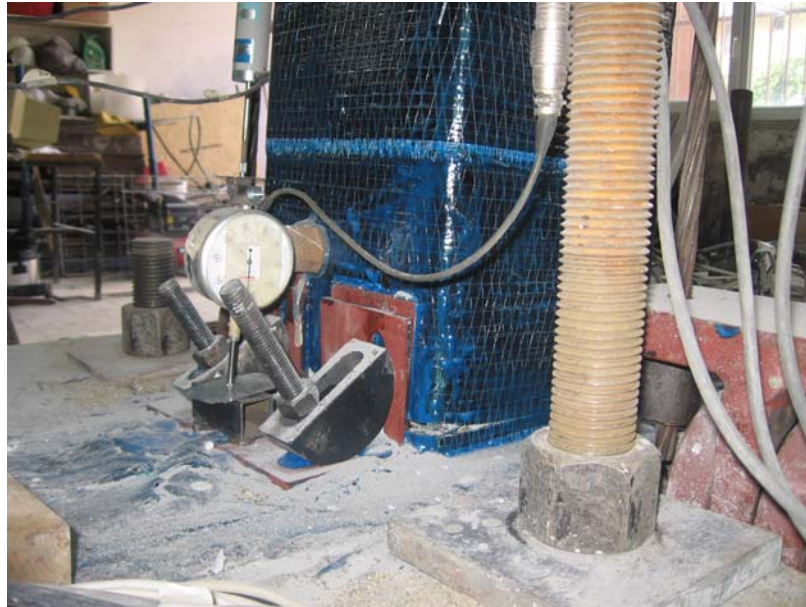
No damage was observed on CFRP in the lap splice region up to a drift level of 2.50 %. During the 2.50 % drift cycles, the CFRP material started to make cracking sounds. During subsequent cycles to 3.00 % drift, the CFRP was started to rupture when the lateral load reached a maximum level of 180 kN in the pull direction. 180 kN was the lateral load capacity of the specimen in both push and pull directions of loading. After 3.00 % drift level, the lateral load capacity of the specimen started to degrade due to progressive rupture of the CFRP (Figure 3.13). At the same time, the flexural cracks in the beam column joint interfaces continued to widen; however, no fracture of the beam reinforcement was observed.

Figure 3.13. Rupture of CFRP in Specimen LS FRP

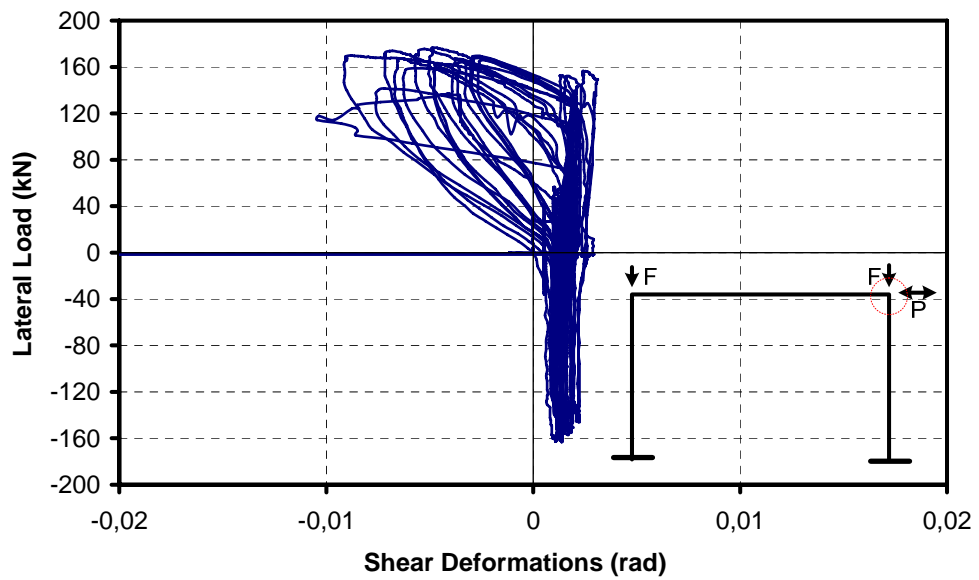
Figure 3.44. Load vs. Shear Deformations at the Right Joint Panel for Control Specimen

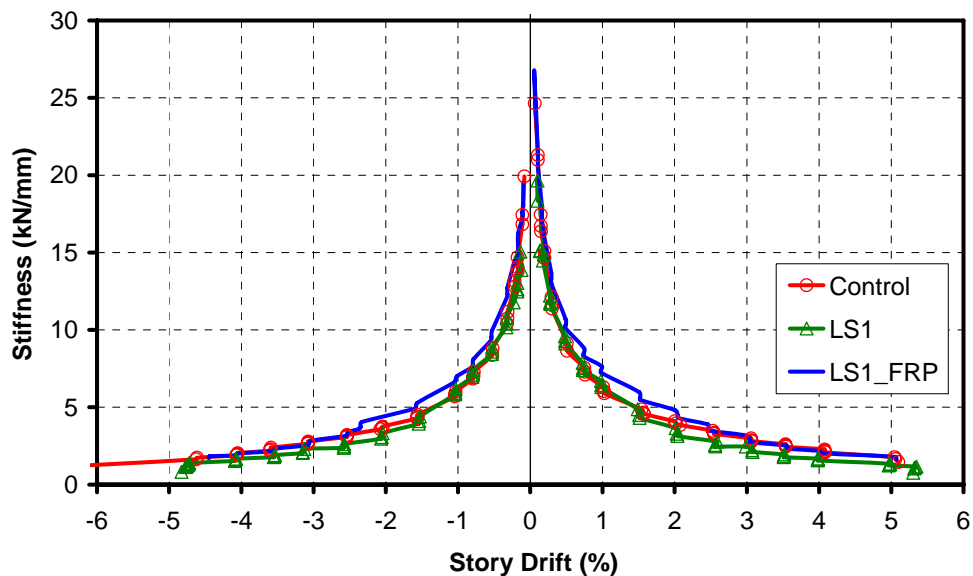
Measured story drift vs. stiffness relationships for the test specimens are presented in Figure 4.3. As observed from the Figure 4.3, as well as Figure 4.1, the initial stiffness of the strengthened specimen (LS-FRP) is higher than that of both the control specimen and Specimen LS. The rate of stiffness degradation was, however, faster in the strengthened specimen compared with the control.

Figure 4.3. Comparison of Stiffness Degradation
