AMBIENT VIBRATION TESTING AND SEISMIC PERFORMANCE  
ASSESSMENT OF HAGIA IRENE

Submitted to the Institute for Graduate Studies in  
Science and Engineering in partial fulfillment of  
the requirements for the degree of  
Master of Science

Graduate Program in Civil Engineering  
Boğaziçi University

2021

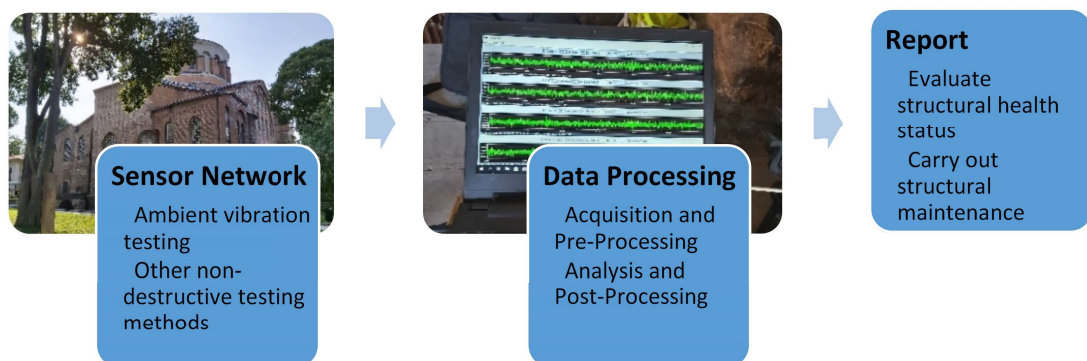
Figure 2.1. Typical Structural Health Monitoring System

In Figure 2.1, a typical structural health monitoring system is shown. There are three main steps in a structural health monitoring system. These are the sensor network, the data processing tool and the final evaluation or report. The sensor network depends on different variables such as the type of damage, the architecture of the structure and even weather conditions. The sensor network is created by using several sensors of the same type, for example accelerometers. The raw data obtained from these

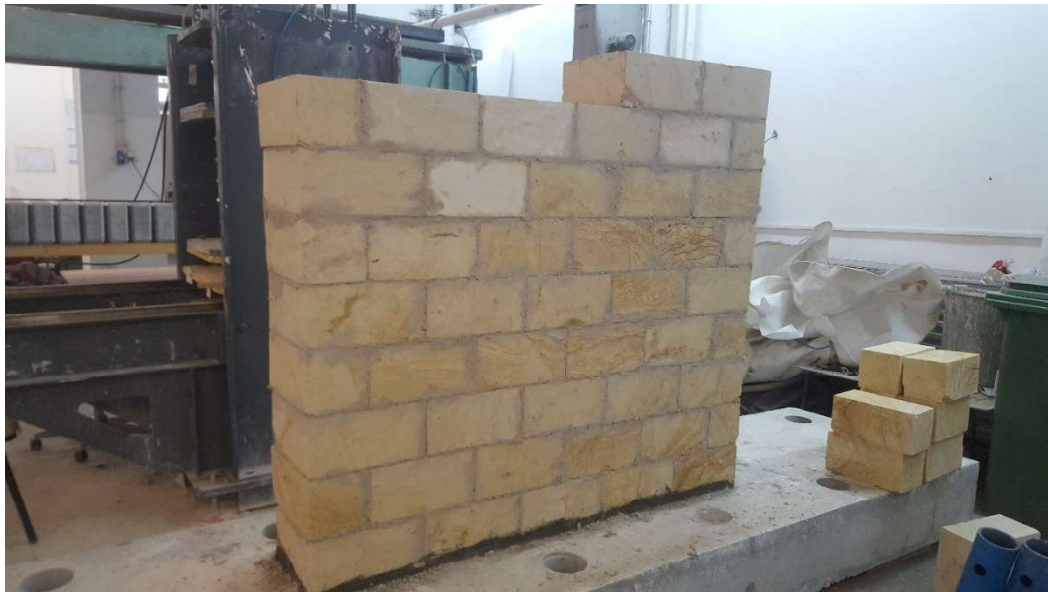
To research of elasticity modulus of stone masonry, a research was conducted in Boğaziçi University [22]. In this thesis, the results obtained and methods used for this research were also used. A wall with the dimensions of 1.5 m x 1.5 m x 0.3 m was constructed using pre-cut limestone blocks with the dimensions of 0.3 m x 0.3 m x 0.15 m and 0.15 m x 0.3 m x 0.15 m. The wall was constructed on a concrete slab. The mortar used in the construction consists of mainly lime. There is almost no cement in the mortar mixture. After the construction was over, the wall was left to cure for a month.

Figure 4.1. The Wall Under Construction

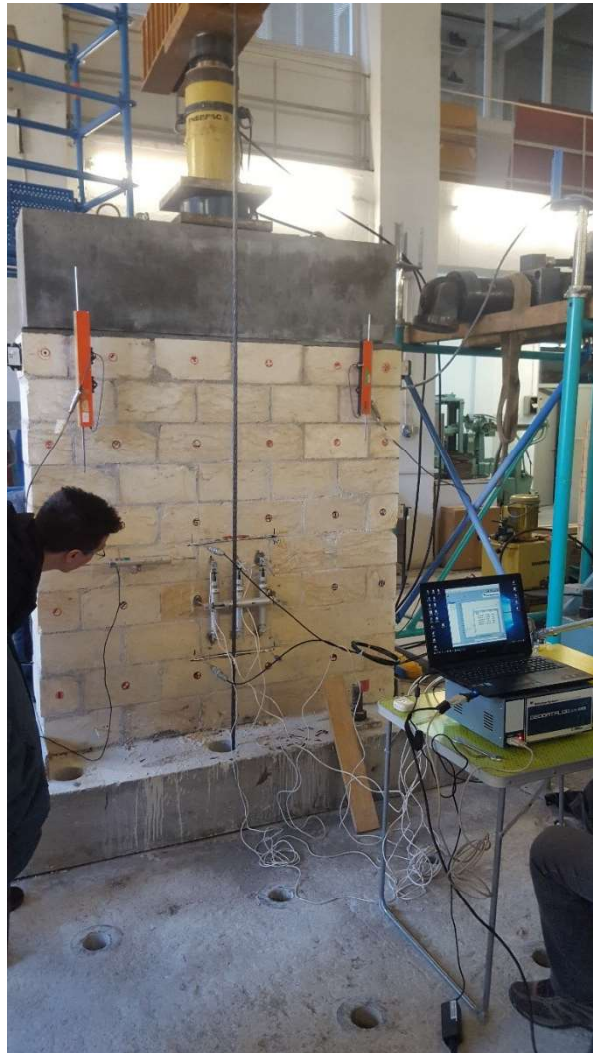
Figure 4.2. Masonry Wall During Flat Jack Test

In Figure 4.2, the preparations for the testing can be seen. There is a concrete slab underneath the wall and a concrete beam over the wall. On top of the concrete beam is the piston and another steel beam. They are used to create the compressive forces on the wall. Steel cables are connected to the steel beam and to the ground. When the piston tries to push the steel beam upwards, the cables hold the steel beam in-place, exerting compressive forces on the wall. Before the actual cyclic test, a flat jack test was done on the wall under the compressive forces to determine the material properties of the masonry. Separate tests on brick and mortar specimens were also conducted to determine their individual material properties.

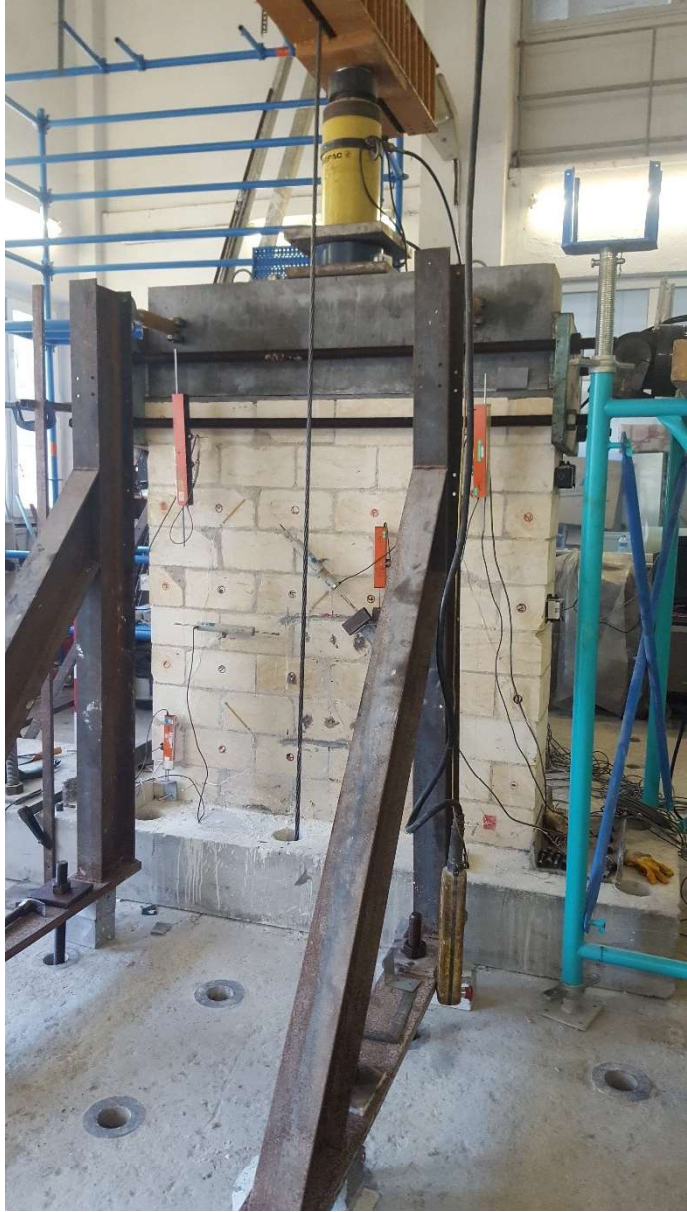
After the ambient vibration test, the preparations for the cyclic test started. The head of the hydraulic press is bolted to a steel plate. The plate was placed so that the hydraulic press would push at a location in between the top of the wall and the concrete beam. Before starting the test, strain gauges and LVDTs are placed at both face of the wall. There were also LVDTs measuring the displacement of the foundation slab, since the system can slide. The final testing system and its sketch with the instrumentation layout are shown in Figure 4.4 and Figure 4.5.

Figure 4.4. Final Testing System

Figure 4.5. Final Testing System Sketch

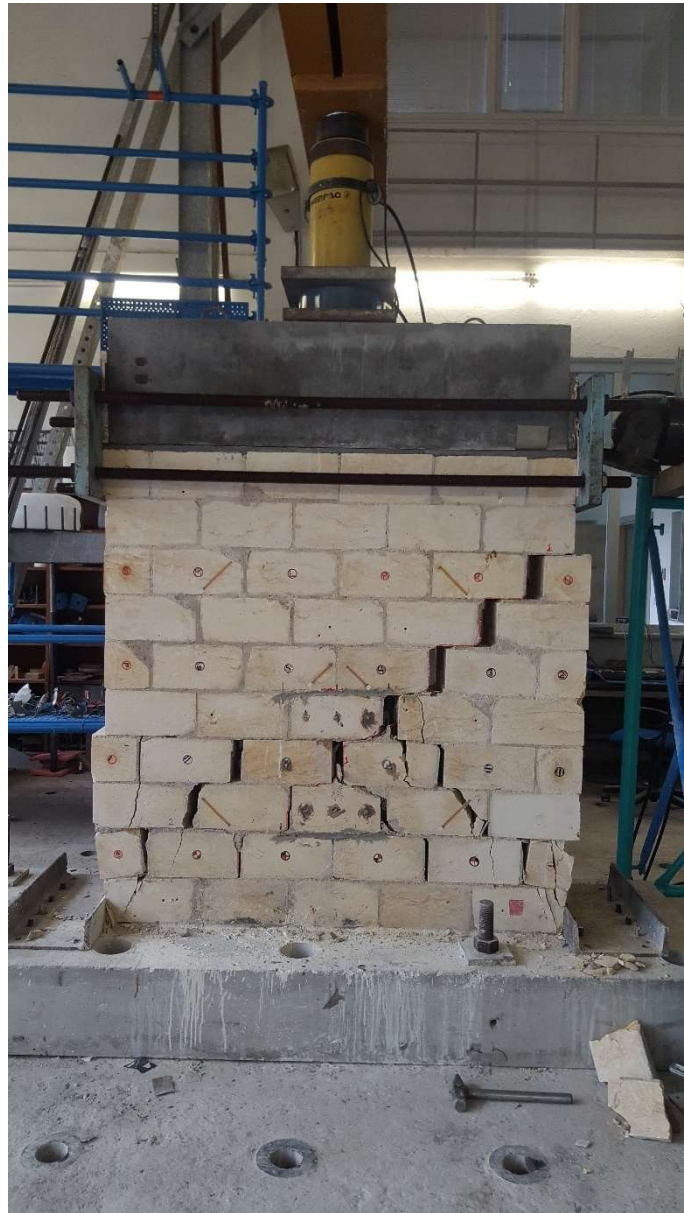
Before the cyclic test started, the wall was loaded with 20 tons of vertical loading. the load pattern for the cyclic loading test was very simple. Starting from very small displacements ( $<1$  mm), the displacement value was gradually increased. The wall was pushed to the target displacement value, then was returned to initial state, and then was pulled to the target displacement value. For each displacement value, this cycle was repeated for three times. After the cycles of the first two displacement values, which were both smaller than 1 mm, the cycle for a displacement value was conducted once, until visible damages started occurring on the wall. At every stage of the loading, the state of the wall was inspected. Any occurring damages were noted down with its corresponding displacement value. The test was over after the wall was heavily damaged. After that, to determine the natural frequencies of the damaged wall, measurements with accelerometers were taken.

Figure 4.6. Damaged Wall After The Test

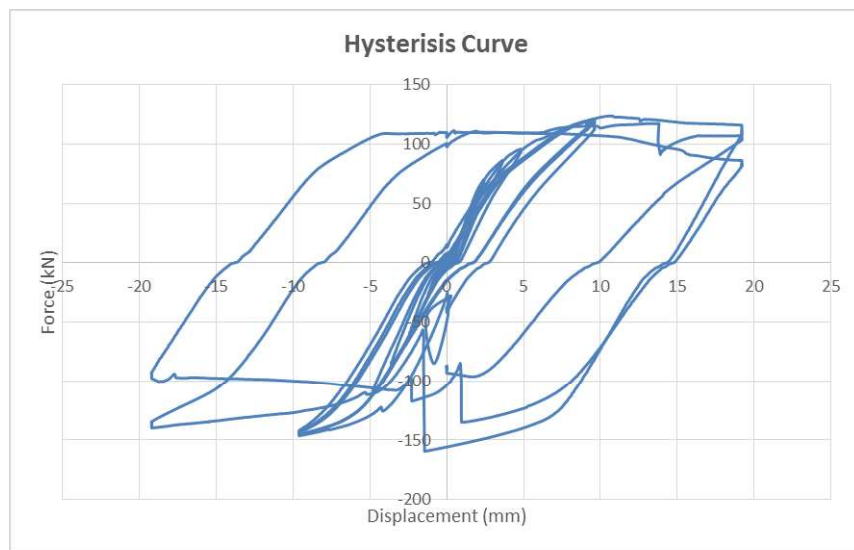
First of all, the hysteresis curve obtained from the cyclic loading test must be inspected. In Figure 4.10, the hysteresis curve is shown. Here, it is evident that the Young's Modulus of the wall changes as the wall was being pushed to greater displacement values. The Young's Modulus gets smaller as more damage is accumulated on the wall.

Figure 4.10. Hysteresis Curve obtained from Cyclic Test

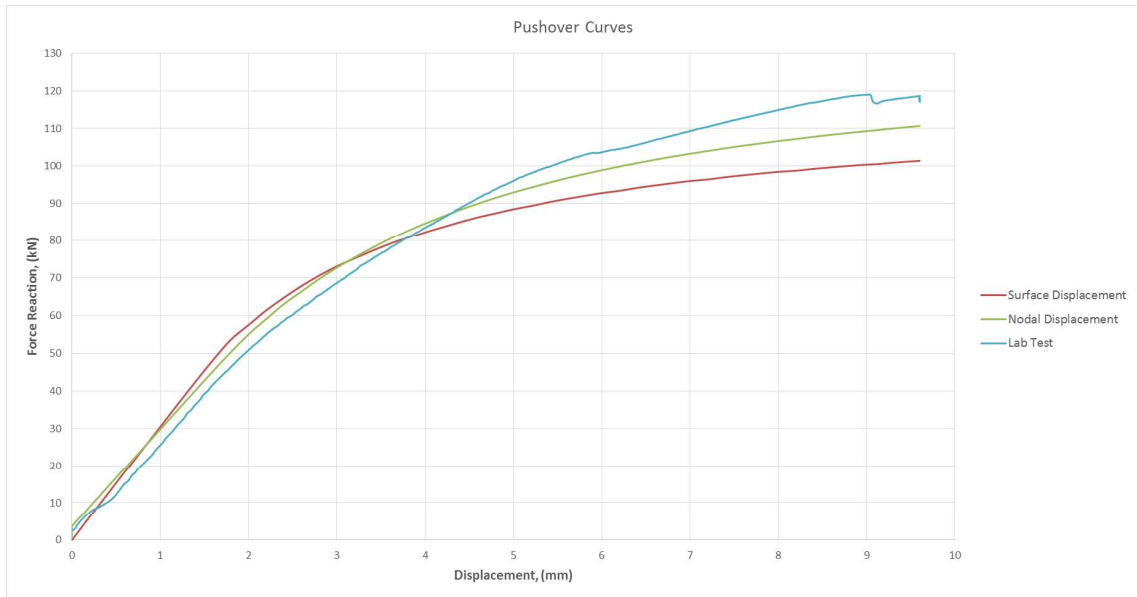
The shear results are not the only parameters which were compared. While loading the wall to the predetermined displacement values during the lab test, the reaction forces were also recorded aside the displacement values. Using these reaction forces and the displacement values, pushover curves were created for the lab test and the individual finite element model cases. In Figure 4.18, the comparison of the actual test data and the data obtained from the finite element model cases are shown.

Figure 4.18. Experimental and Numerical Pushover Curves

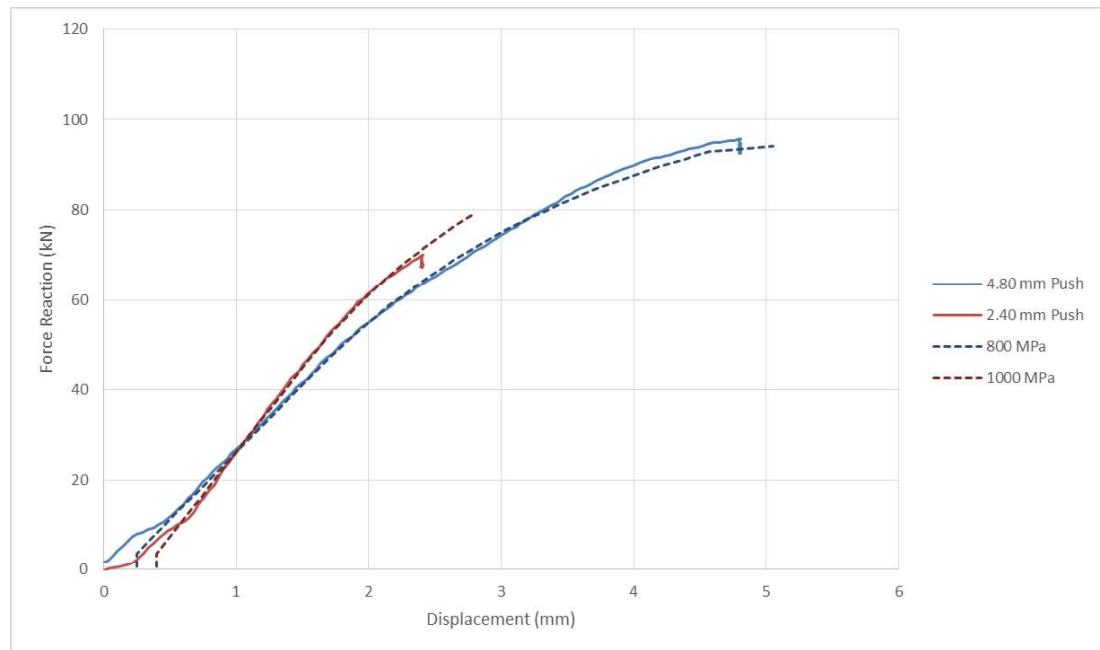
The change of the Young's Modulus can be seen in Figure 4.19. As the displacement values increase, the wall gets damaged and the Young's Modulus value grows smaller. The curves for smaller displacements values such as 1.2 mm and 0.6 mm follow the same path of the displacement value of 2.4 mm, therefore they are not shown. The finite element model was pushed to smaller displacement values to obtain the curves with the dashed lines. The solid lines are the results from the cyclic test. The results from the finite element model were shifted in the x-Axis to be able to better compare the slopes of the dashed and solid lines.

Figure 4.19. Young's Modulus Change

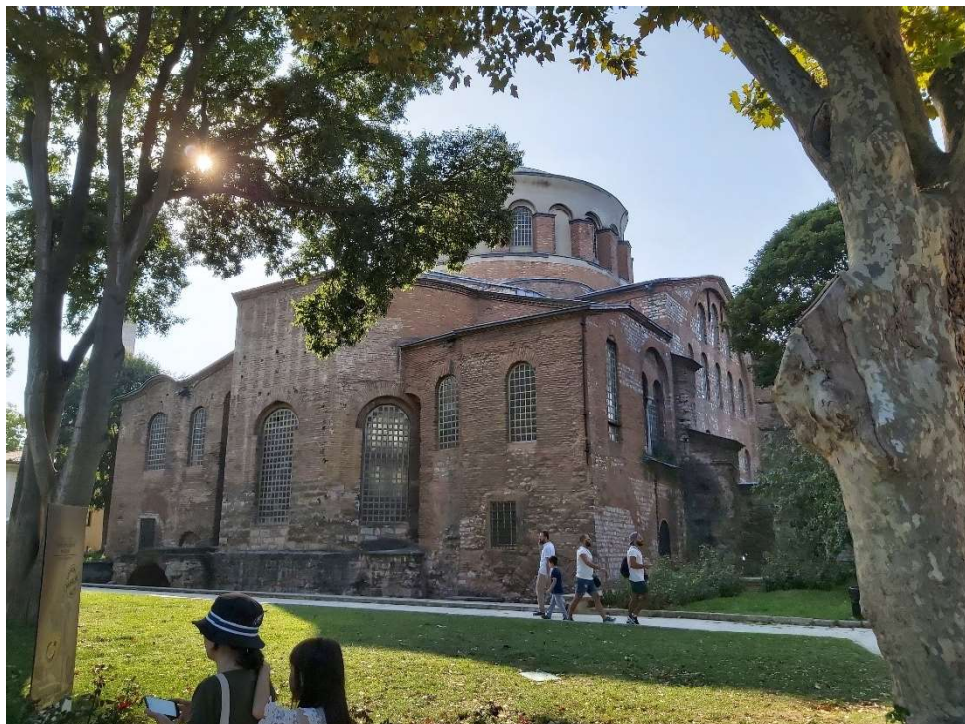
Rebuilt in 548, 15 years after its destruction during the Nika riots, Hagia Irene is a phenomenal example of the early era Byzantine domed basilicas. Although it could never rival the magnificence of Hagia Sophia, it remains the second largest Constantinopolitan church which has survived until today. The base plan of the church measure around 58 m x 30 m, without the atrium. The church is defined as a paradigmatic domed basilica with two aisles and a nave. The aisles and the nave open into the central space. The large dome which is still present in its original state nowadays, has a diameter of approximately 15 m. With a height of 35 m, the dome rests on four brick arches on four sides supported by four massive pillars. It has twenty windows, but most of them are closed. The smaller dome also rests on four arches supported by four pillars. It is almost 27 m high and has an elliptical plan with diameters of 11 and 14 m.

Figure 5.1. Hagia Irene from Outside

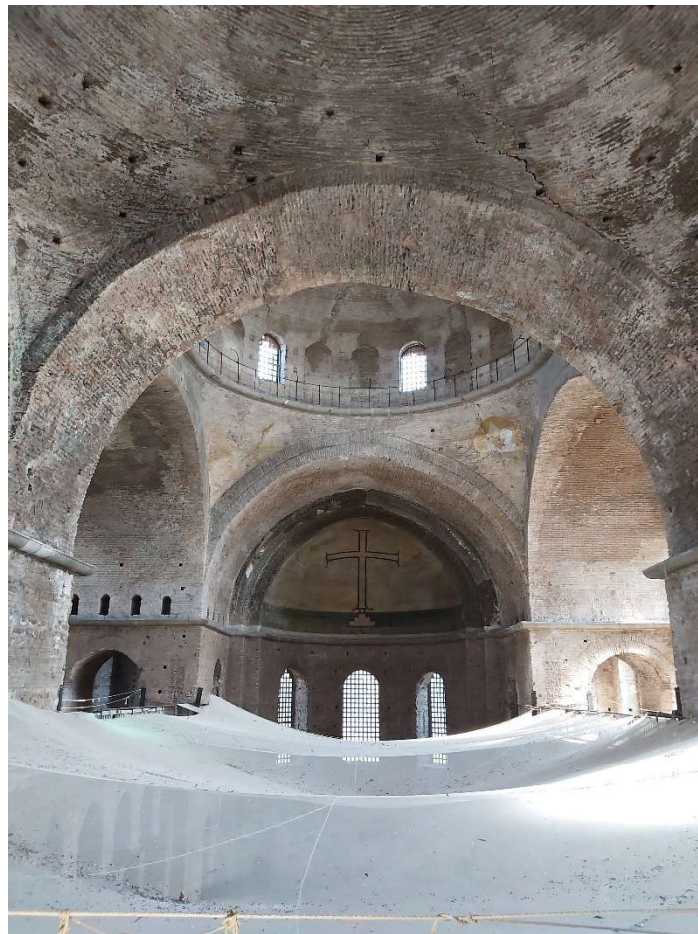
The aisles on the both sides of the central space are two storeyed and have rectangular plans. The dimensions are approximately 40 m in length and 5.50 m in width. The aisles are divided into subparts by arches. In the second floor, or the gallery floor, the aisles are divide into three subparts by the arches sitting on the pillars on both sides. The aisles are covered with two thick arches supporting the domes. The walls separating the aisles from the outside have numerous windows, especially the ones on the gallery floor.

Figure 5.2. Hagia Irene Inside

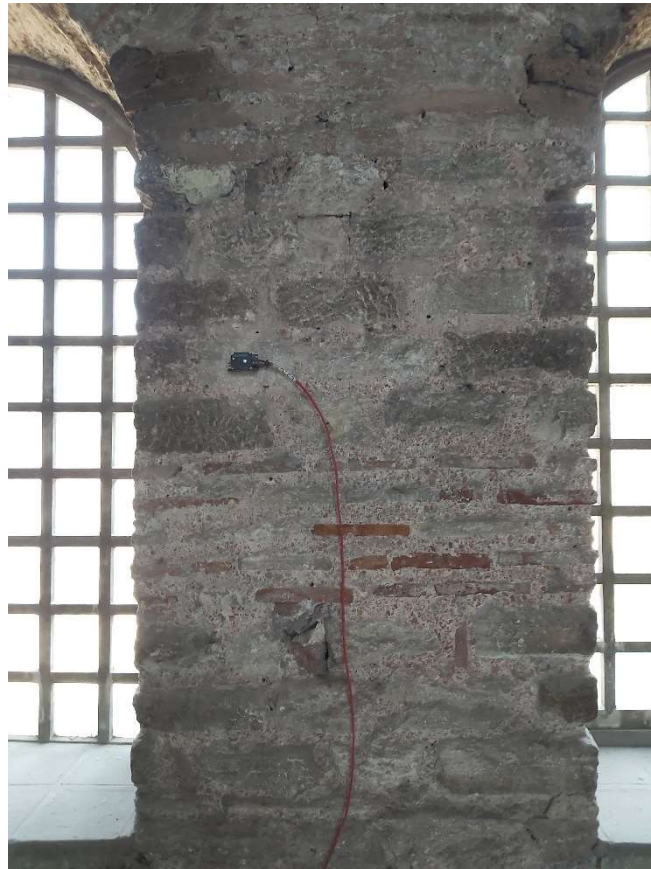
Secondly, the accelerometers were placed. There were 10 accelerometers attached to each of the stations, in total 20 accelerometers. The accelerometers were placed in different locations on the walls or on the ground along the aisles. They were fixed in their locations using molten silicon. The fixed accelerometers are shown in Figure 5.4 and 5.5.

Figure 5.4. Accelerometers on the Ground, in Two Different Directions

Figure 5.5. Accelerometer on the Wall

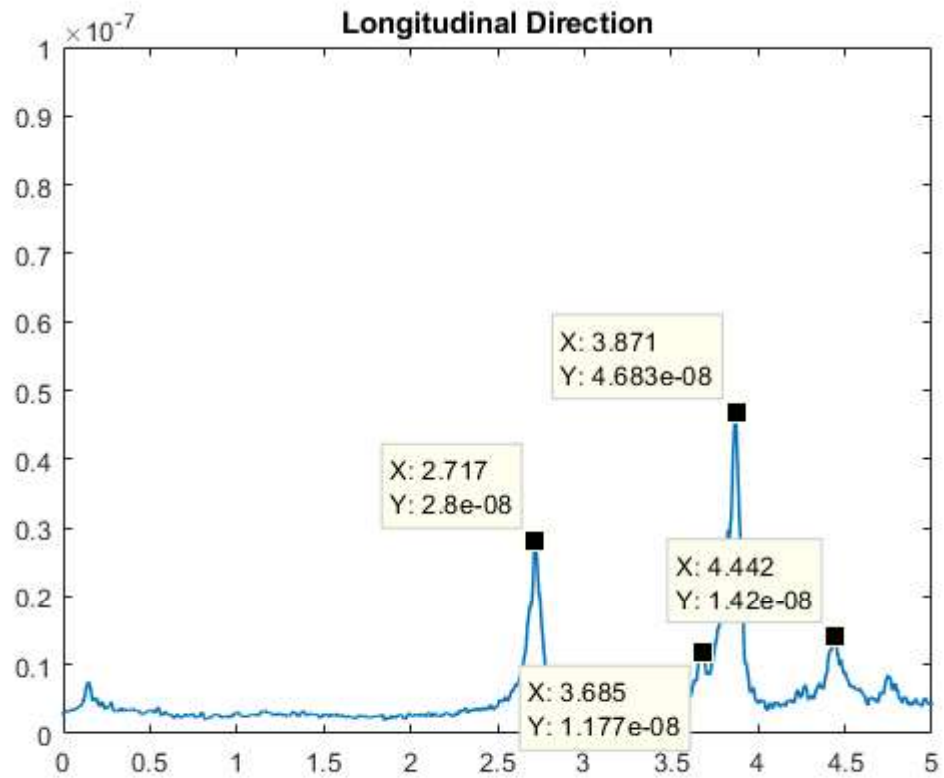
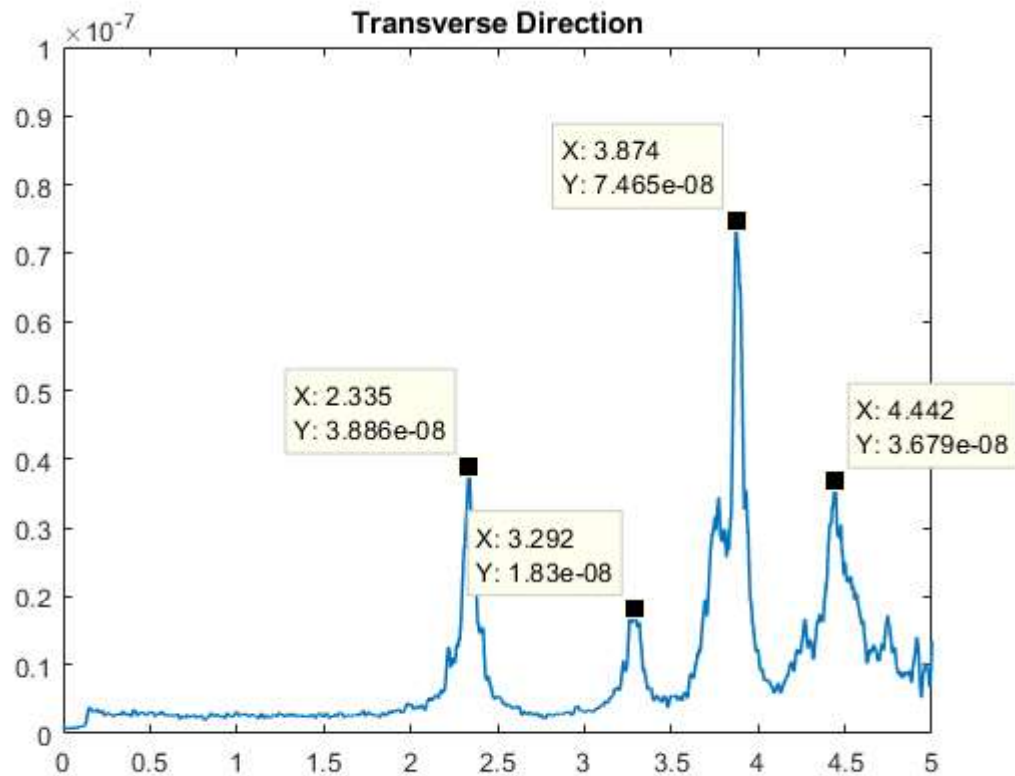
Set 1 was chosen for the signal analysis and modal identification. The peaks show the fundamental frequencies of Hagia Irene in longitudinal and transverse directions. In Figure 5.7 and Figure 5.8, the Fourier amplitude functions of the two directions can be seen. The effects of the Savitzky-Golay filter can also be clearly inspected in these figures. The peaks defining the modal frequencies were searched in the interval of 0 Hz to 5 Hz, resulting in the discovery of 8 modal frequencies in total.

Figure 5.7. Peaks with Filter in Longitudinal Direction

Figure 5.8. Peaks with Filter in Transverse Direction

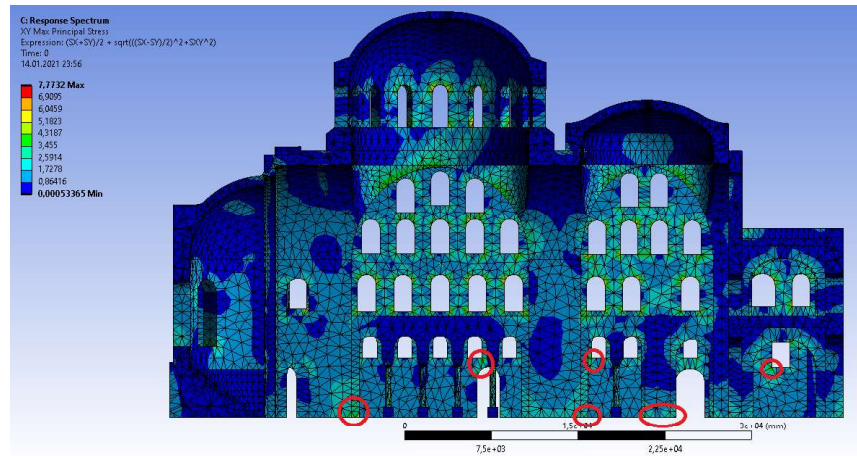
It is possible to see the stress concentrations at the narthex and the pillar bases. The stress values coded by the colors yellow and orange pass the compressive strength limit of the material model. However, there are little to no stresses developing around the arches on top of marble columns.

Figure 7.6. Entry 1 Damages

Figure 7.7. Entry 1 Damages FEM Results
