**SEISMIC PERFORMANCE EVALUATION OF
PUBLIC SCHOOL BUILDINGS
IN ISTANBUL METROPOLITAN AREA**

Submitted to the Kandilli Observatory and
Earthquake Research Institute in partial
fulfillment
of the requirements for the degree of
Master of Science
in
Earthquake Engineering

Boğaziçi University

2005

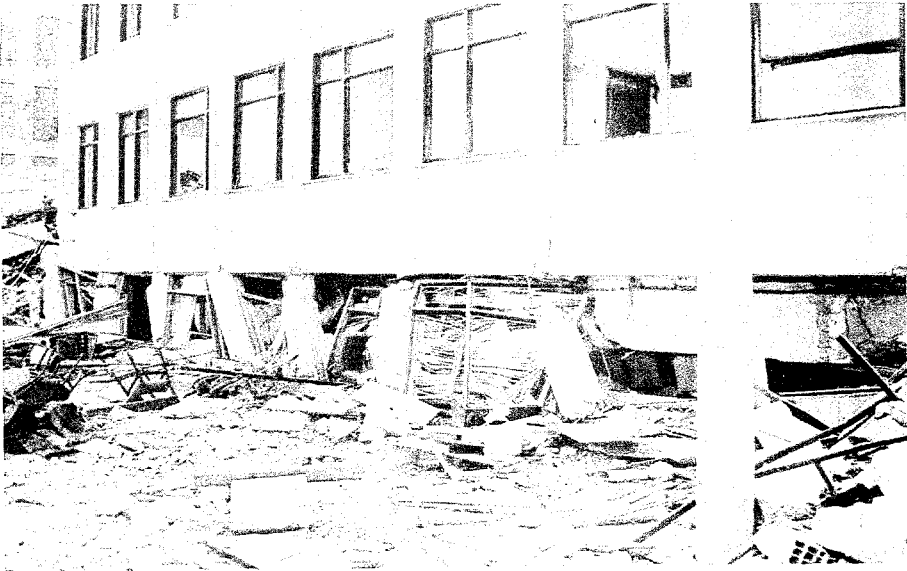
Photo 2.3 – High school building heavily damaged in Burdur earthquake

A modern reinforced concrete high school building suffered heavy damage during Burdur earthquake as shown in Photo 2.3. The shear capacity of the columns was inadequate to carry the shears produced at a lateral load intensity of only 0.07g although the bending moment capacity of these sections was considerably higher. There was practically no confinement in the column – girder connection regions as shown in Photo 2.4. Other requirements of ductility, like anchorage of tensile reinforcement and transverse reinforcement in the junction of beam – column were also neglected. [25]

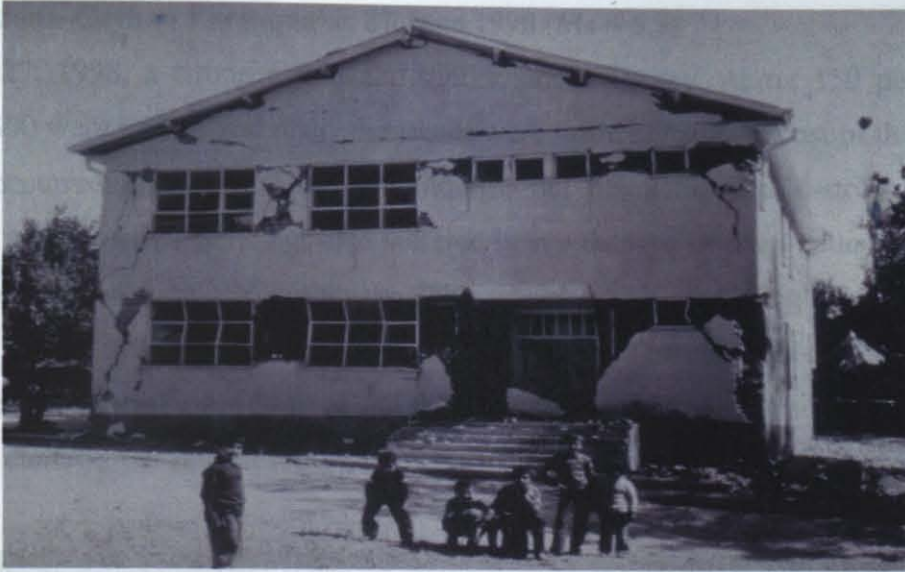
Photo 2.6 – Shear failure and cracked walls at Lice Secondary School

On September 6, 1975, a destructive earthquake occurred near the town of Lice about 75 kilometers north northeast of Diyarbakır, eastern Anatolia. Approximately 8,149 houses collapsed or were heavily damaged and Lice also suffered more than 2,384 fatalities out of a population of about 8,200. The whole damages in the city were \$17 million. The town of Lice most of the official buildings especially school and government buildings were severely damaged because they were not designed to resist shaking. The two-storey Lice Secondary School Building's brick and mortar structures were damaged and the walls were cracked badly as shown in Photo 2.6. All lateral resisting elements were shattered in the west wall of the secondary school building. [15], [20]

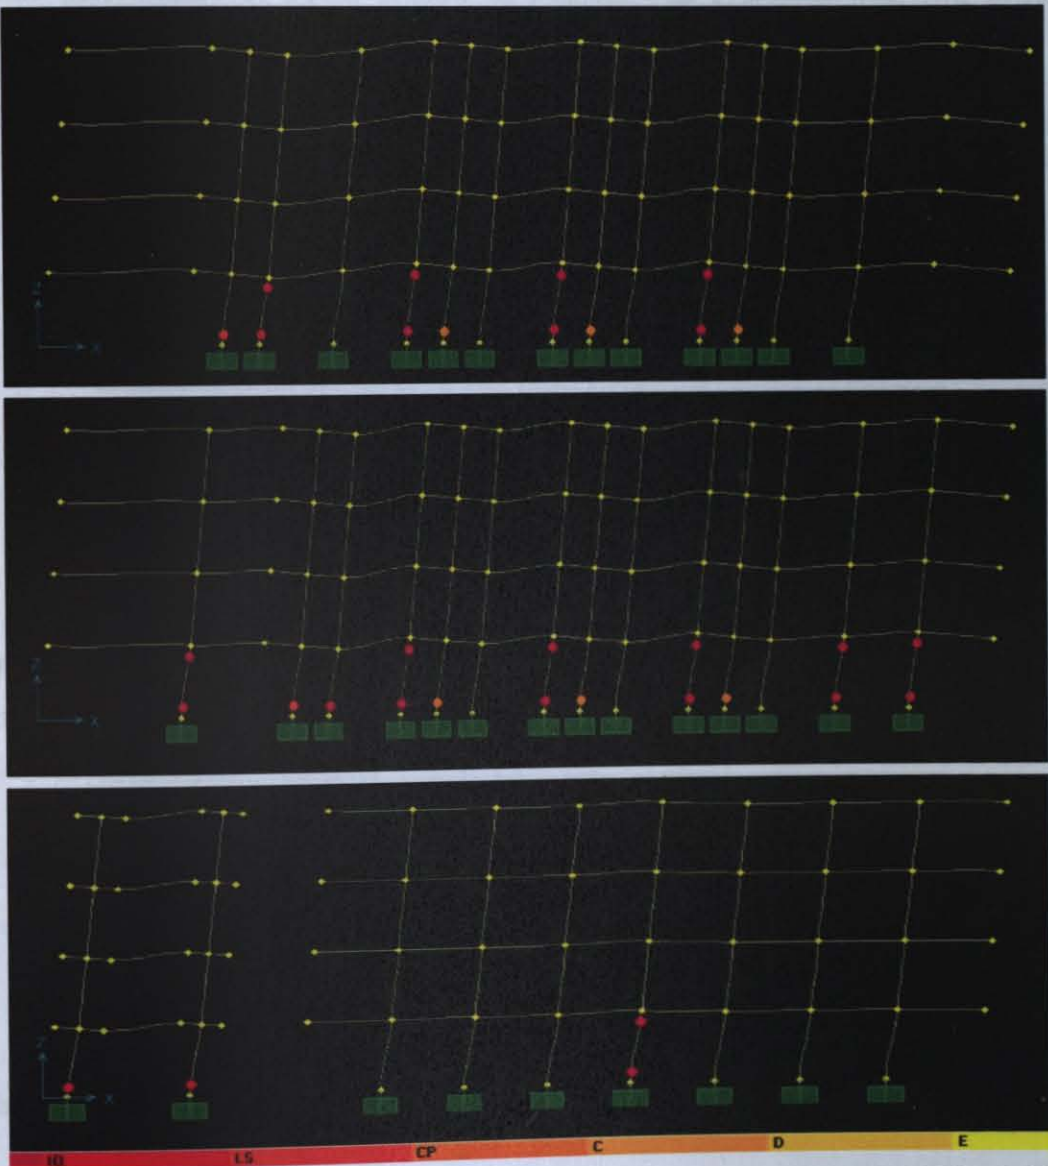
Figure 3.38 – Plastified hinges at the performance point of 4-storey type 10025 R-480

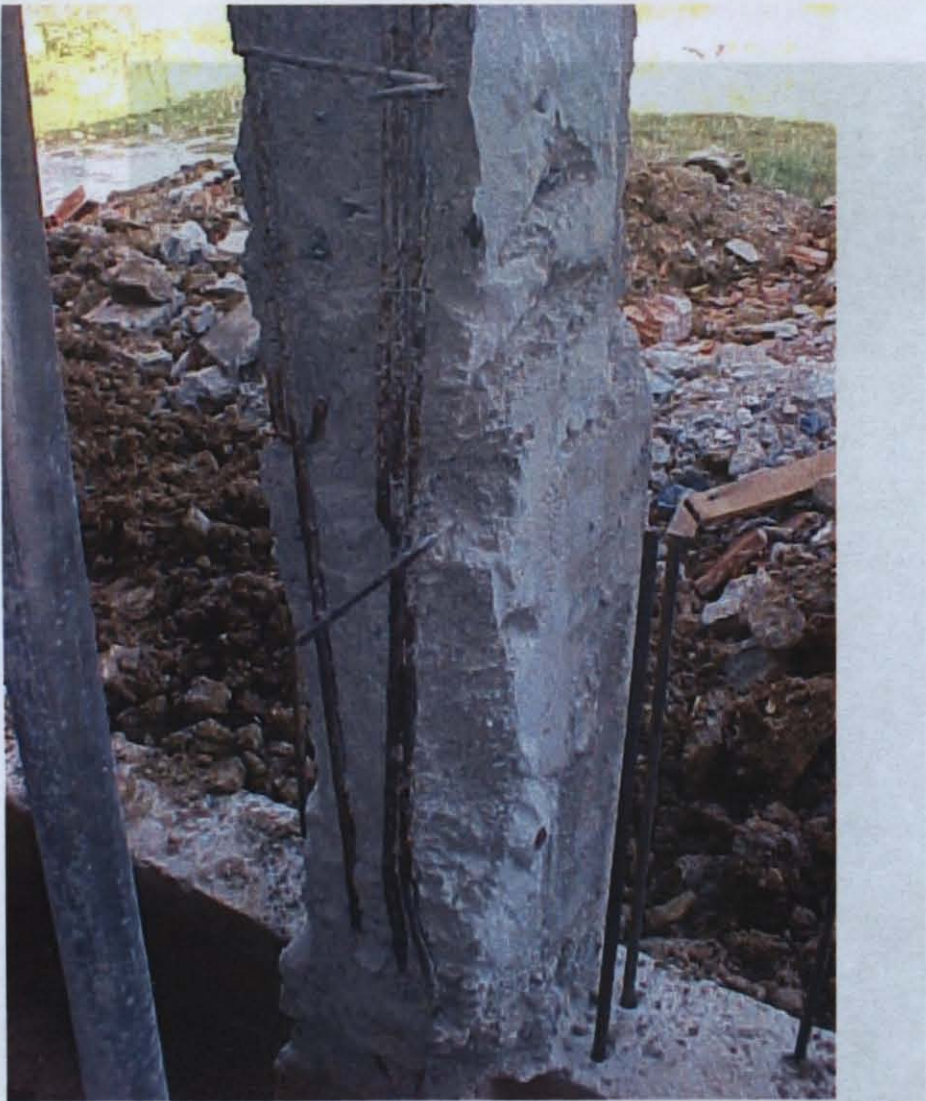
Photo D.1 – Unconfined concrete problem at Beykoz Dereseği İ.Ö.O.

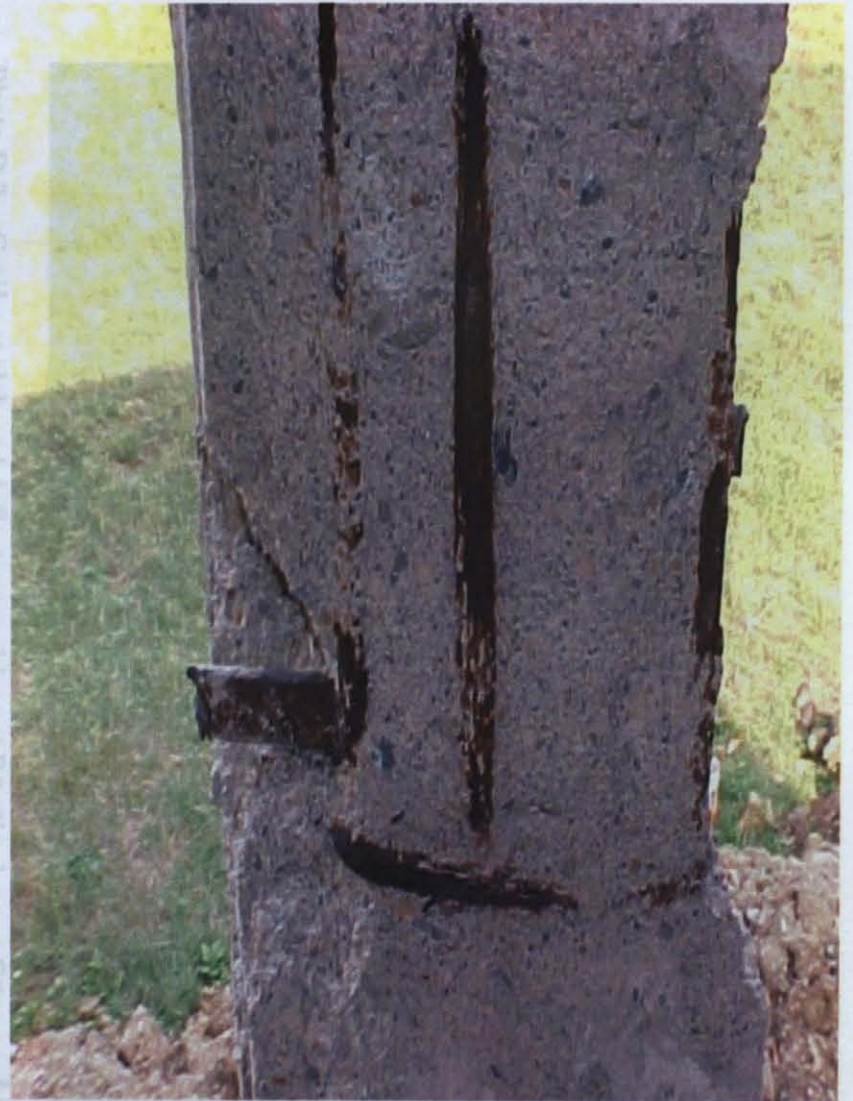
Photo D.3 – Cracks at slab and dislocation problems at Beykoz Dereseği İ.Ö.O.

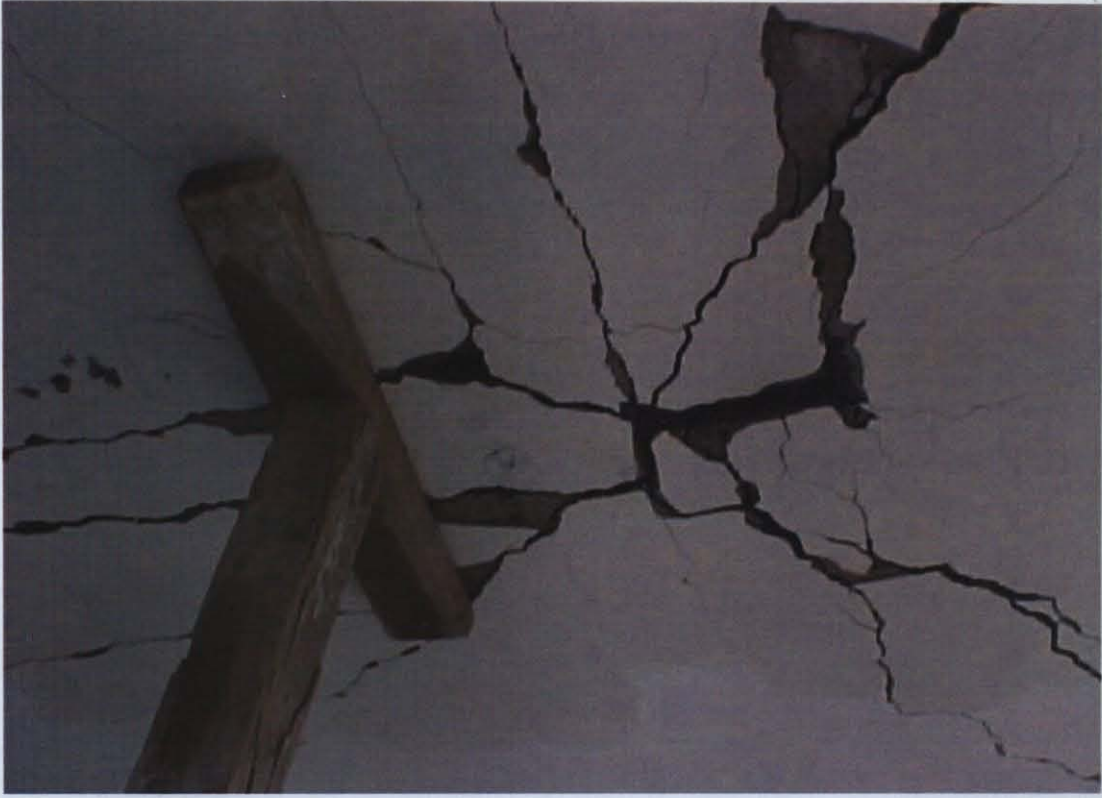
Photo D.3 – Cracks at slab and deflection problem at Büyükçekmece Gürpınar İ.Ö.O.

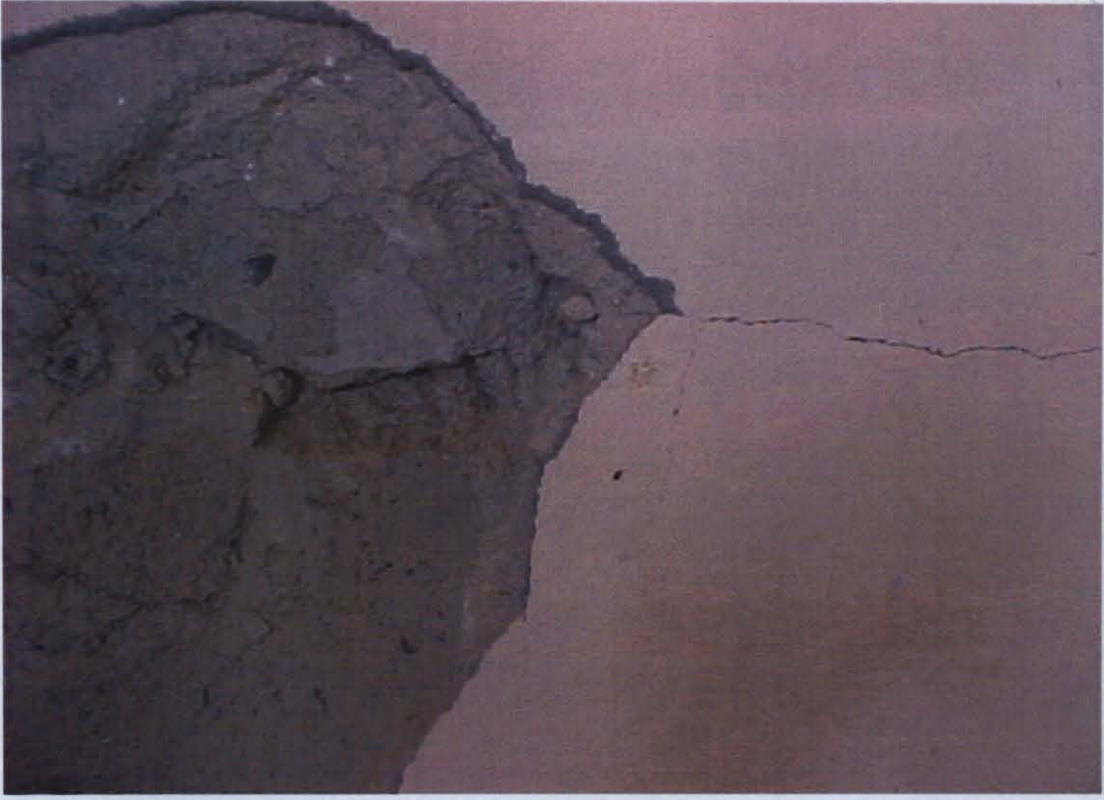
Photo D.5 – Heavy damaged shear wall crack at Büyükçekmece Gürpınar İ.Ö.O.

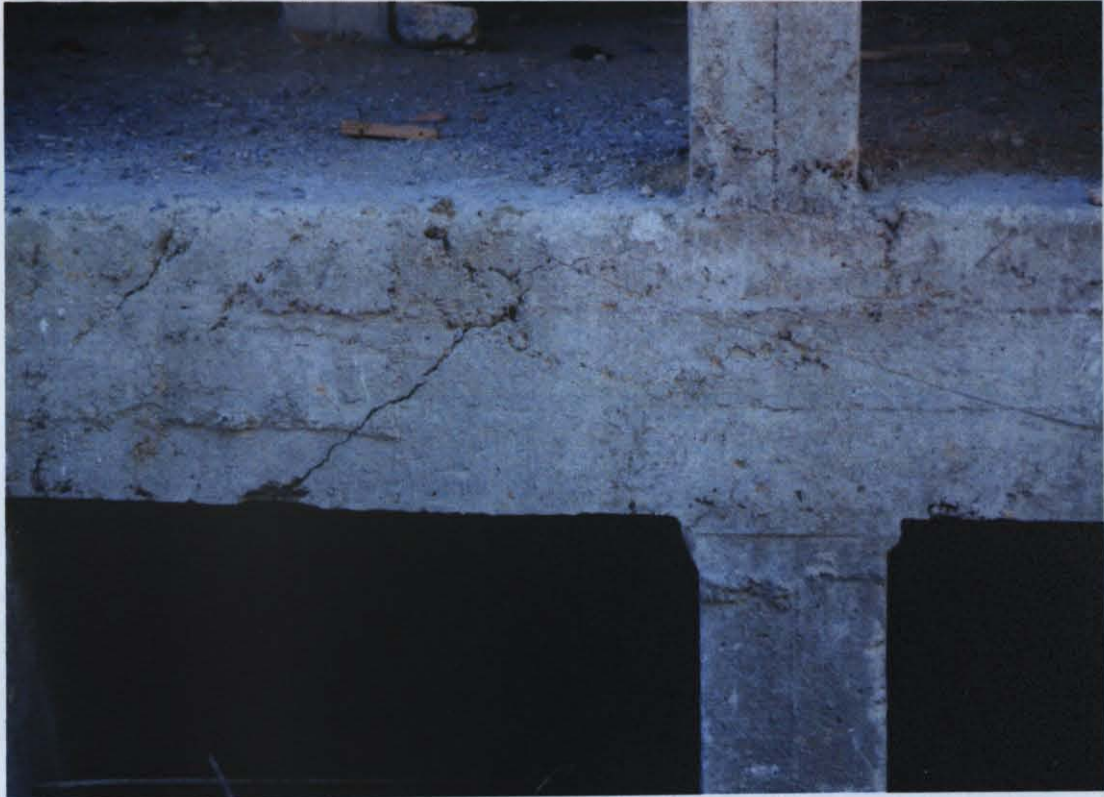
Photo D.6 – Shear crack at beam at Sarıyer Şükrü Nail İ.Ö.O.

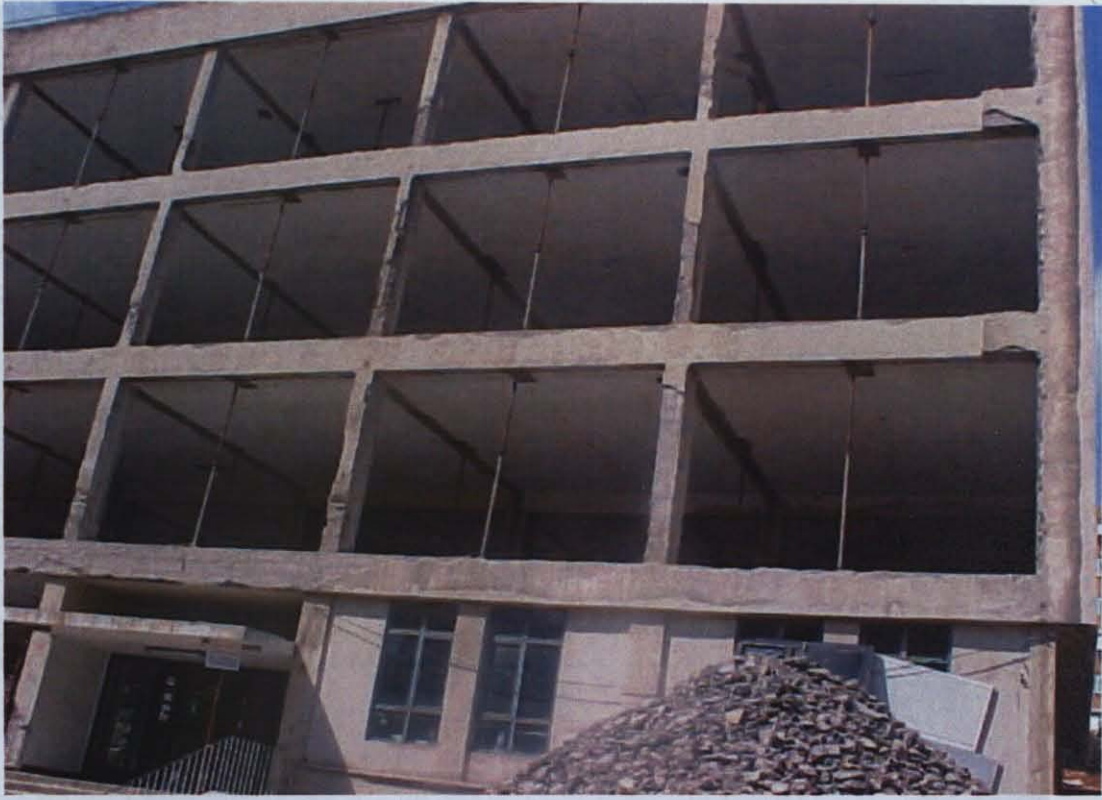
Photo D.7 – Insufficient structural design at Kadıköy Avni Akyol Güzel Sanatlar Lisesi

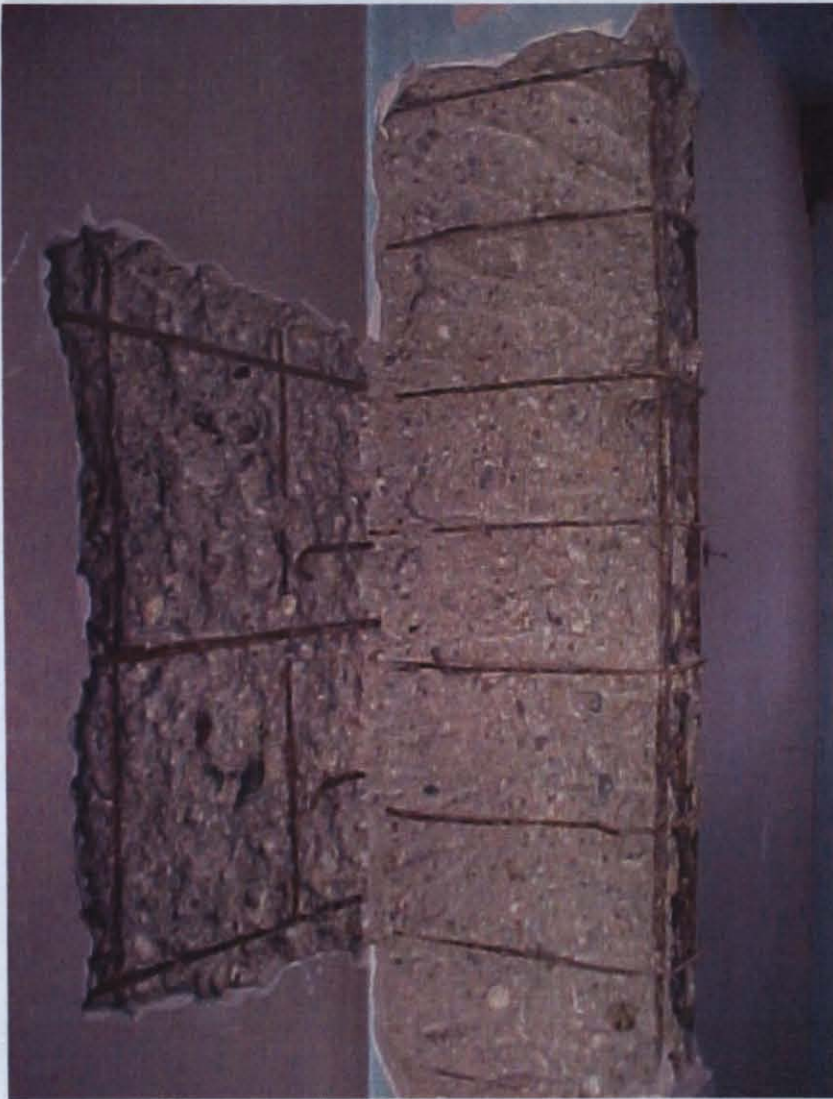
Photo D.9 – Corrosion problem and lack of confinement at Fatih Kırımlı Aslanbey İ.Ö.O.

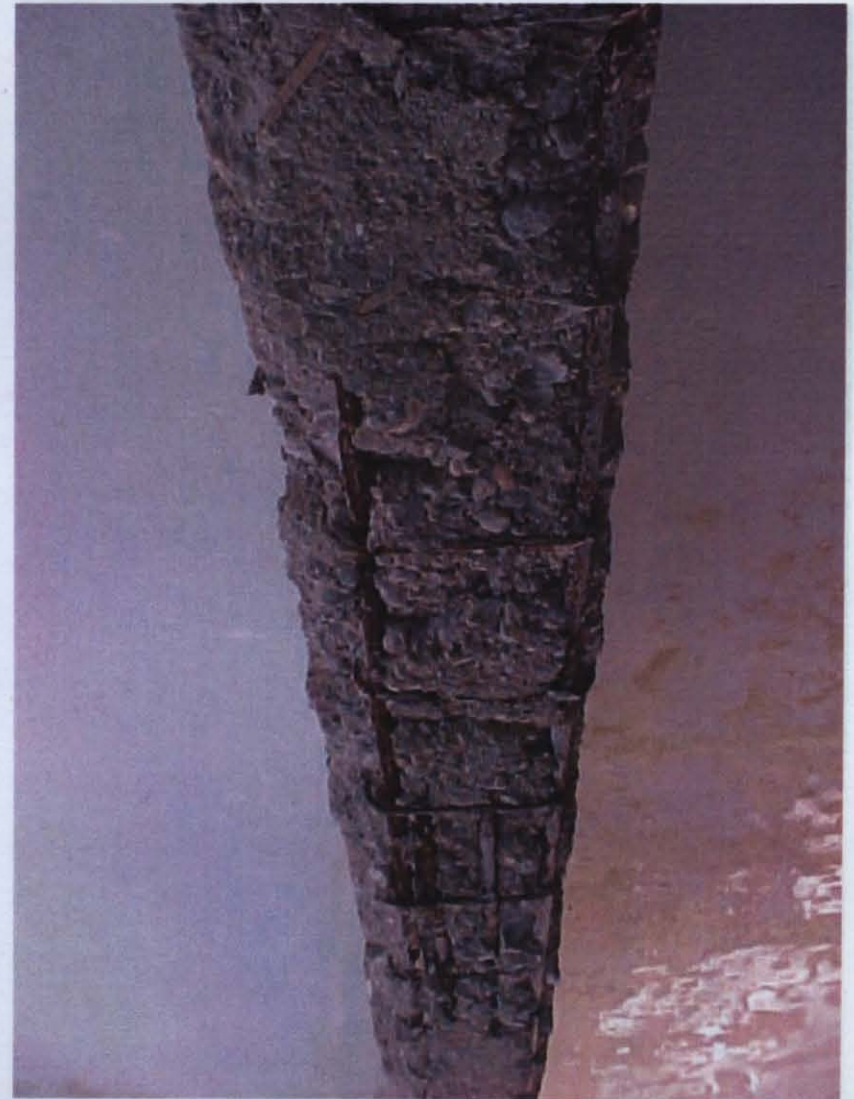
Photo D.10 – Lack of confinement and concrete strength problem at Fatih Kırımlı Aslanbey İ.Ö.O.

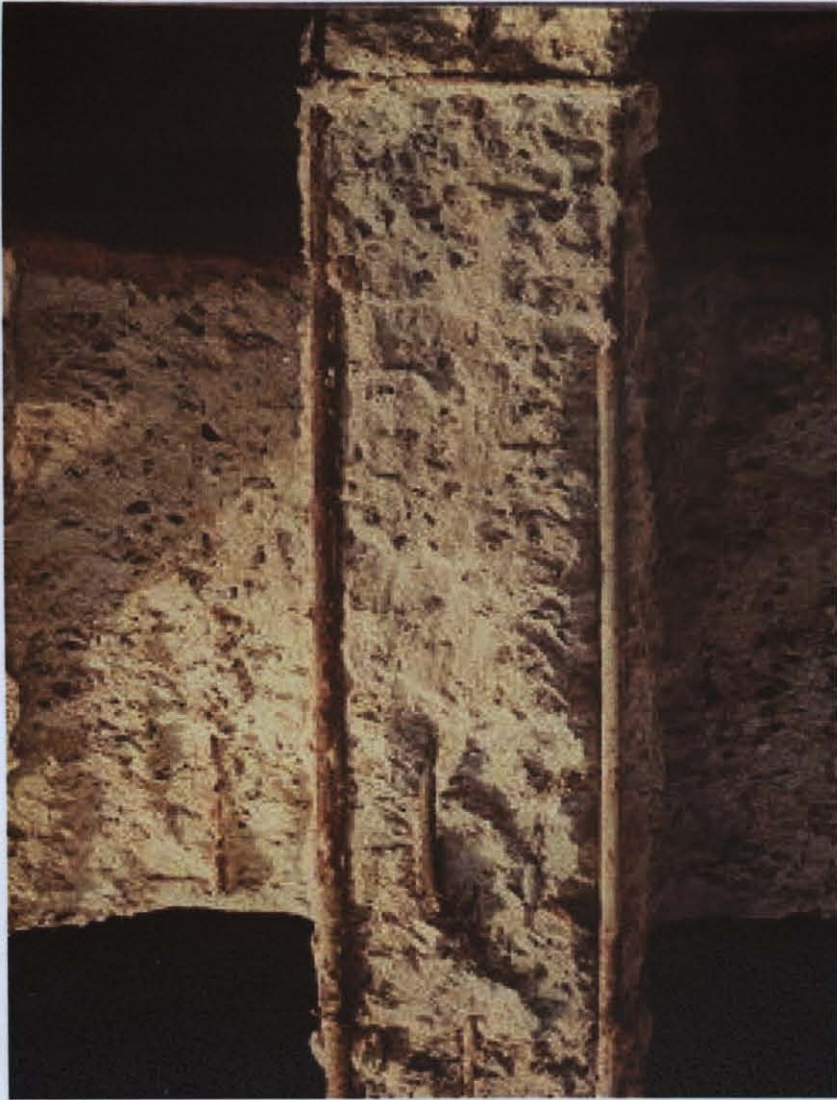
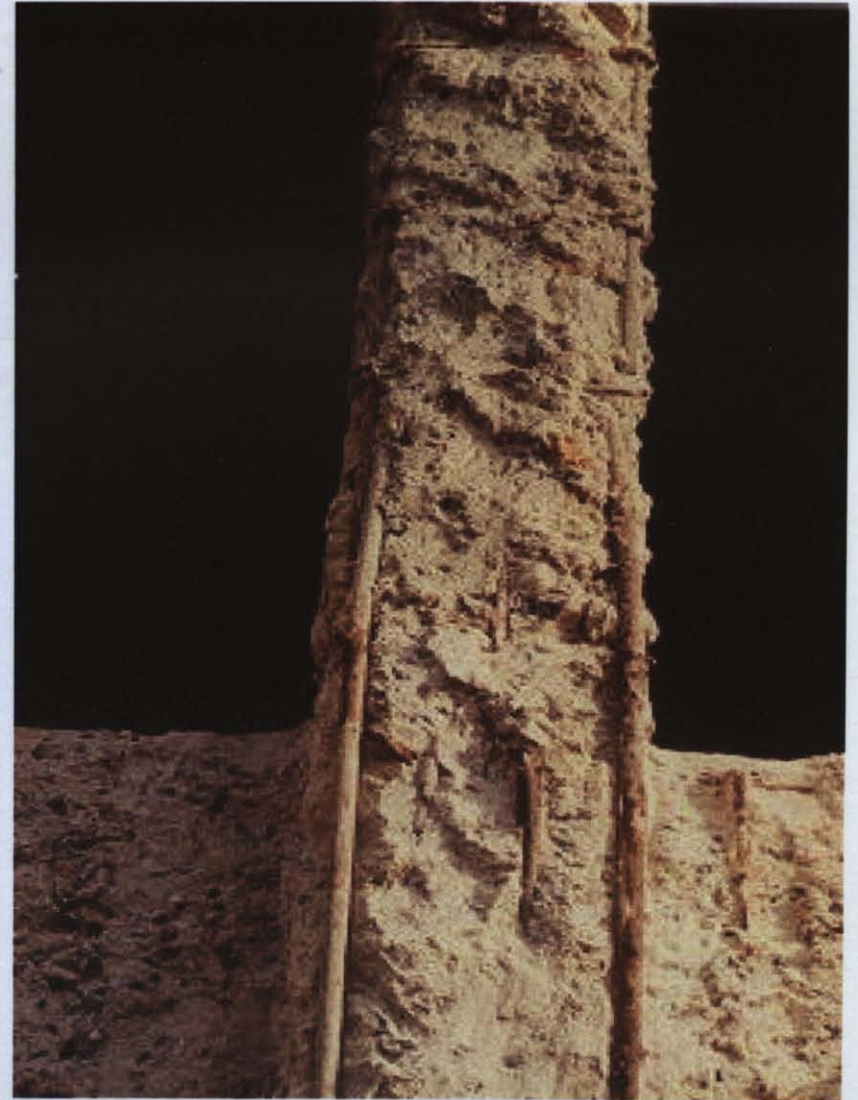
Photo D.11 and Photo D.12 – Poor quality concrete, lack of confinement and corrosion problem at Gazi Mahallesi İstiklal İ.Ö.O. Kartal Anadolu Lisesi

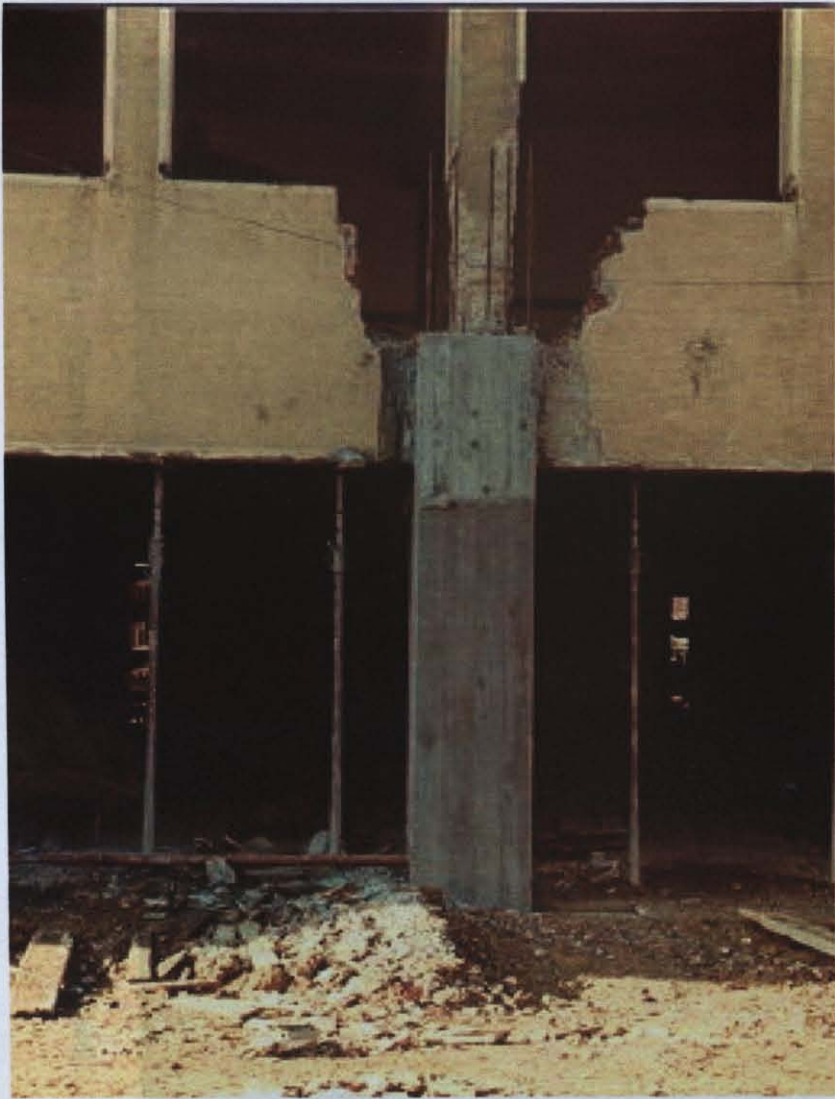
Photo D.13 – Slender column and structure design problem at Gazi Mahallesi İstiklal İ.Ö.O.

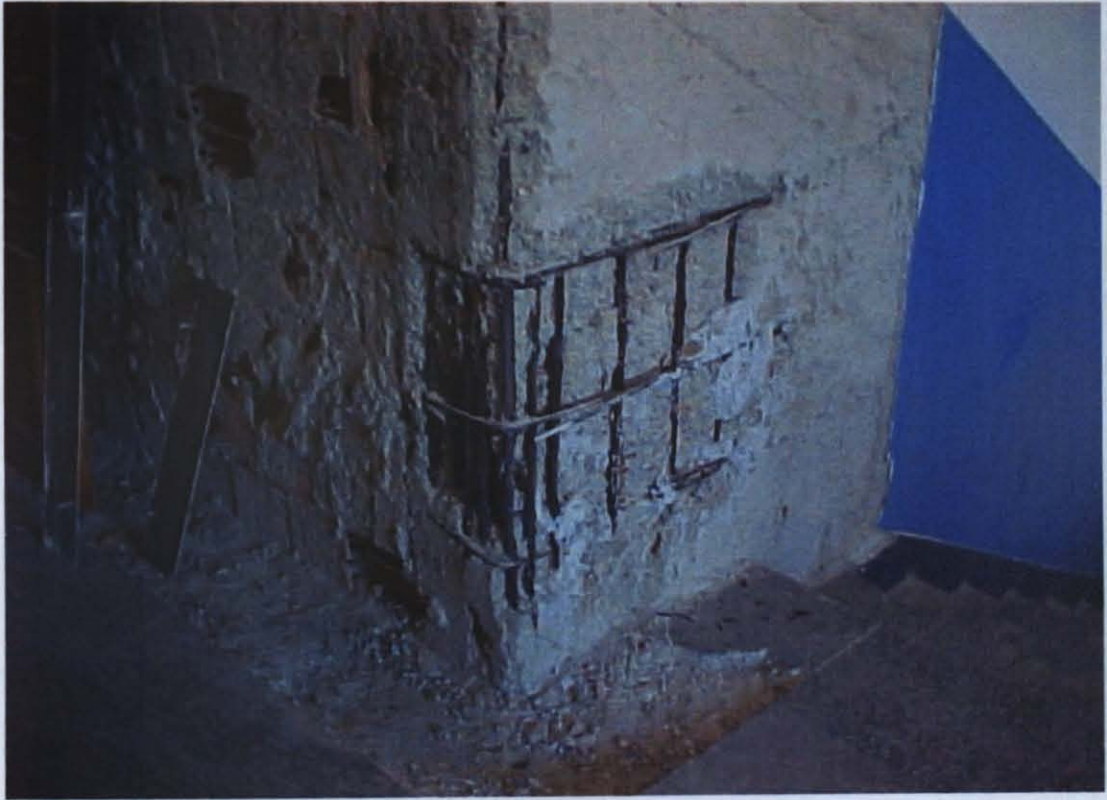
Photo D.16 – Concrete spalling at column end at Kartal Anadolu Lisesi

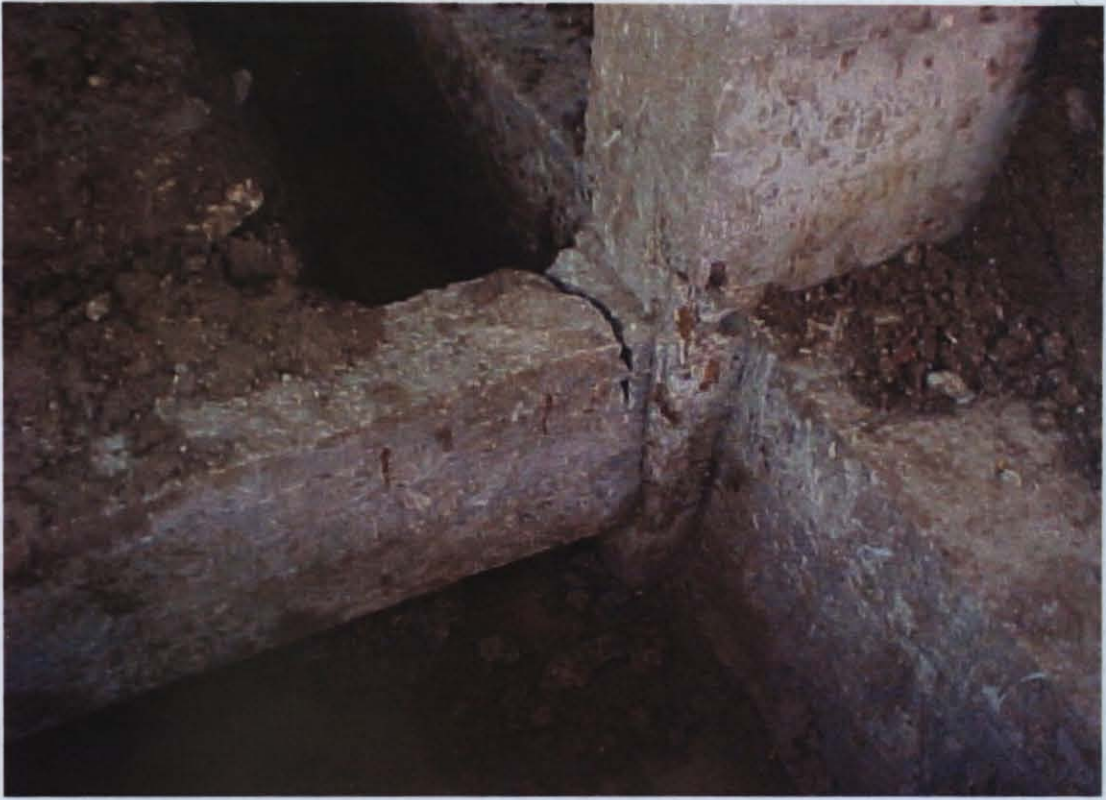
Photo D.17 – Bending crack on tie beam at Küçükçekmece Yunus Emre İ.Ö.O.

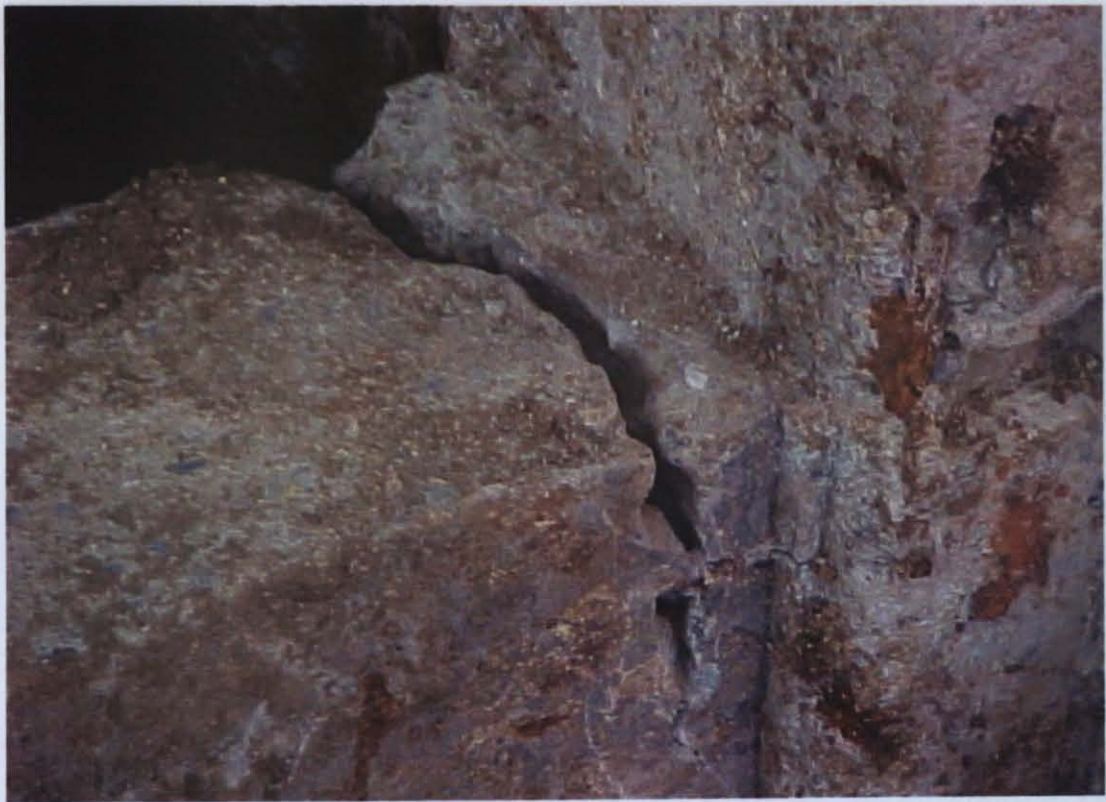
Photo D.18 – Close up of bending crack on tie beam at Küçükçekmece Yunus Emre İ.Ö.O.

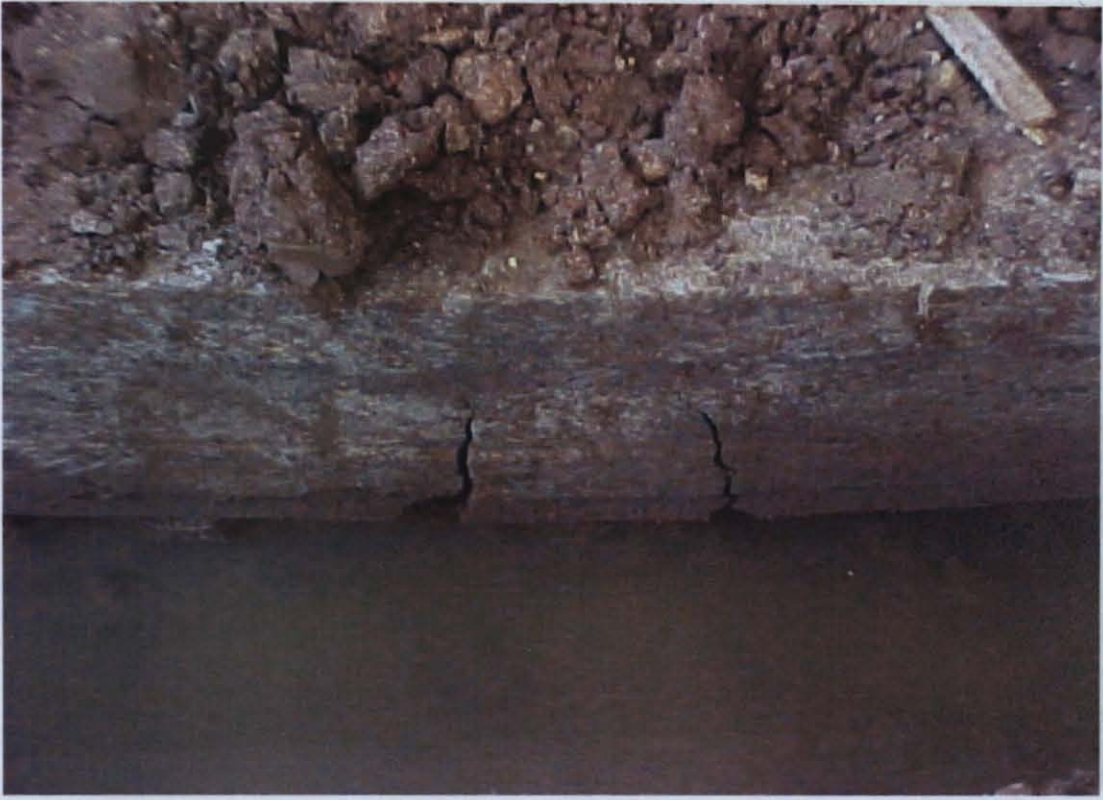
Photo D.19 – Shear crack in basement at Küçükçekmece Yunus Emre İ.Ö.O.

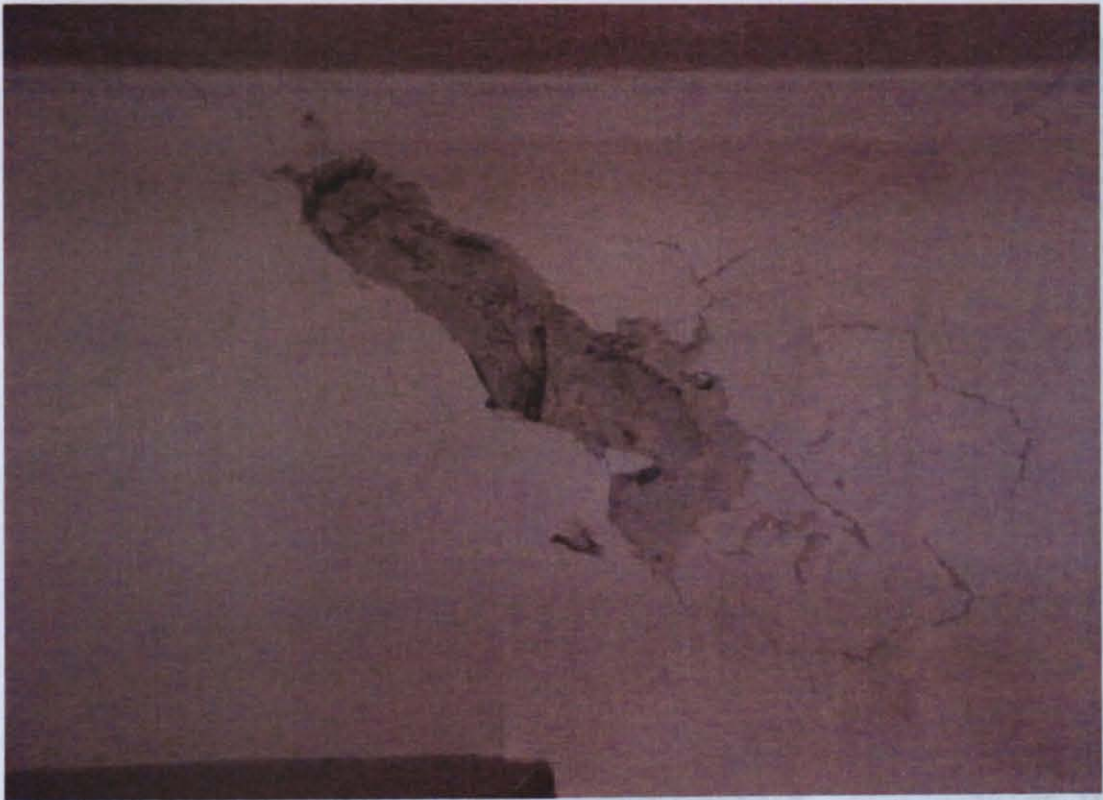
Photo D.20 – Heavy damaged shear wall at Küçükçekmece Yunus Emre İ.Ö.O.

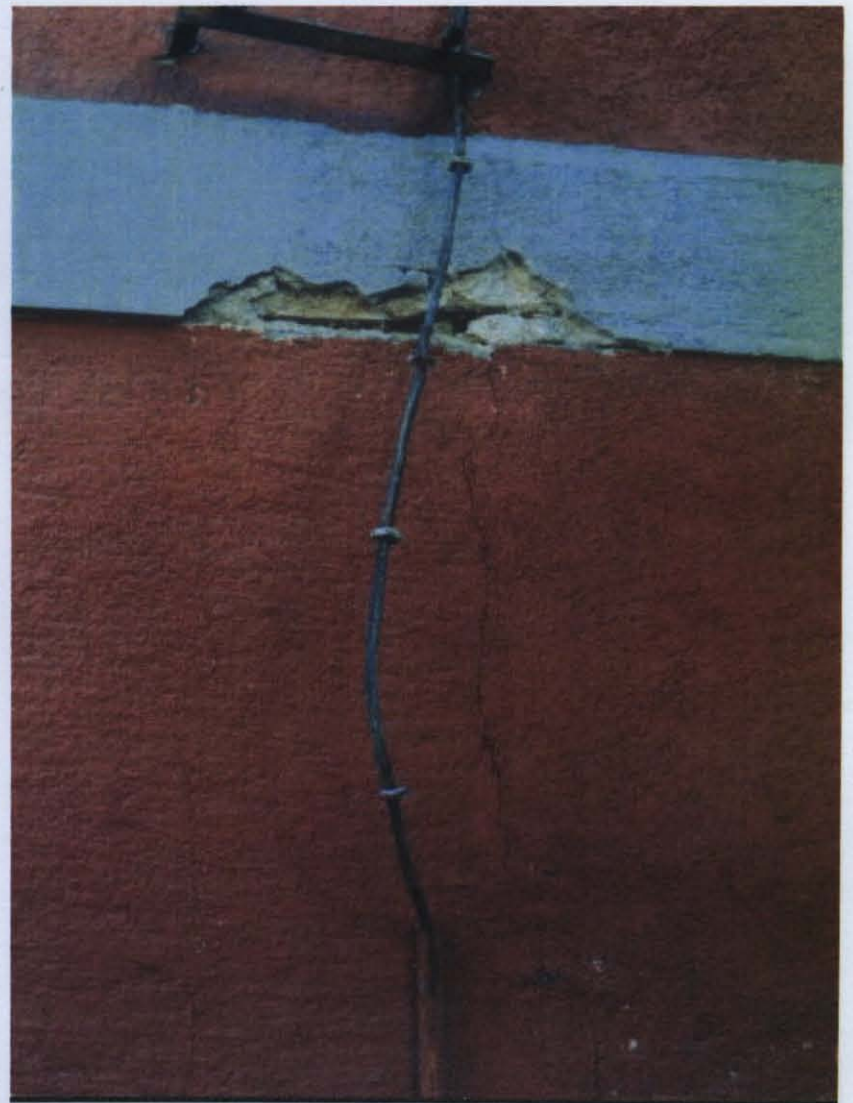
Photo D.28 – Crack on infill walls and corrosion problem at Üsküdar Halil Rüştü İ.Ö.O.

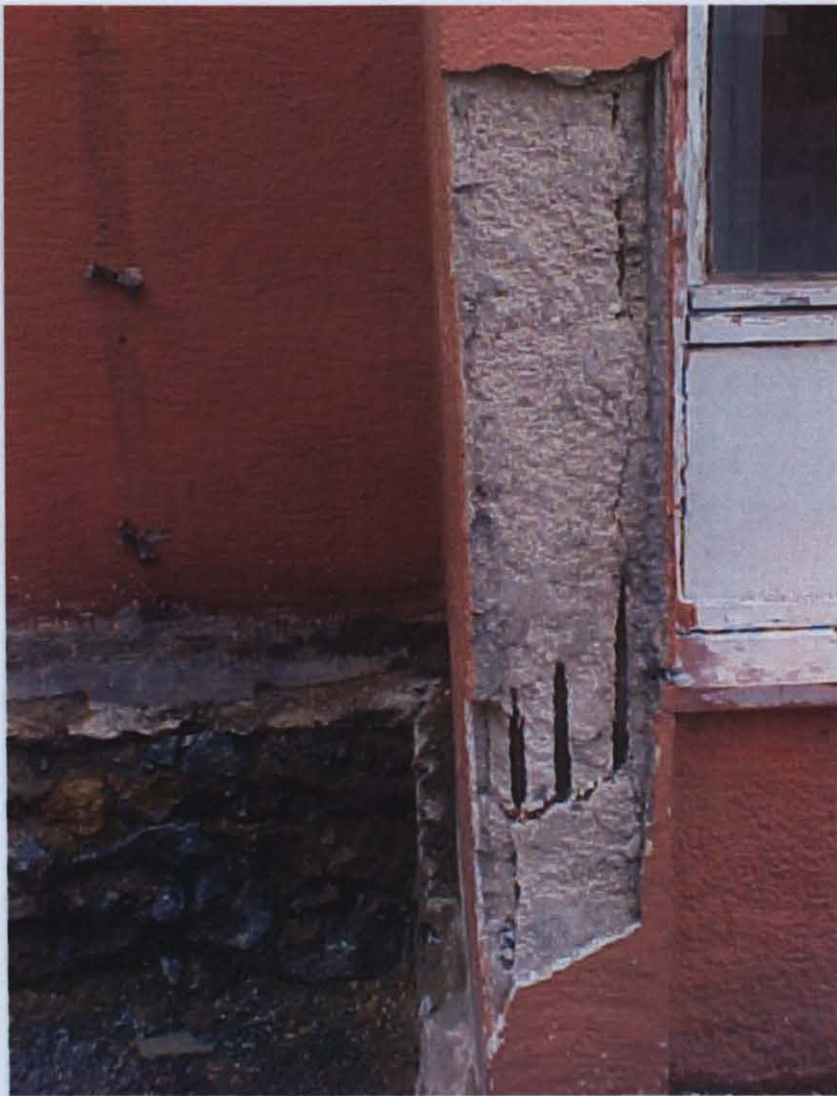
Photo D.29 – Corrosion of reinforcing bars with poor quality of reinforced concrete at Zeytinburnu Yedikule İ.Ö.O.

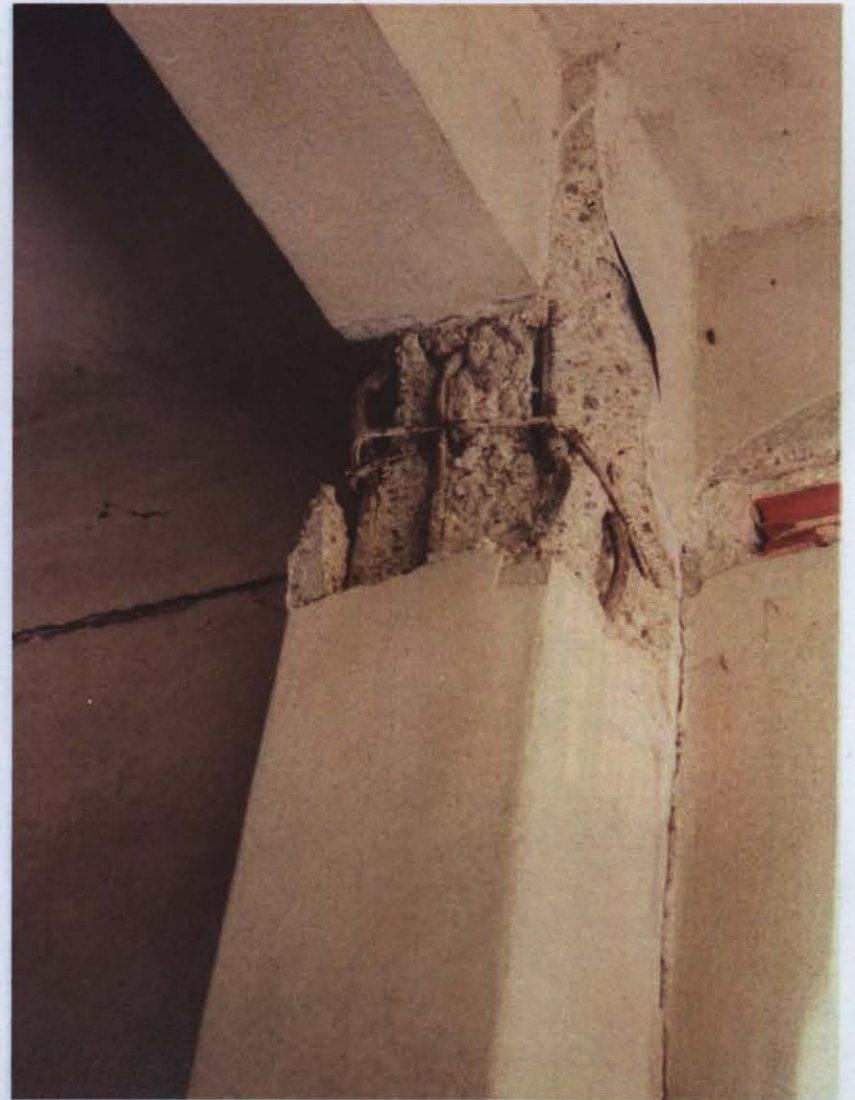
Photo D.30 – Failure of column/beam connection with buckling of longitudinal bar due to poor confinement Zeytinburnu Yedikule İ.Ö.O.

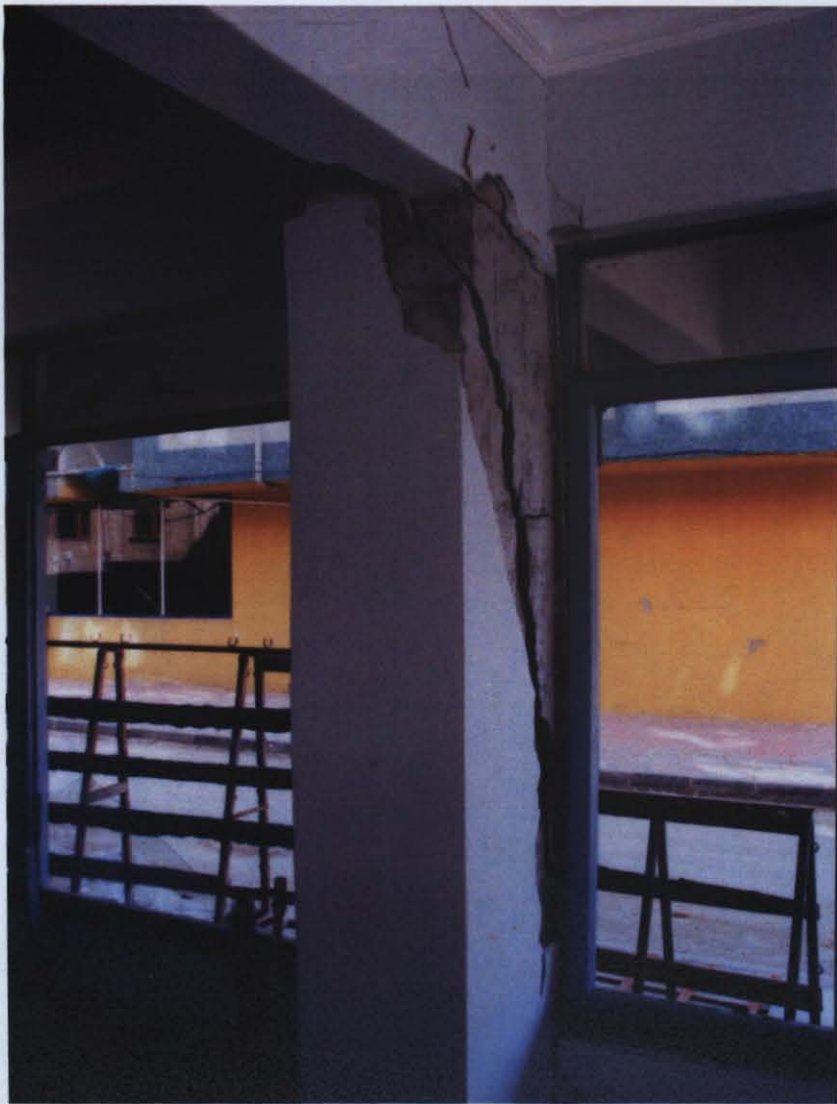
Photo D.31 – Heavy damaged column with shear crack

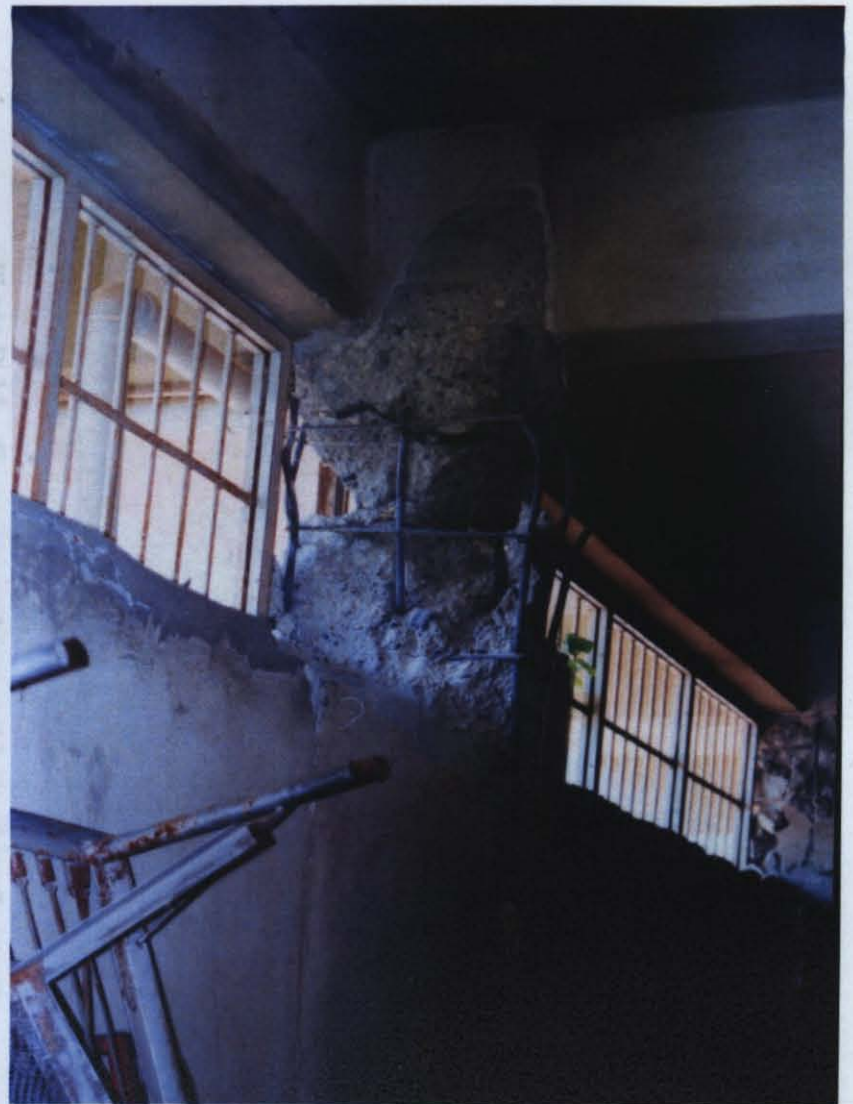
Photo D.32 – Short column effect with lack of confinement

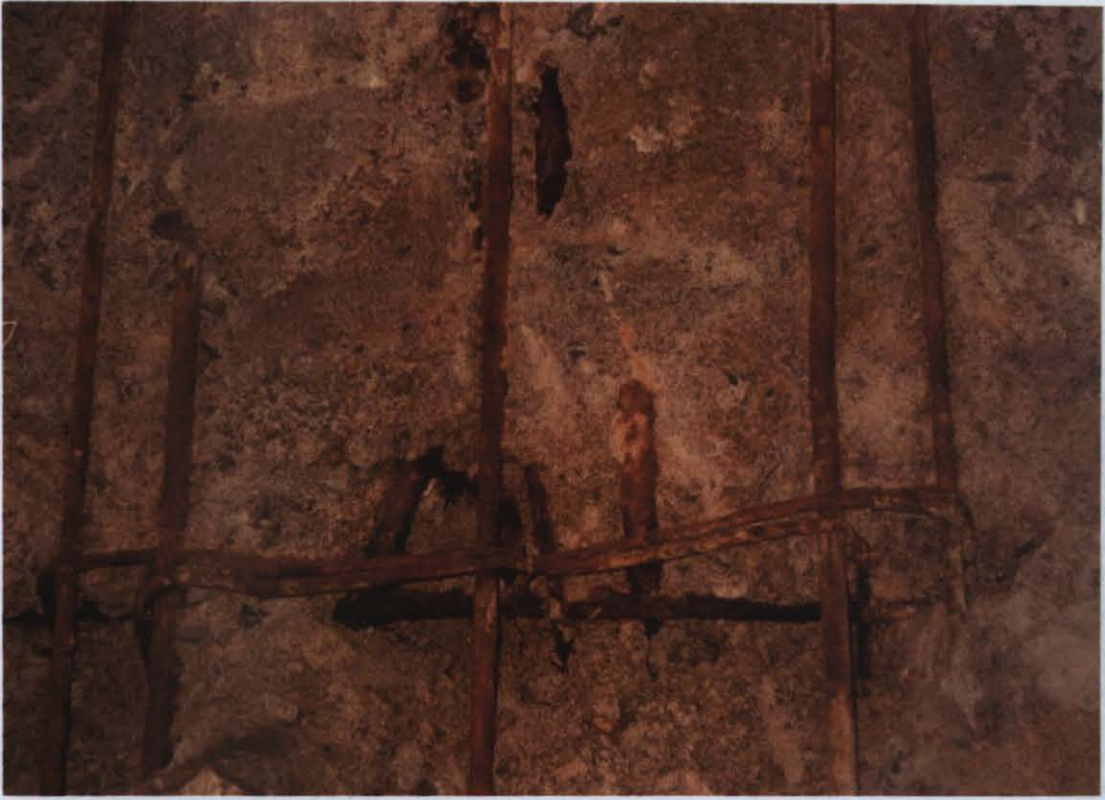
Photo D.33 – Corrosion problem and lack of confinement
