**SEISMIC PERFORMANCE EVALUATION OF
PUBLIC SCHOOL BUILDINGS
IN ISTANBUL METROPOLITAN AREA**

Submitted to the Kandilli Observatory and
Earthquake Research Institute in partial
fulfillment
of the requirements for the degree of
Master of Science
in
Earthquake Engineering

Boğaziçi University

2005

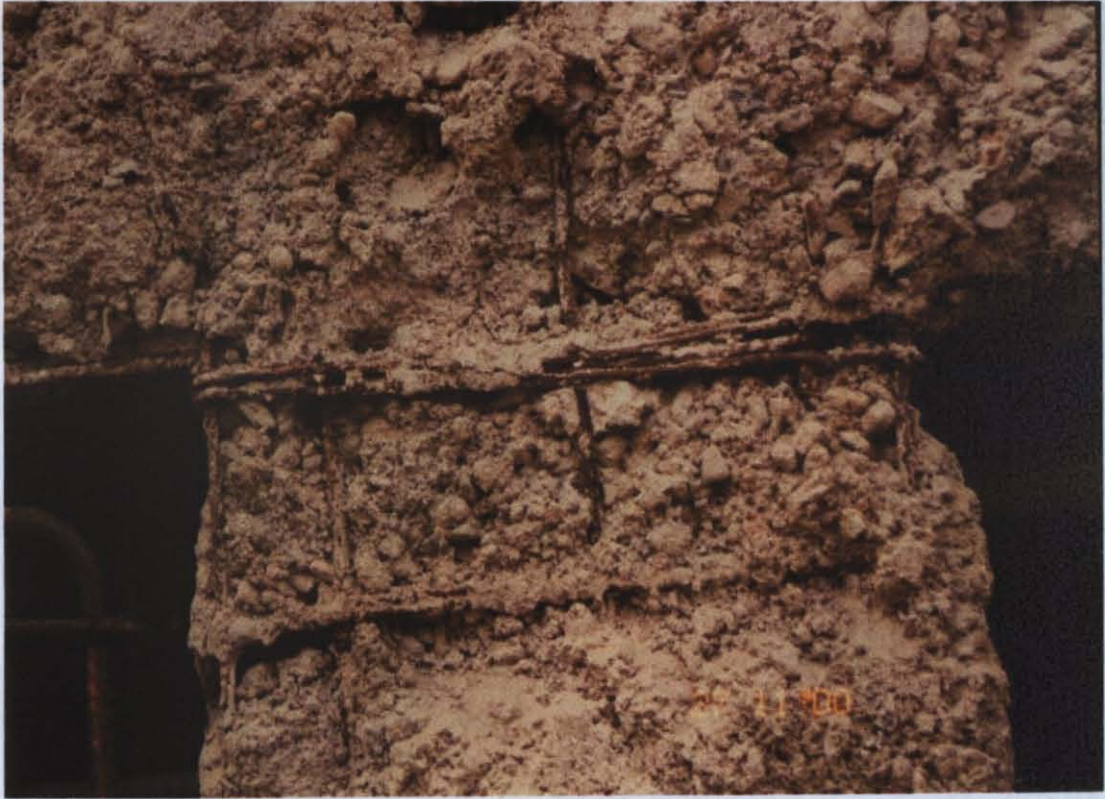
Photo D.34 – Corrosion problem, poor quality concrete and lack of confinement

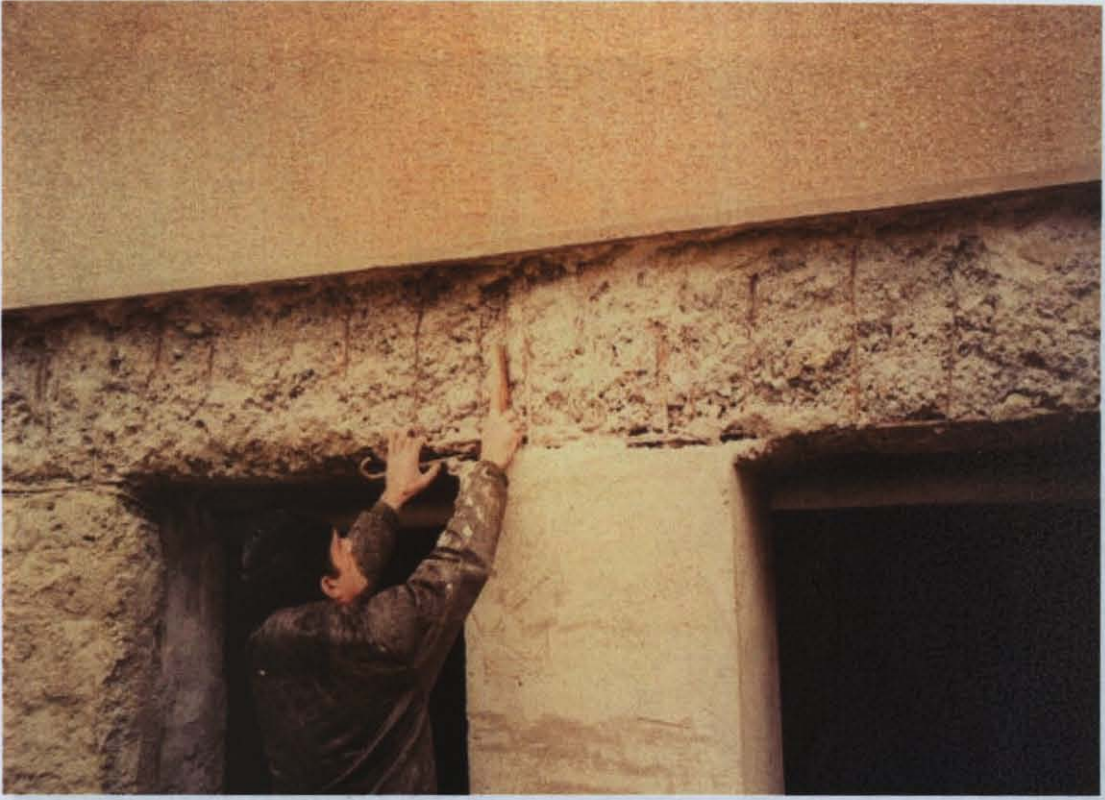
Photo D.35 – Purifying the reinforcing rebars from corrosion

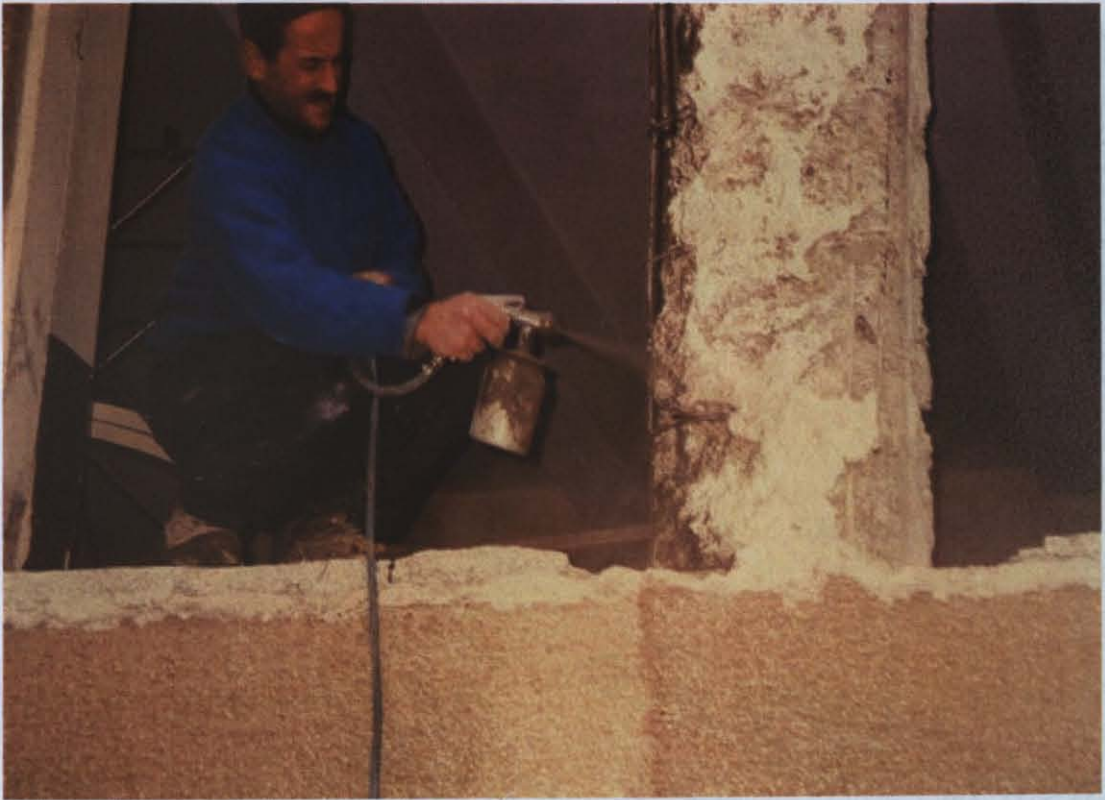
Photo D.36 – Protecting the reinforcing rebars from corrosion with protective material

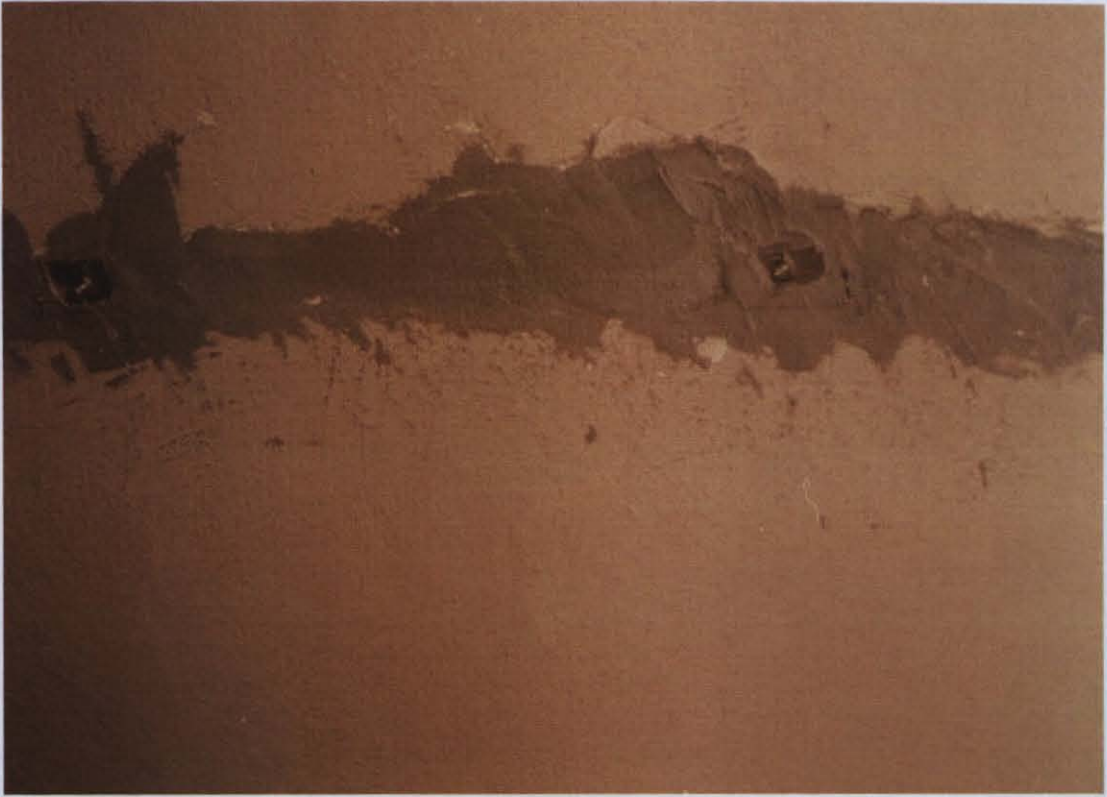
Photo D.37 – Retrofit of slab with epoxy

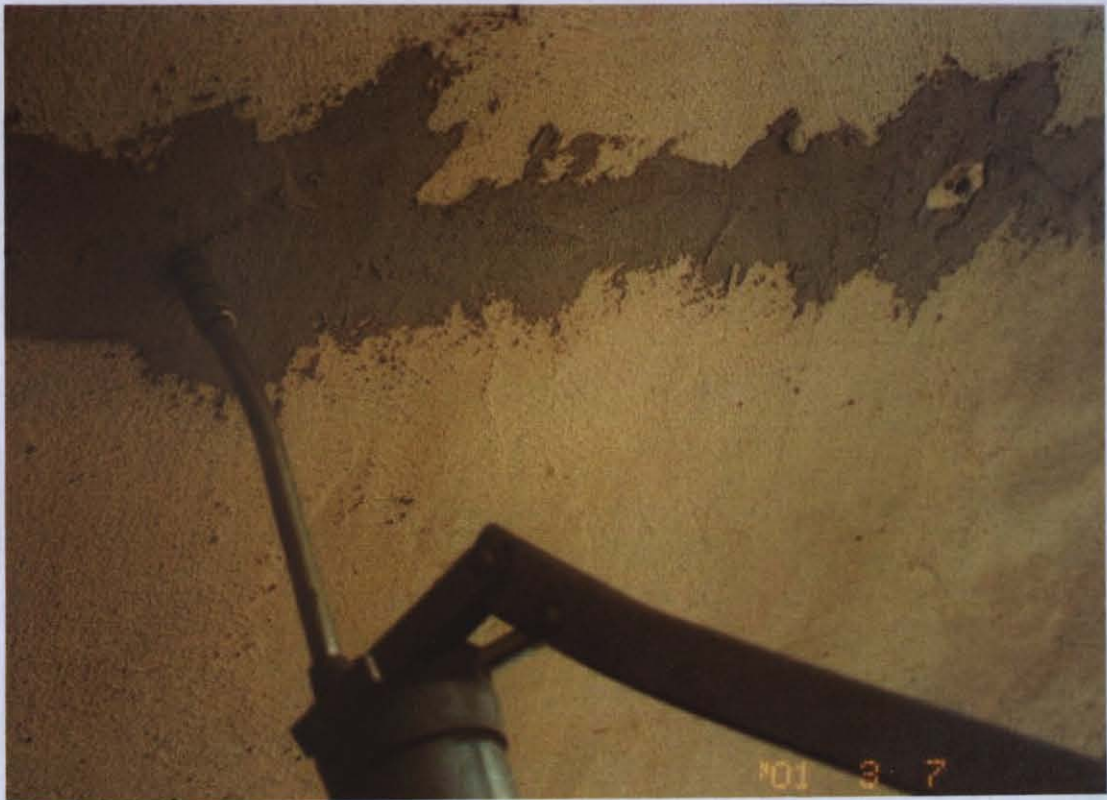
Photo D.38 – Filling the cracks with using injection of epoxy
