EXPERIMENTAL EVALUATION OF THE LATERAL LOAD BEHAVIOR OF SQUAT
STRUCTURAL WALLS

Submitted to the Institute for Graduate Studies in
Science and Engineering in partial fulfillment of
The requirements for the degree of
Master of Science

Graduate Program in Civil Engineering
Bođaziçi University

2011

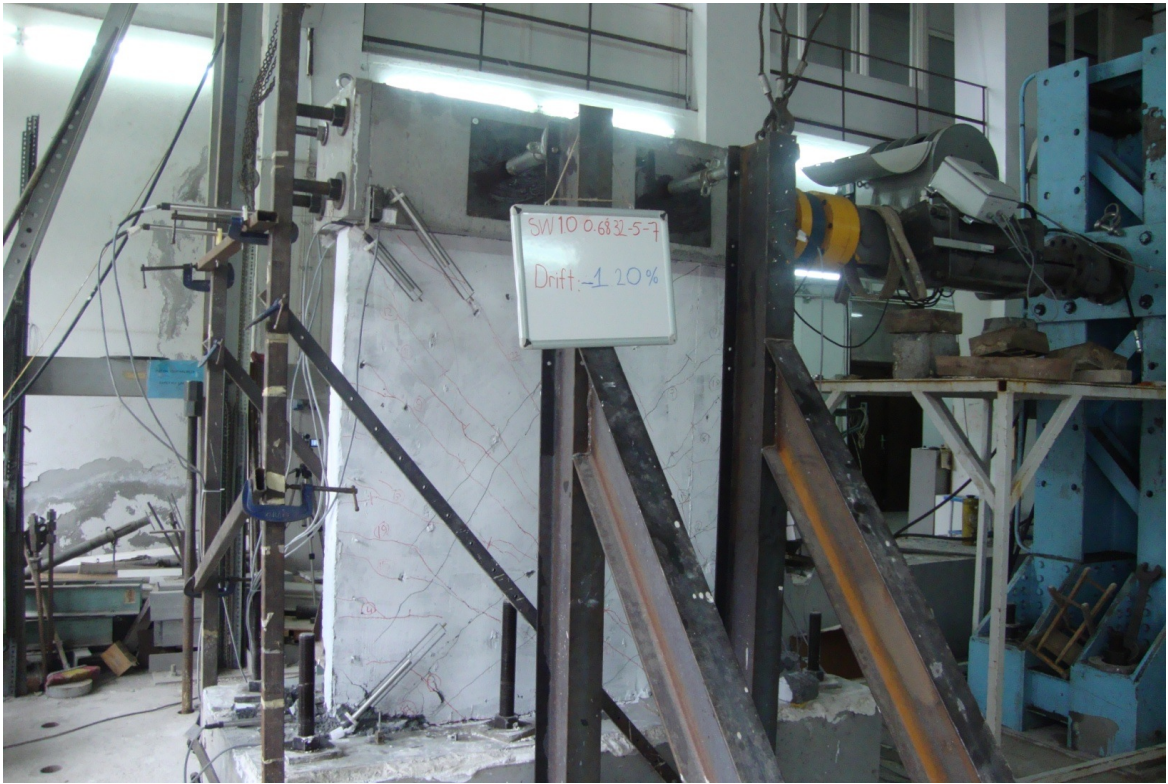
Lateral loading was applied with an actuator having a capacity of 1000 kN. One end of the actuator was fixed to a steel reaction wall. The reaction frame was connected to the strong floor by twelve 60 mm diameter high-strength threaded rods. Before placing the reaction frame in place, 2 cm thick grout was poured on the strong floor for leveling, as well as to avoid sliding. Each threaded rod of the reaction frame was post-tensioned with 300 kN of tensile force, and the bolts were tightened before the post-tensioning loads were removed. During the first test, the displacement of the reaction frame relative to the ground was monitored. Although 900 tons of lateral load was applied, no sliding of reaction wall was measured.

Figure 2.26. Test Setup Photo.

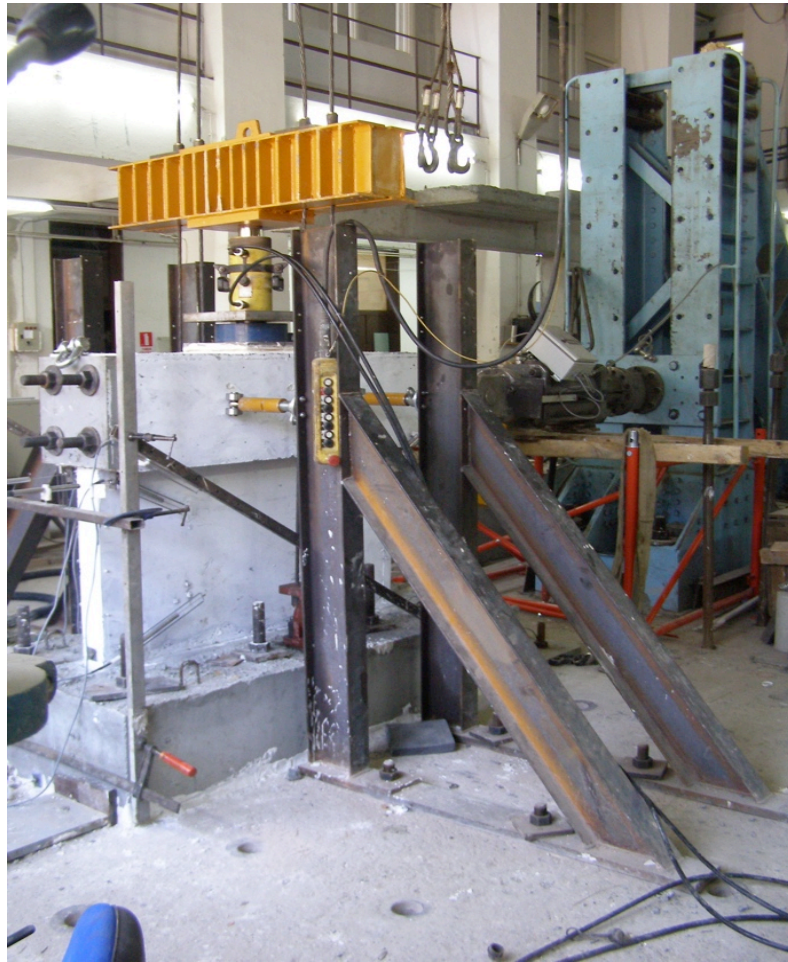
There were two specimens tested under at $5\%A_gf_c$ and $10\%A_gf_c$ axial load levels. The axial load was applied using four pre-stressed steel cables each having 250 kN axial tension capacities. The cables were connected to the bottom pedestals of the specimens with special steel hinges, and to transverse steel beams at the other ends. The axial load was applied through a hydraulic cylinder placed between the steel beams and the top pedestal (load transfer beam) of each specimen. Figure 2.27 shows a photo of the axial load setup.

Figure 2.27. Axial Load Test Setup

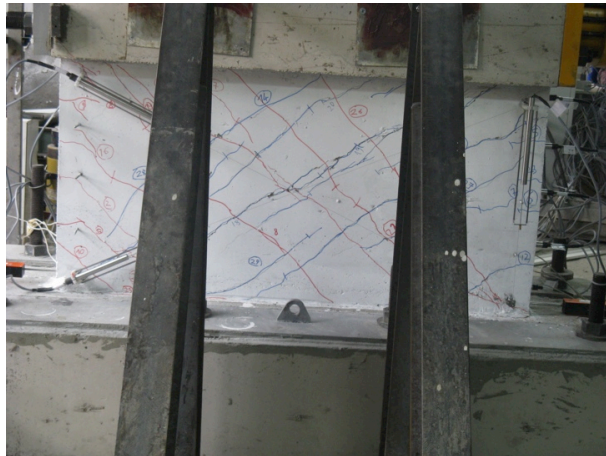
For the successive drift levels, new diagonal cracks were observed, the previous cracks extended (elongated), and crack widths increased. New cracks generally formed in zones with no cracks. At 0.8% drift level, crushing of the concrete started at the bottom corners. The largest crack width went up to 1.5 mm. At 1% drift level, the maximum lateral load capacity of 635 kN was reached. When the lateral load capacity was reached, none of the transverse (horizontal) reinforcing bars had yielded. On the other hand, longitudinal boundary reinforcement had yielded at the 1.0% drift level, when the capacity was reached. Figure 3.2 shows the cracking pattern of the specimen at the lateral load capacity.

Figure 3.2. Cracking Pattern at Ultimate Load (T1-S1).

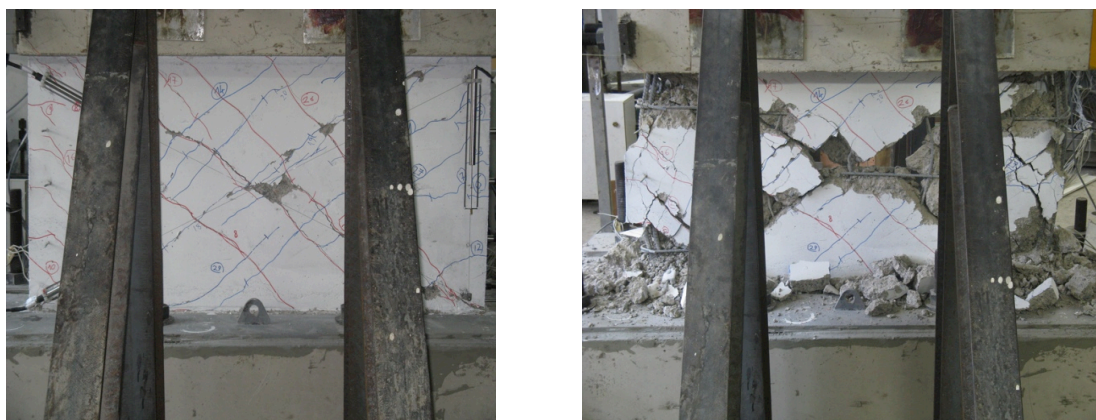
At the 1.2% drift level, strength degradation started and concrete started to crush at the center section of the wall. After the ultimate load level, crushing and spalling of the concrete concentrated at the center. This specimen had 0.34% vertical and horizontal reinforcement ratio, which is greater than the minimum reinforcement ratio (0.25%) in most design codes. This specimen failed under diagonal tension. The main cracks followed the direction of the principle compressive stresses. Figure 3.3 shows photos for medium and high damage levels of this specimen. The main diagonal cracks opened and closed at every cycle, and eventually the crushing of concrete propagated along the diagonal tension and compression struts, indicating a general diagonal tension type of squat wall failure, as described by Paulay and Priestley (1992).

Figure 3.3. Medium and High Damage Levels (T1-S1).

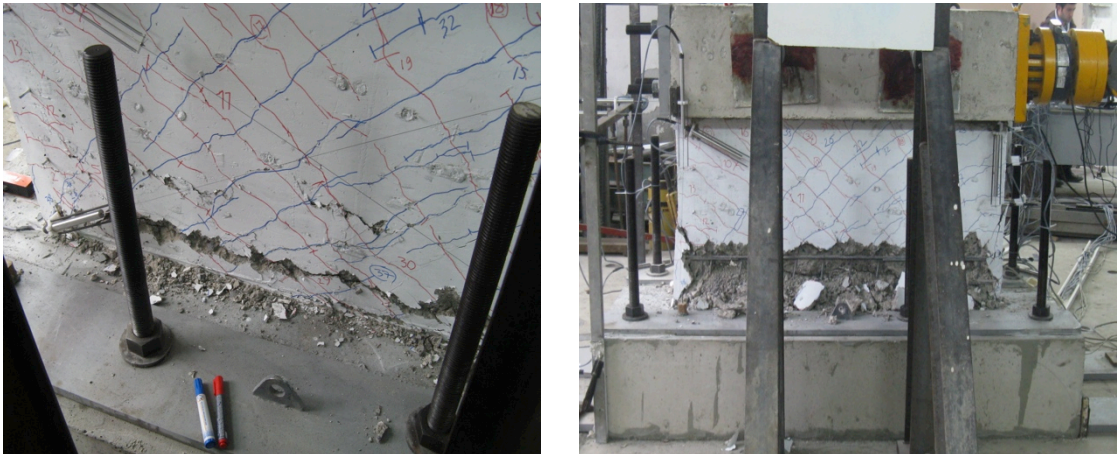
Figure 3.6. Medium and High Damage Levels (T2-S1).

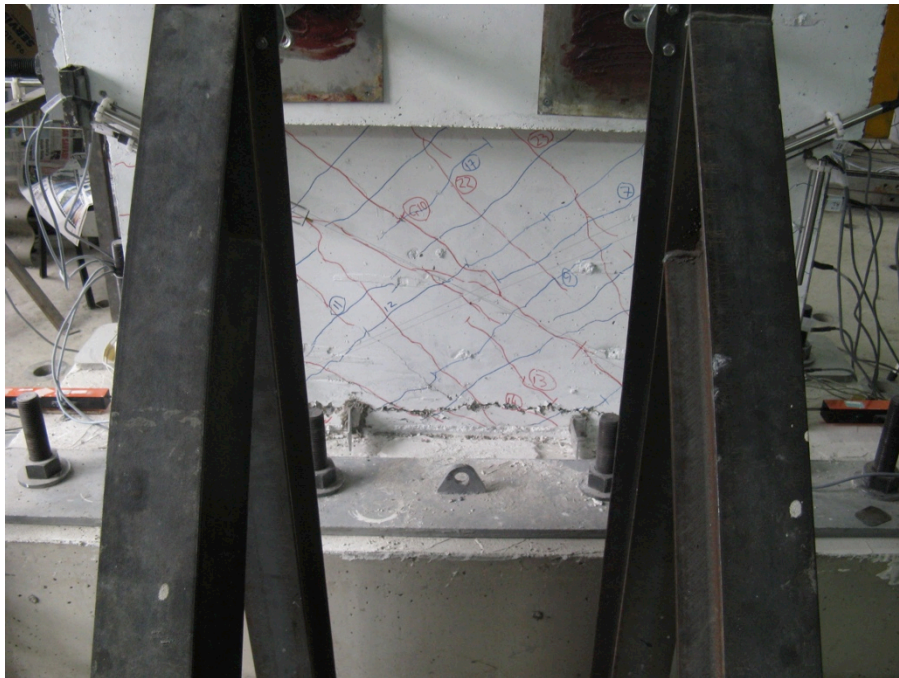
After the ultimate load capacity, the strength of the specimen degraded gradually. At 1.8% drift level, a residual strength of around 12% of ultimate lateral load capacity remained. The lateral load did not degrade beyond this point. At higher drift levels, the crushing of the concrete propagated through the center, but remained in the lower half of the wall height. This type of behavior proved that when the transverse reinforcement ratio is high, it is unlikely to have crushing along diagonal struts. The failure mode of this specimen was also diagonal compression failure, under combined shear and flexure effects. After the crushing of the corners, crushing propagated towards the wall center at the base, and the wall underwent sliding along the crushed base. Figure 3.9 shows observed medium and high damage levels for Type2 – Specimen2.

Figure 3.8. Cracking Pattern at Ultimate Load (T2-S2).

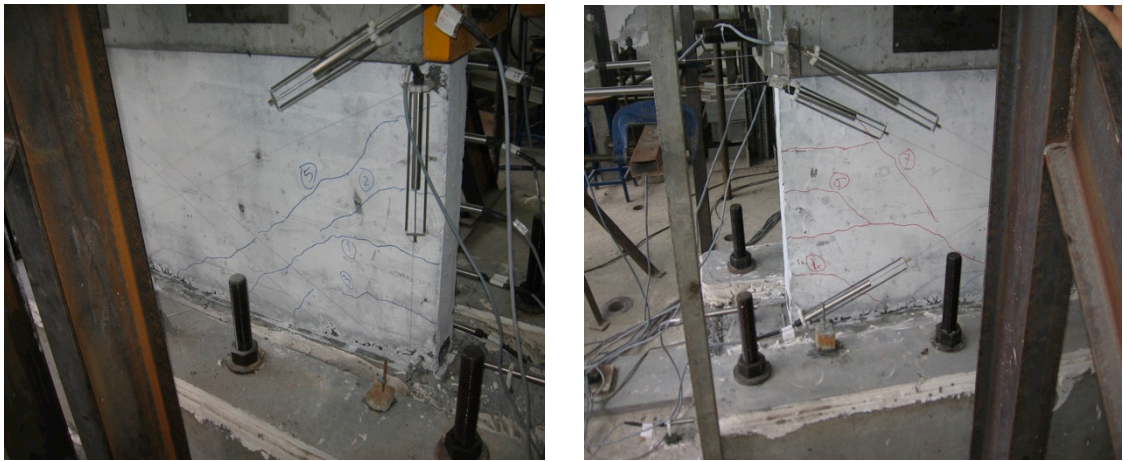
Figure 3.10. Initial Diagonal Cracks (T2-S3).

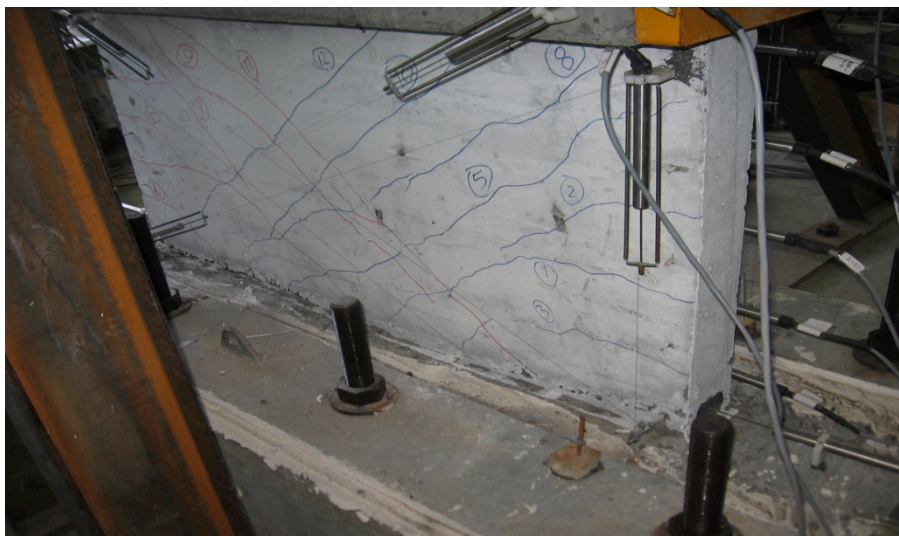
For this specimen, other major diagonal tension cracks formed at 0.2% and 0.3 % drift levels, both causing instantaneous strength degradation. Figure 3.11 shows the crack pattern at 0.3% drift. Cracks 9 and 10 formed during the 0.2% drift level and cracks 11 and 12 formed during 0.3% drift. The diagonal tension cracks occurred at 0.15%, 0.2%, and 0.3% drift levels caused stiffness degradation of the specimen. Beyond that point, the stiffness almost remained linear, until reaching the lateral load capacity.

Figure 3.11. Cracking Pattern at Ultimate Load Level (T2-S3).

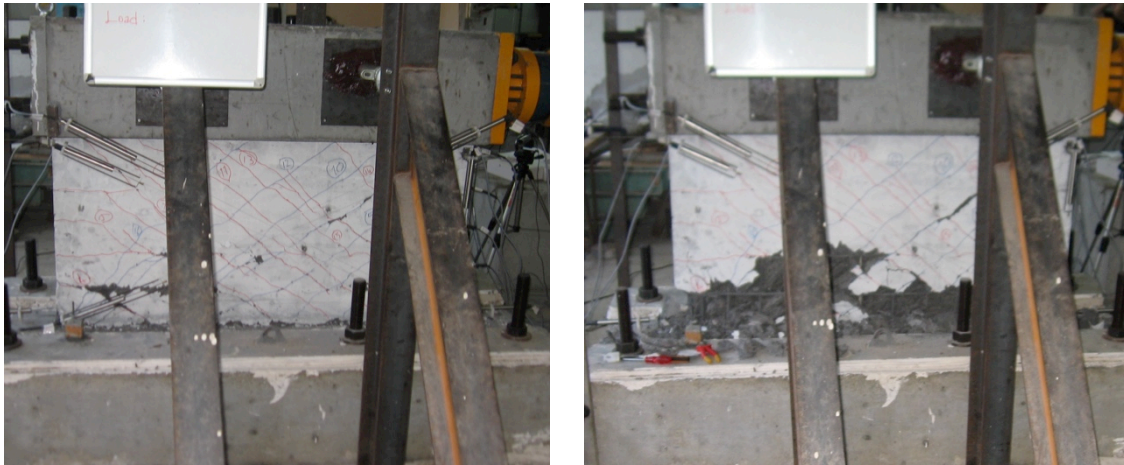
The specimen has reached its lateral load capacity at 0.6% drift, at a load level of around 810 kN. When the lateral load capacity was reached, the vertical web reinforcement close to the wall ends also yielded. At 0.8% drift level, the lateral load level remained almost same as the capacity. Strength degradation started at 1% drift level. Crushing of the concrete started at the bottom corner at the negative loading cycle to 1% drift, and crushing propagated along the width of the wall at the bottom during larger drift levels. Also at 1% drift, relatively minor concrete crushing was observed along one of the diagonal cracks. However, crushing at the bottom was much more pronounced and progressive.

Figure 3.12. Medium and High Damage Levels (T2-S3).

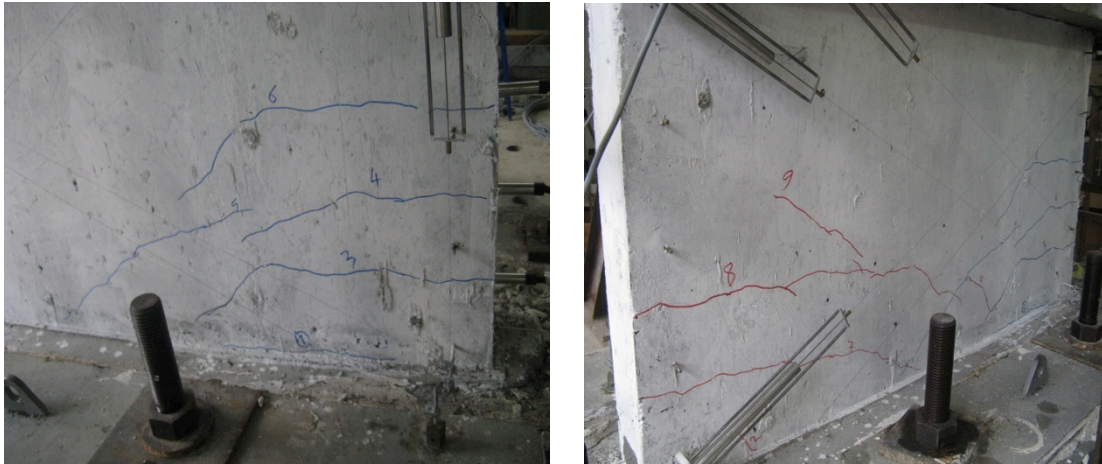
shear failure mode at the base of the wall. After a 50 kN load-controlled initial drift level, 0.0125%, 0.025%, 0.05%, 0.1%, 0.15%, 0.2%, 0.3%, 0.4%, 0.6%, 0.8%, 1.0%, 1.2%, 1.4%, 1.6%, 1.8%, 2.0%, 2.4%, 3.2% drift levels were applied under displacement control. At the 0.0125%, 0.025%, and 0.05% drift levels, there was no visible damage on the specimen. At 0.1% drift a few initial inclined cracks formed, as shown in Figure 3.13.

Figure 3.13. Initial Diagonal Cracks (T3-S1).

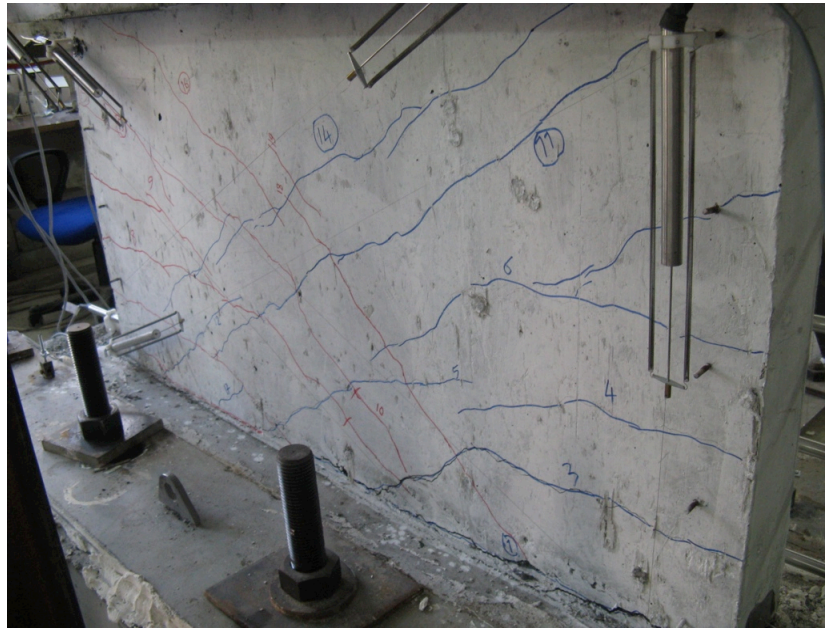
The strain gauge data showed that none of the horizontal web reinforcement bars yielded during the test, whereas all boundary reinforcement yielded at 0.4% drift level, and all vertical reinforcement bars yielded at 0.6% drift level. This data also shows that the sliding shear failure mode was triggered by flexural cracking and initiation of flexural yielding at the wall-pedestal interface.

Figure 3.14. Cracking Pattern at Ultimate Load Level (T3-S1).

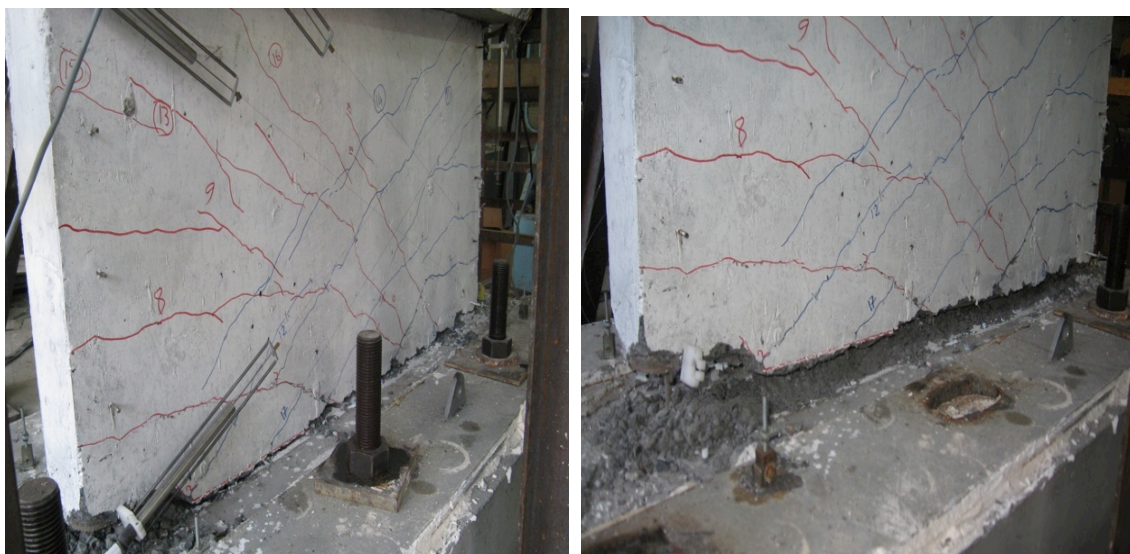
At 1% drift the interface crushed along the entire wall width, and the interface crack widened significantly at each loading cycle. After 1.2% drift, the vertical reinforcing bars fractured one by one, at each successive drift level. At the end of the test, all of the vertical reinforcing bars were fractured at the interface. Figure 3.15 shows the medium and high damage levels for the specimen. Interestingly, after the ultimate lateral load level capacity was reached, strength degradation was gradual, possibly due to kinking of the vertical bars during sliding of the specimen.

Figure 3.15. Medium and High Damage Level (T3-S1).

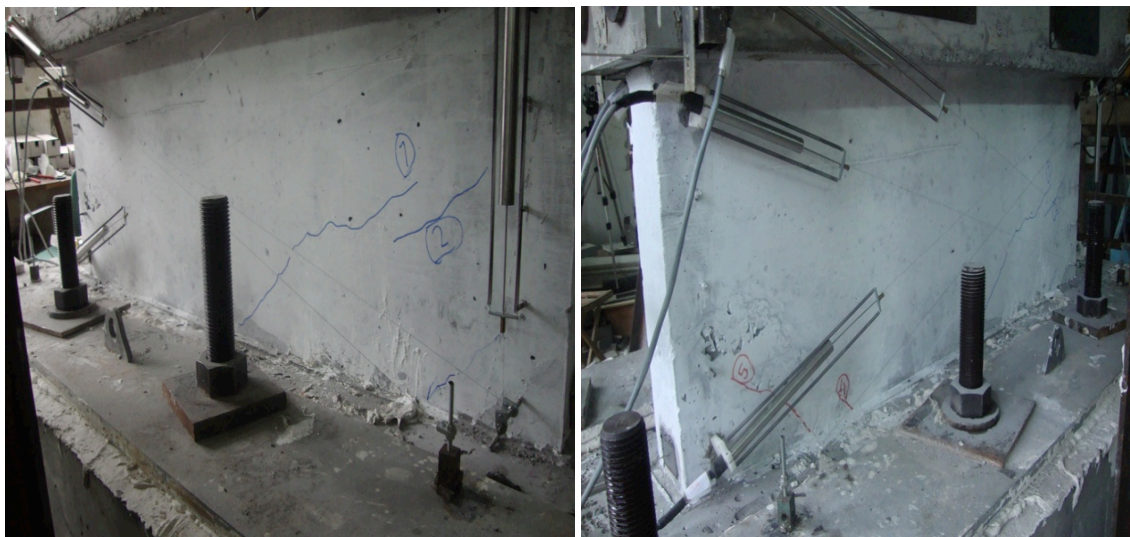
At the initial three drift levels, no damage was observed. First diagonal tension cracks formed at 0.05% drift level at the bottom corners. Figure 3.16 shows the positions of initial diagonal cracks. Under larger drifts, new diagonal cracks formed closer to the wall center at each successive drift level. The crack formation and alignment were similar to Type1 and Type2 specimens. Diagonal cracks formed at 0.1% and 0.2% drift levels caused instantaneous strength and stiffness degradation. Up to 0.6% drift, new cracks formed, while existing cracks extended and widened.

Figure 3.16. Initial Diagonal Cracks (T4-S1).

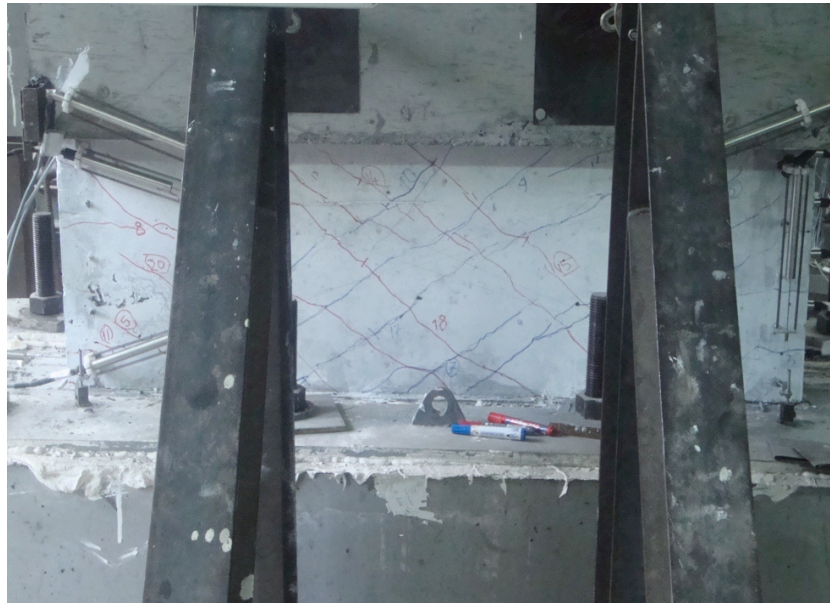
half of the wall height, close to the center. Figure 3.17 shows the diagonal cracking pattern at the ultimate load capacity.

Figure 3.17. Diagonal Cracking Pattern at Ultimate Load Level (T4-S1).

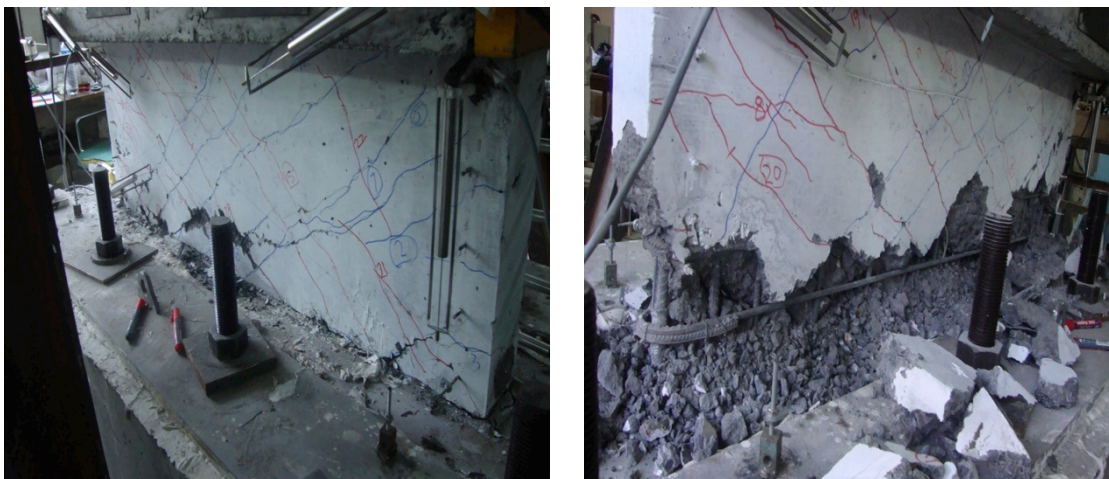
Figure 3.18. Medium and High Damage Levels (T4-S1).

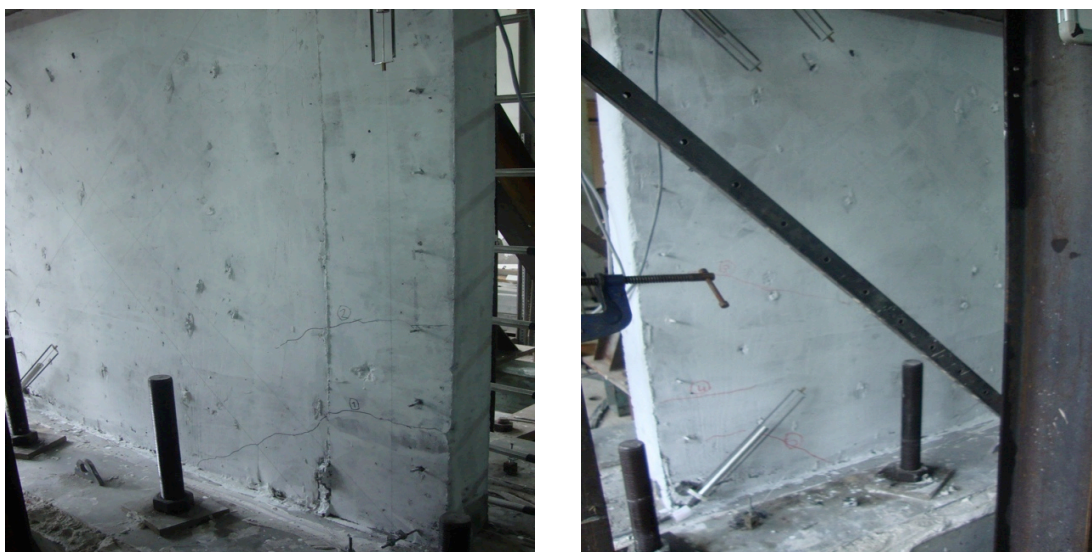
Figure 3.19. Initial Diagonal Cracks (T5-S1).

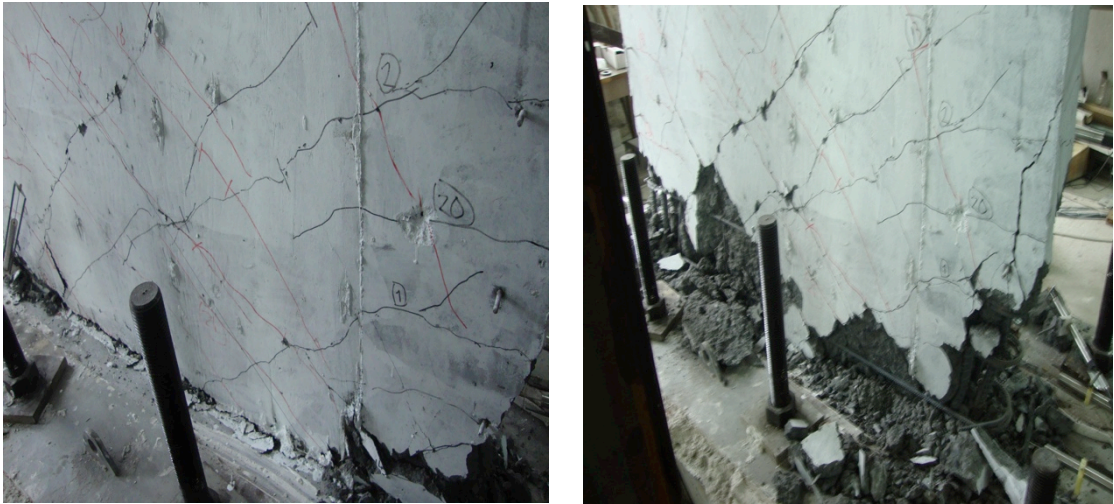
Figure 3.21. Medium and High Damage Levels (T5-S1).

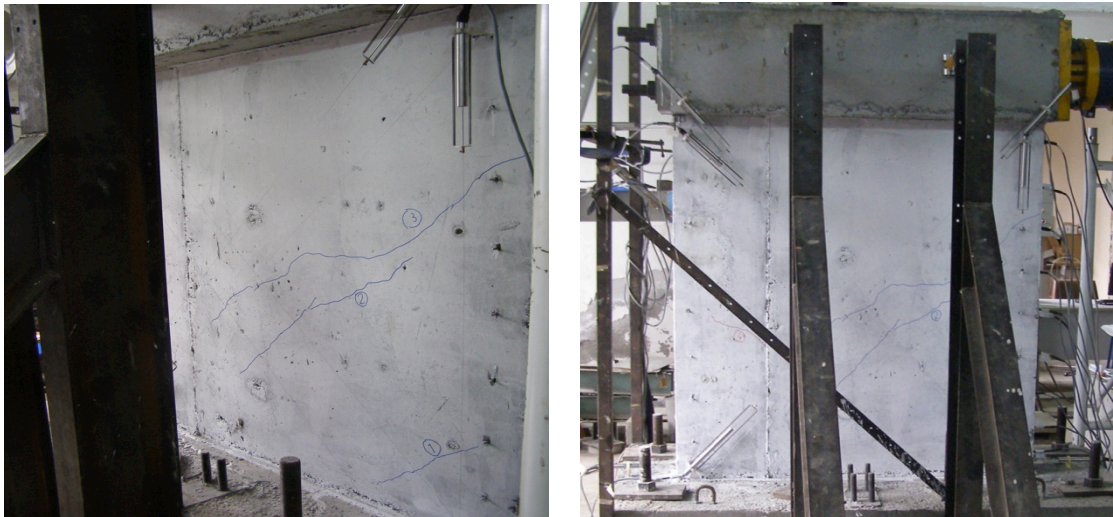
Figure 3.22. Initial Diagonal Cracks (T6-S1).

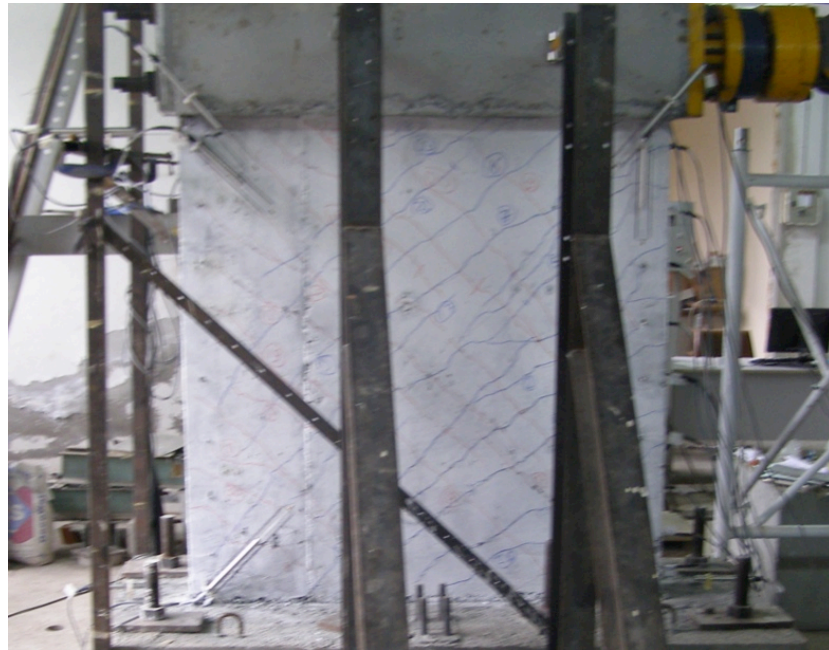
Figure 3.23. Diagonal Cracking Pattern at Ultimate Load (T6-S1).

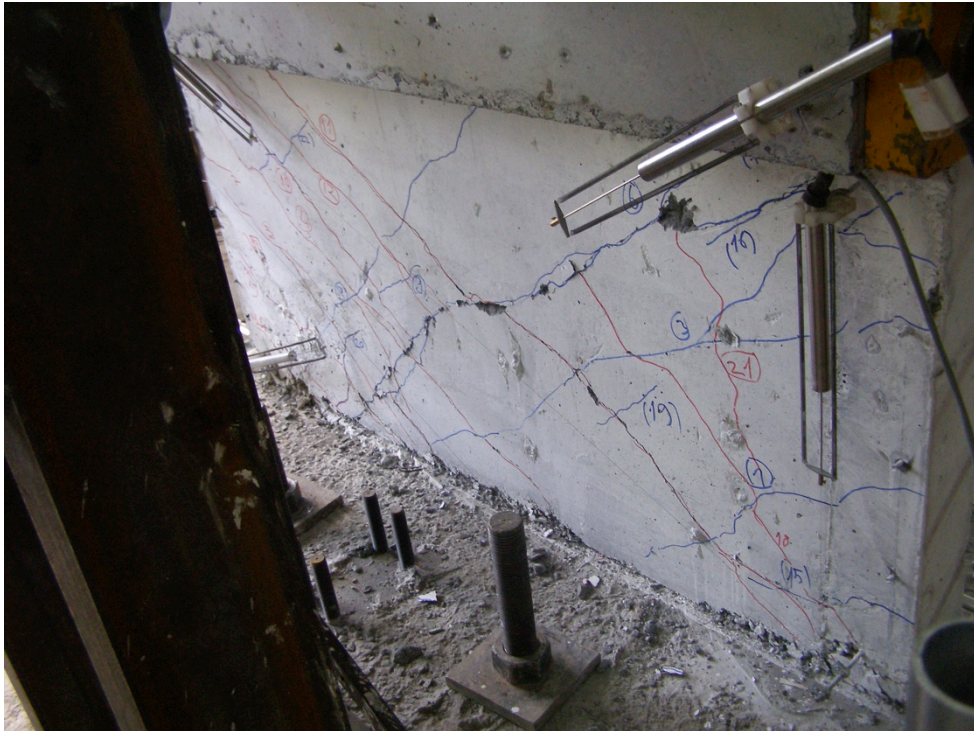
Figure 3.25. Main Diagonal Crack at Ultimate Load (T1-S2).

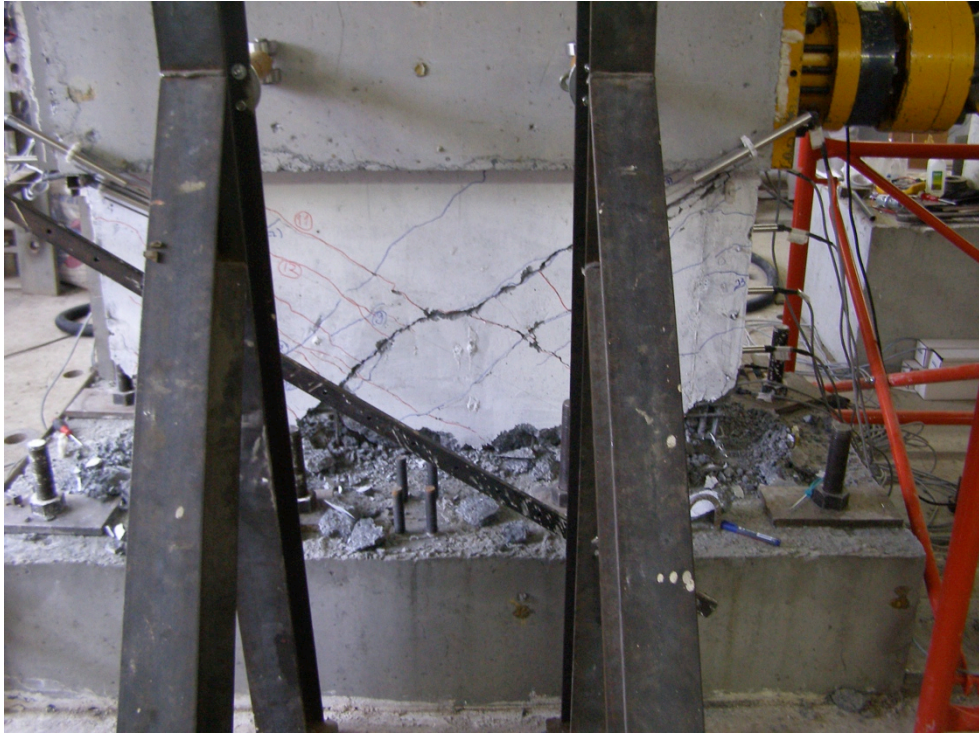
Figure 3.26. High Damage Level (T1-S2).

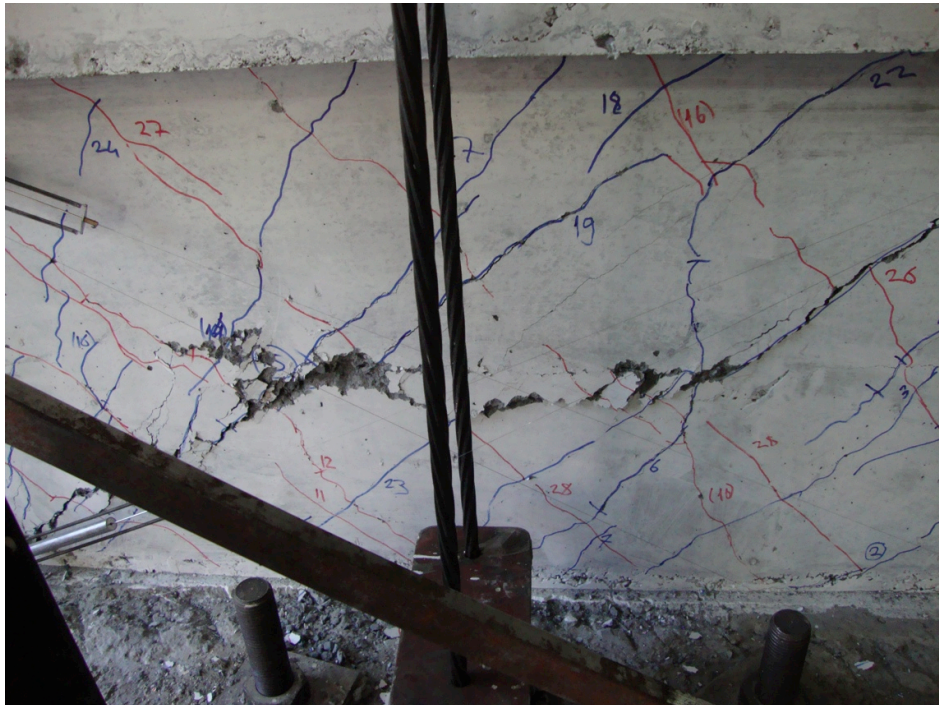
Figure 3.28. Main Crack (T1-N10-S1).

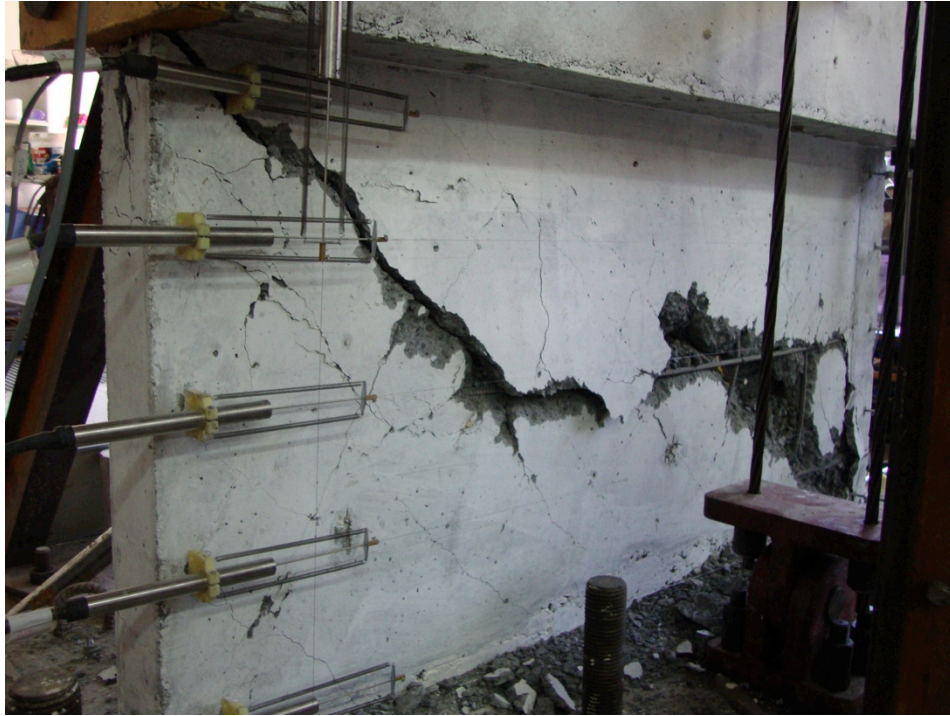
Figure 3.29. High Damage Level (T1-N10-S1).

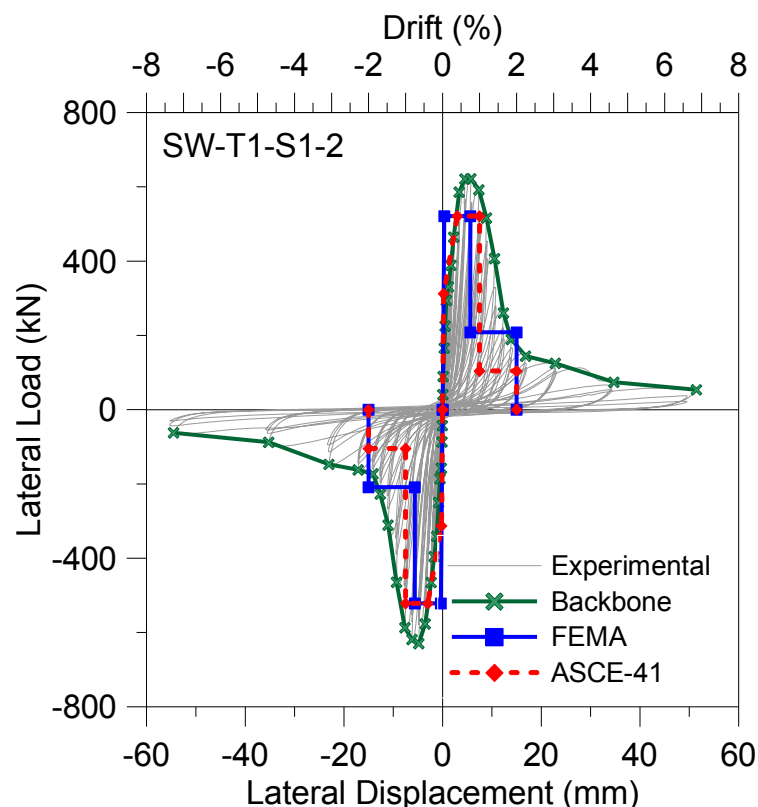
Figure 6.3. Shear-Controlled Response, Backbone Curve and Modeling Criteria, T1-S1.
