EXPERIMENTAL RESEARCH ON SEISMIC RETROFITTING OF R/C CORNER
BEAM-COLUMN-SLAB JOINTS UPGRADED WITH CARBON FIBER
REINFORCED POLYMER (CFRP) SHEETS

İbrahim Topcu

Master of Science

Boğaziçi University

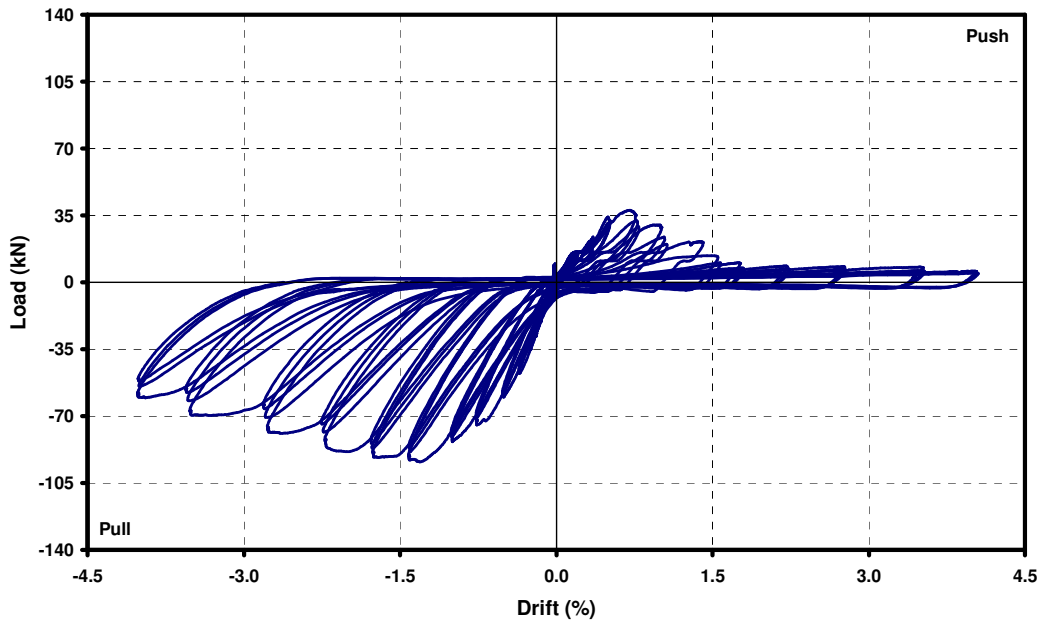
Figure 4.5. Load vs. story drift graph of US3-C-Control

As shown in Figure 4.5, brittle behavior (a sudden drop in load carrying capacity) was observed both in push and pull directions of loading due to the bond slip and joint shear failures, respectively. Because of the diagonal shear cracking of the joint region and bond-slip failure of the inadequately anchored beam bottom longitudinal reinforcement, the loops exhibited considerable pinching (the middle part of each hysteretic loop was relatively narrow). Also stiffness and strength degradations occurred during the repeated cycles of a drift level. Failure due to bond-slip was more brittle when it was compared to joint shear failure since it resulted with a higher rate of strength degradation.

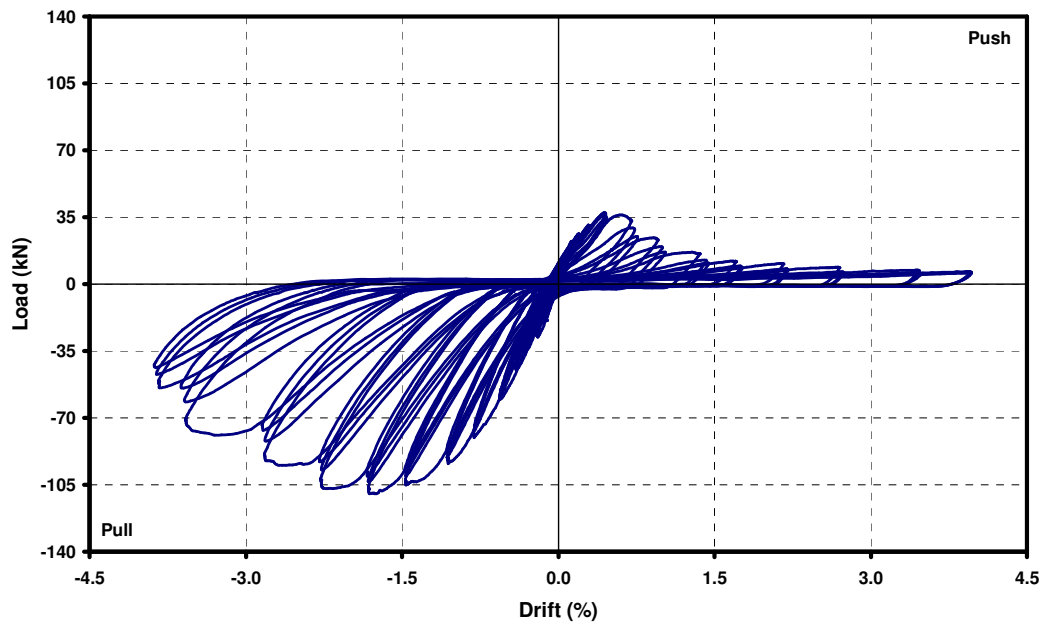
Figure 4.7. Load vs. top displacement graph of US3-CS-Control

The lateral load vs. story drift graph of US3-CS-Control subassembly is given above in Figure 4.7. The general shape of the graph is the same as the one of US3-C-Control. Brittle bond slip and joint shear failures governed the behavior again in push and pull directions of loading, respectively. In the same figure, pinching of the hysteresis loops, stiffness and strength degradation can also be observed. Failure pattern of US3-CS-Control is given below in Figure 4.8.

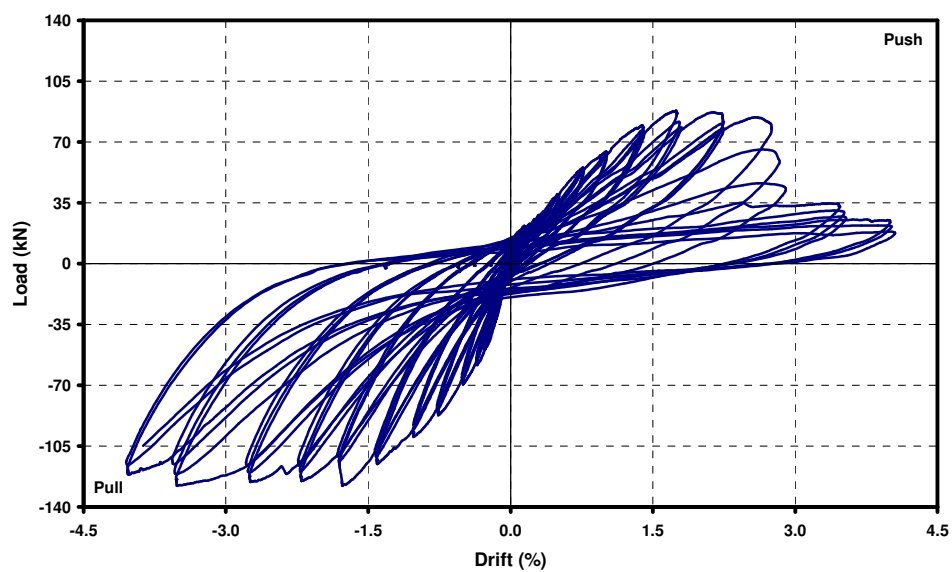
Figure 4.9. Load vs. story drift graph of US3-CS-FRP1

Lateral load vs. story drift response of US3-CS-FRP1 is shown in Figure 4.9. In this figure, it can easily be observed that lateral load increased gradually up to 1.75% drift level in push direction of loading and reached its maximum of 88 kN at that drift level. From the drift levels of 2.20% to 2.75%, maximum lateral load remained constant. However for the second and third cycles of 2.75% drift level, load decreased sharply because of the slippage of longitudinal beam bottom reinforcements. After that, decrease in the lateral load was continuous in the push direction of loading up to the end of the test. In the pull direction of loading, lateral load increased gradually until 1.75% drift level, which corresponded to a maximum lateral load of 128 kN. From that drift level on the lateral load remained constant.

Finally, it can be concluded that the main reason of the failure in push direction of loading was again the slippage of longitudinal beam bottom reinforcements which caused a sudden failure. On the other hand, it can easily be observed by considering lateral load vs. column top displacement response (Figure 4.9) that the failure was ductile in pull direction of loading.

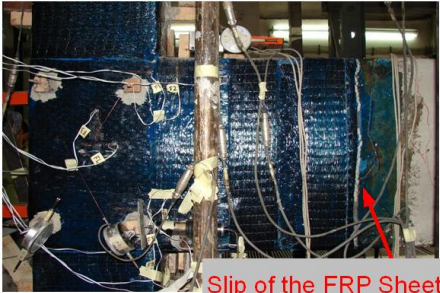
<p>Slip of the FRP Sheets as a result of the debonding.</p>

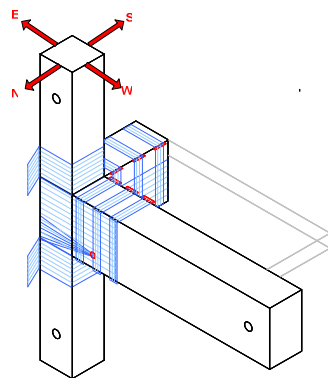
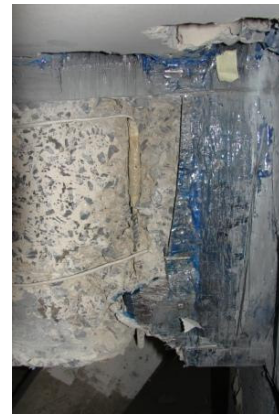
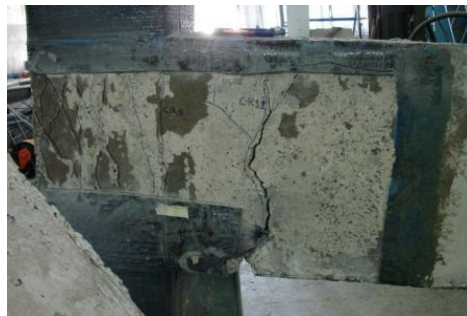
Figure 4.10. Views of crack #11 under FRP wraps

In order to inspect the damage visually for a more comprehensive explanation on the behavior of the specimen, FRP wraps were removed after the experiment. Crack patterns at the longitudinal beam and joint region under the FRP wraps are shown in Figure 4.10 and Figure 4.11. Crack #11 was the most significant crack which is shown in Figure 4.10. It occurred in push direction of loading at the bottom of the longitudinal beam at 2.20% drift level as a result of the slippage of longitudinal beam positive reinforcements when the moment at that cross-section was 106 kNm. At the following drift levels, because slippage increased dramatically, crack #11 widened too much that not only concrete cover but also

the concrete core spalled. Figure 4.11 shows the damage at the joint region under the FRP wraps. The joint shear deformation was critical for control specimens which caused the brittle failure of specimens in pull direction of loading. Therefore, one of the main objectives of CFRP retrofitting was to limit joint shear deformations. As it is shown in Figure 4.11, some diagonal shear cracks occurred at the joint region but they were not so remarkable.

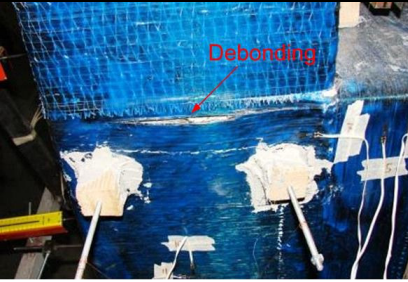
<p>(c) Debonding of outer L-shape FRP sheets at the joint region</p>

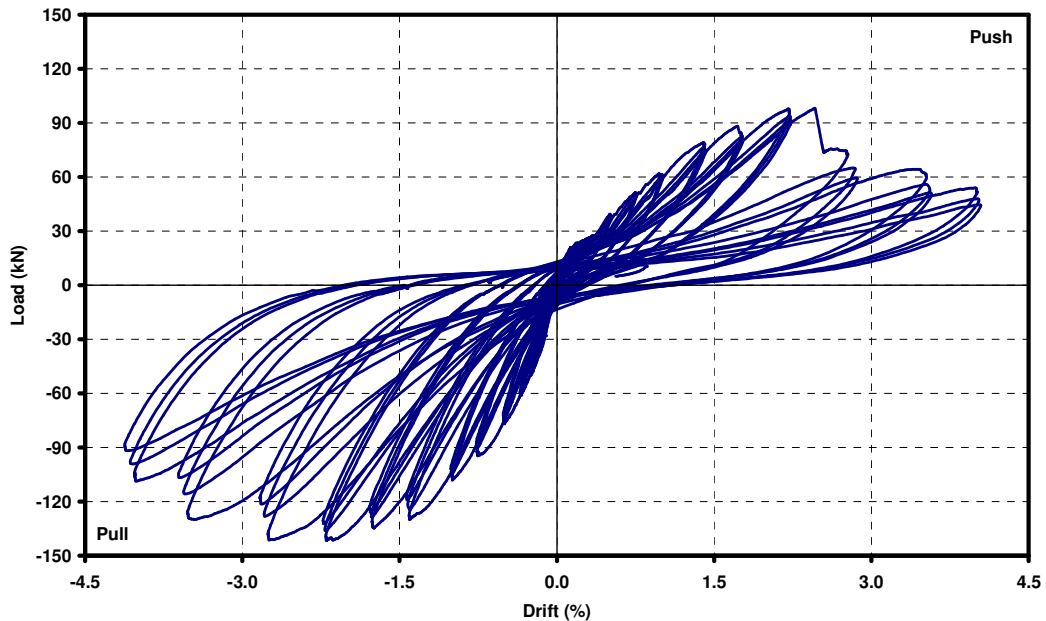
Figure 4.13. Load vs. story drift graph of US3-CS-FRP2

Lateral load vs. story drift response of US3-CS-FRP2 is shown in Figure 4.13. In this figure, it can easily be observed that lateral load increased gradually up to 2.20% drift level in each direction of loading and reached the maximum of 99 kN in push and 141 kN in pull direction of loading. At the drift level of 2.75%, lateral load decreased sharply in push direction of loading as mentioned above. After that, decrease in the lateral load was gradual up to the end of the test. At the drift level of 4.00%, maximum lateral load was 54 kN in push direction of loading. In pull direction of loading, debonding of outer L-shape FRP sheets caused joint shear failure and thus, lateral load decreased gradually after the drift level of 2.75%. In general, it can be concluded that, rapid strength and stiffness degradation due to bond-slip failure was limited in US3-CS-FRP2 when it was compared with other subassemblies. However, in the pull direction of loading, the desired ductile failure observed in US3-CS-FRP1 could not be occurred in this subassembly.

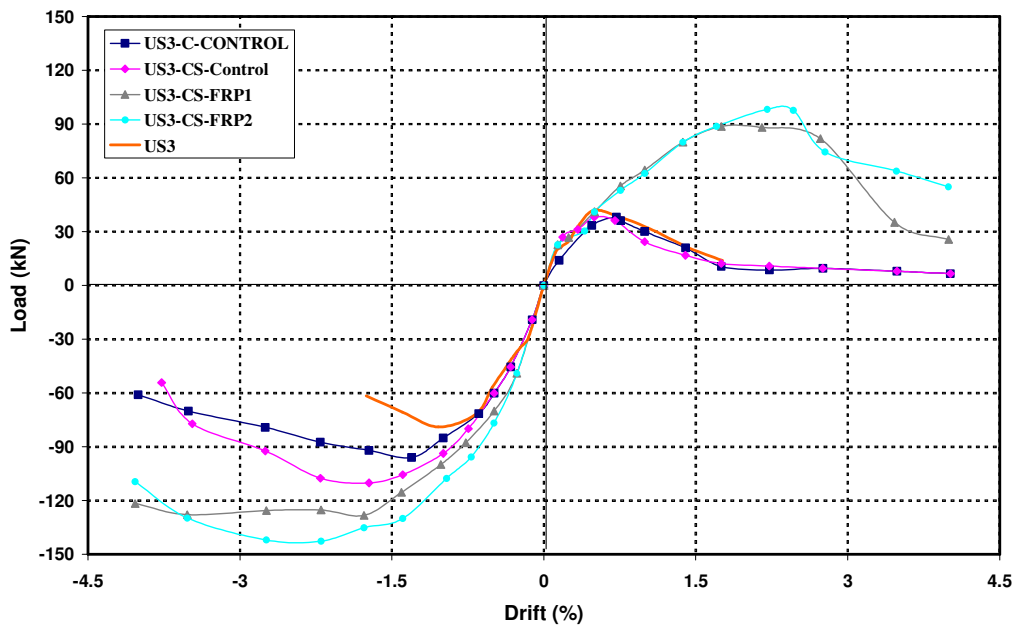
Figure 5.1. Hysteretic loop envelopes of test subassemblies

Sudden decrease in the lateral load carrying capacities of subassemblies confirmed that brittle failure occurred in both push and pull directions of loading of US3-C-Control and US3-CS-Control specimens. As it was also mentioned in previous chapter, joint shear and bond slip failures were main reasons of brittle behavior for both specimens in pull and push directions of loading, respectively. The only difference between these subassemblies was the presence of slab which increased maximum lateral load reached in pull direction of loading approximately 10%. Hence, it can be concluded that slab contributed to flexural strength of longitudinal beam in pull direction of loading when the slab bars were in tension. While the failure was due to joint shear deteriorations in pull direction of loading and the presence of slab does not increase joint shear strength, it may be concluded that joint shear demand was reached at higher lateral load level in US3-CS-Control when it was compared with US3-C-Control. The presence of slab seems inconsequential for seismic behavior in push direction of loading since the shapes of envelopes of these subassemblies were nearly the same.

Limiting the bond-slip and overcoming joint shear failure were main goals of retrofitting technique applied in US3-CS-FRP1 in order to move plastic hinge formation to the longitudinal beam for a desired ductile failure. Retrofitting scheme developed to serve these goals was given in previous chapter. As it can easily be observed from Figure 5.1, US3-CS-FRP1 behaved quite better than control specimens. In push direction of loading, bond slip failure was detained until the drift level of 2.75 % and the maximum lateral load increased 2.5 times when it was compared with US3-CS-Control. However, brittle failure again occurred at that drift level as a result of the significant slippage. On the other hand, US3-CS-FRP1 executed a desired performance in pull direction of loading. Ductile failure was achieved that joint shear deformations were limited and could not govern the behavior before beam hinging formed. In addition to that, maximum lateral load also increased 16%.
