REHABILITATION OF THE DAMAGED BRICK INFILLED RC FRAMES BY CFRP  
OVERLAYS AND EPOXY INJECTION

Submitted to the Institute for Graduate Studies in  
Science and Engineering in partial fulfillment of  
the requirements for the degree of  
Master of Science

Graduate Program in Civil Engineering  
Boğaziçi University

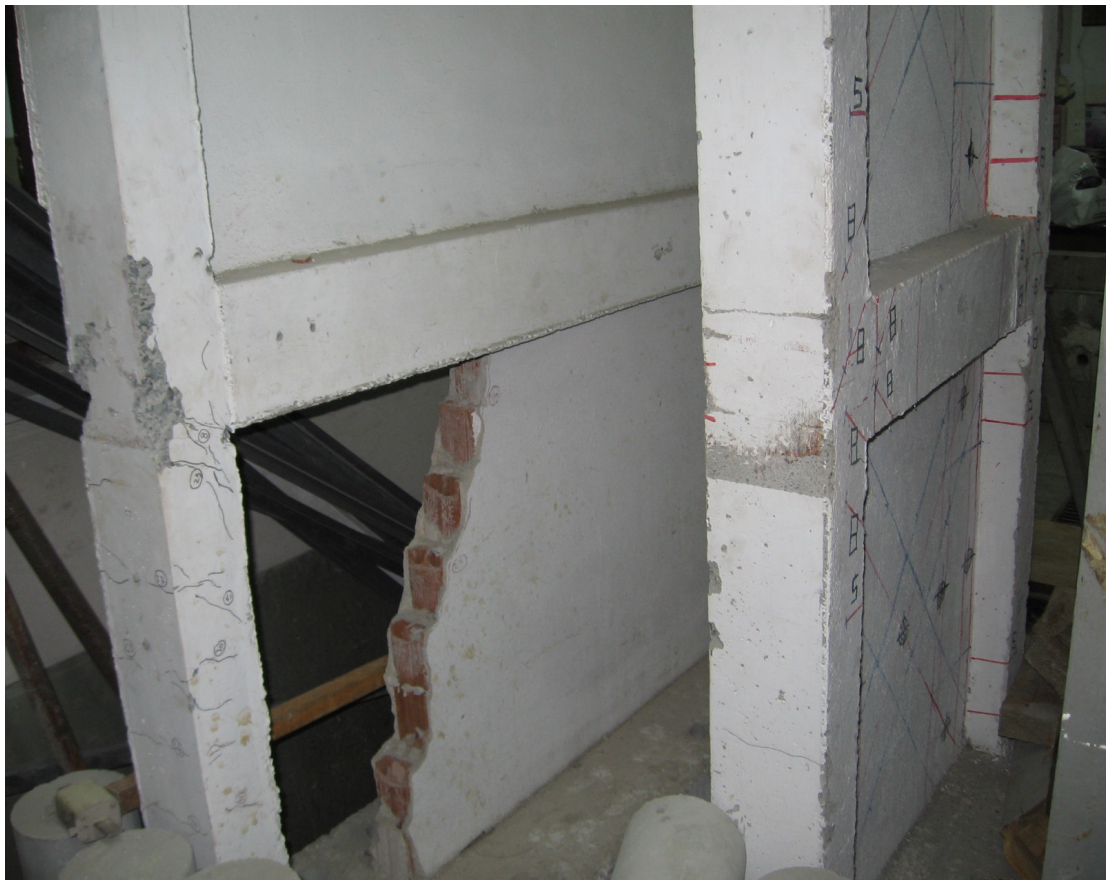
Figure 3.4. First floor of test specimens

As it was seen from the Fig.3.4, brick loss was appeared at only test specimen O2 with an aspect ration 2.3. For the specimen O1, only plaster repairs had been applied for the backside. Two different repairing options for the brick repair had been examined. One of them was to demolish all first floor brick and rebuilt it. The other one was only repairing and filling the missing parts. The second way of repair had been chosen due to the fact that, repairing philosophy had to be feasible and realistic. Also, there was a problem if we would choose the way to demolish such that, the plaster and mortar strength and condition might change compared with the results of Atmaca's specimen.

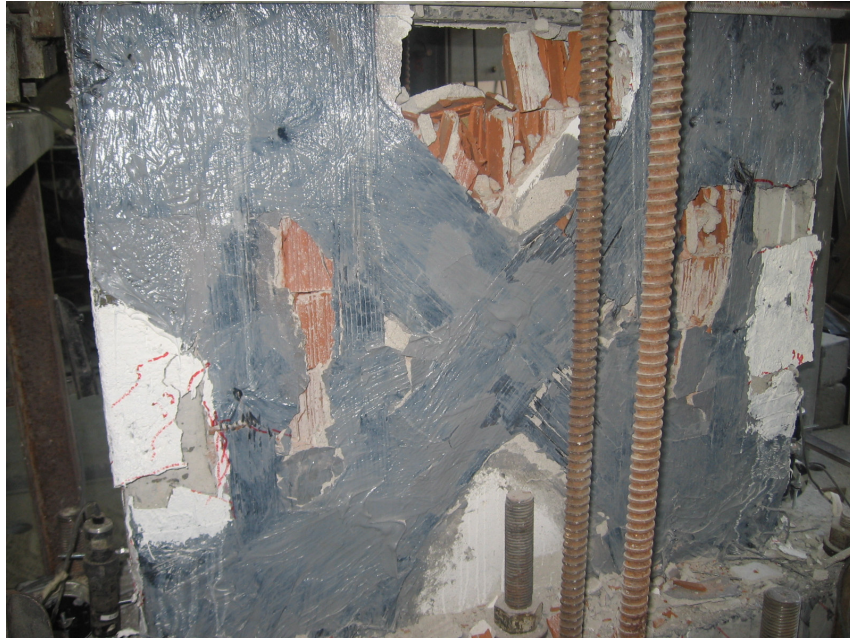
The test was terminated at a drift level of 0.018 at the end of the 17th cycle. Figures 4.11 and 4.12 showed the final situation of the specimen. Failure would be attributed to tensile failure of columns, and rupturing of vertical and diagonal FRP at backside under the axial FRP stresses. Due to the tensile failure and FRP failure plastic hinges occurred at the columns on the first story level. Separation between infill and columns around was observed significantly. Masonry infill separated into two main parts due to upper mid-height rocking action of the specimen after rupturing of vertical FRPs as shown in Figure 4.13. On the other hand, formation of horizontal cracks on the infill implied a horizontal movement of the frame. Spalling of unconfined concrete was not observed at the bottom ends of the columns around lap splices. Although the specimen failed with the rupture of vertical FRP strips, the top deformation of the frame was influenced by a sliding shear type of deformation took place at upper midheight of the first story. This resulted in a so-called ductility and anticipated pinching behavior in the hysteretic loops. As a result, compared with the specimen of Atmaca which has not any damage, damaged specimen O1 was approximately same behavior and failure modes with a close lateral load carrying capacity.

Figure 4.5. Final condition of backside of specimen O1

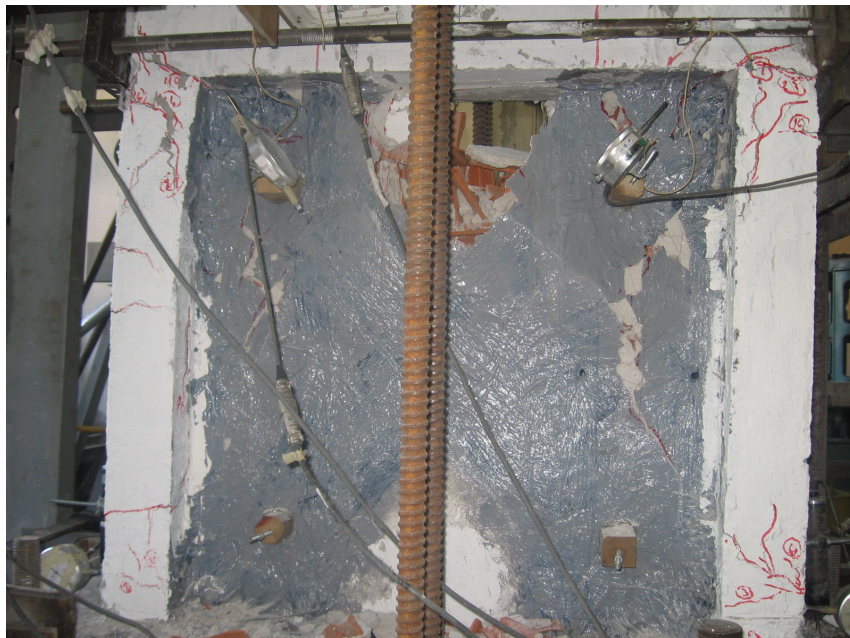
Figure 4.6. Final condition of frontside of specimen O1

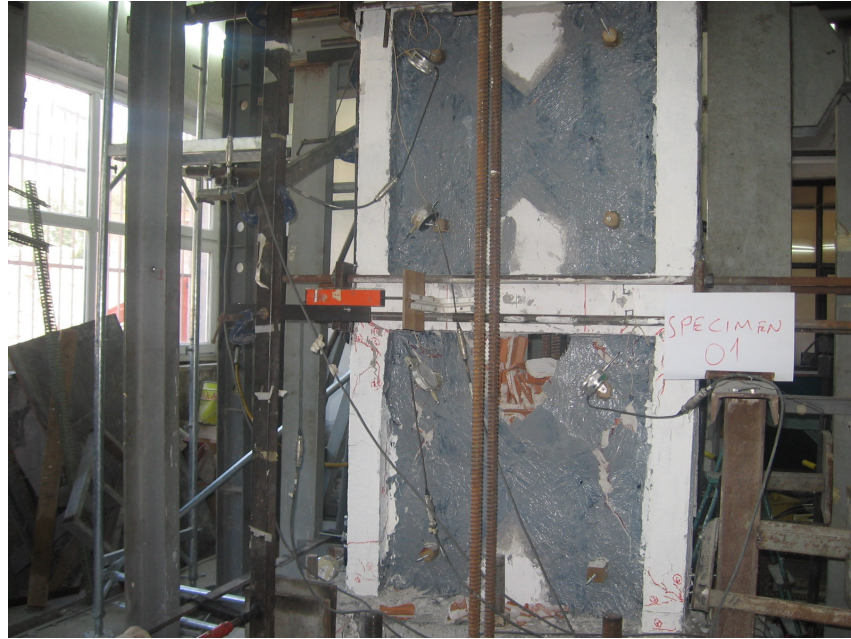
Figure 4.9. Condition of specimen O1 after the test

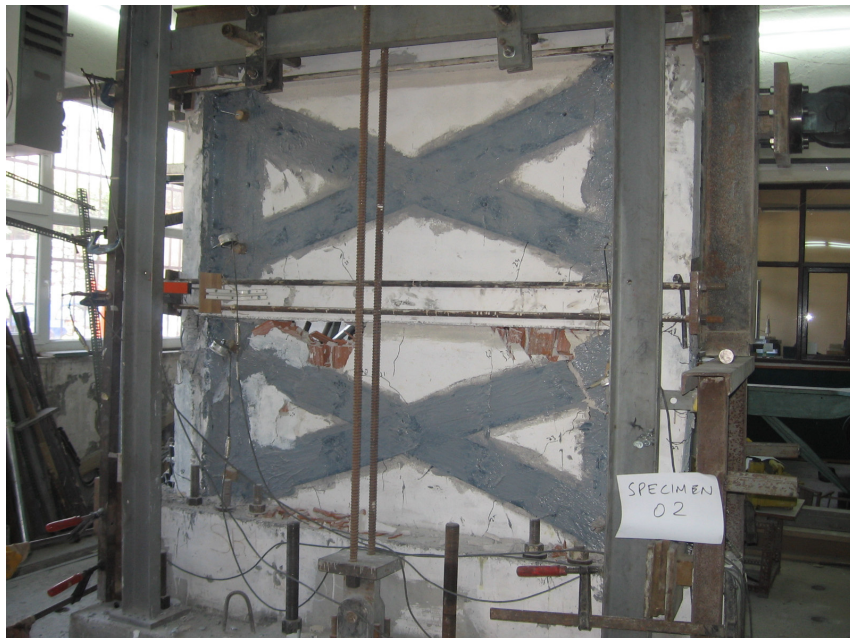
In the next two cycles, drift levels corresponding maximum loads for the forward half cycles were about 1.26% and 1.68% respectively. After the FRPs were ruptured, heavy damage occurred as shown in Figure 4.61 and test was terminated at the end of the 22nd cycle. Loading type and maximum values for each successive drift level are summarized in Table 4.2. Failure could be attributed to the rupturing of FRPs and capacity exceedance of the columns. Frame columns failed under a combined action of shear, moment and axial forces. Rupturing of FRPs transferred all the actions from the FRP strengthened frame to the infilled frame and deterioration took place. Buckling of the longitudinal steel on the left column top end, spalling of cover concrete and loss of inadequately confined core concrete which can cause vertical movement implied gravity collapse of the frame after crushing of the infill at the end of the test. Separation of the infill from the surrounding frame was observed clearly after rupturing of the FRPs. Formation of horizontal cracks on the masonry panel was the indicator of sliding but this was not seen as predominant on the failure. At the last cycle, pictures illustrated that the frame and infilled masonry behaviors were not consistent with each other especially after rupturing of FRPs and crushing of masonry around the corner flags. In other words separation was much more notable. Behavior of the specimen showed that axial load failure occurred right after the shear failure of the columns that of which was in good agreement with the literature.

Figure 4.17. Condition of specimen O2 after the test
