CONVERTING EXISTING BUILDINGS TO GREEN BUILDINGS:  
IMPLEMENTATIONS IN TURKEY

B.S., Civil Engineering, Boğaziçi University, 2011

Graduate Program in Civil Engineering  
Boğaziçi University  
2013

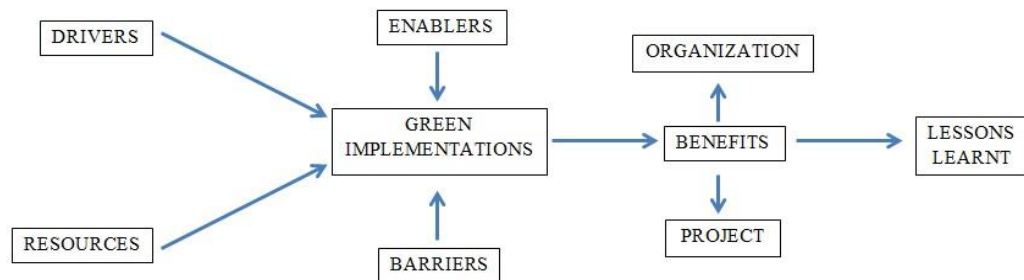
Ozorhon (2012) developed a framework to analyze the innovation process in a construction project setting by using components like drivers, inputs, barriers, enablers, innovative activities and outputs. Based on that previous framework, a similar framework is formed to investigate green building projects in Turkey. The proposed framework can be seen in Figure 3.1. According to the framework, drivers and resources lead owners or tenants to apply green building energy efficient implementations. During implementation

stage, barriers and enablers are encountered. After the project is completed, negative or positive benefits occur both at organization and project level. Independent of being successful or unsuccessful, lessons learned from each unique project process occur at the end of this process.

Figure 3.1. Framework to investigate greening projects in this research.

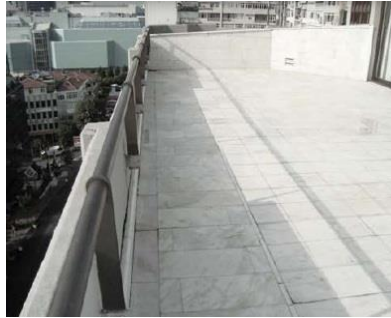
Figure 4.1. White tiles on the roof.

- All investments were chosen so that they had short payback periods.
- Terrace roof of the building is covered with white tiles which reflect the sun light and prevents warming of the roof. Additionally, on the firm ground around the building light colored tiles with high solar reflectance index were preferred so that heat island effect was removed.

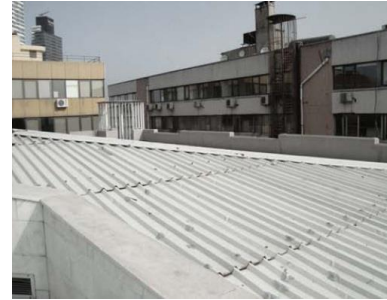
Figure 4.2. White roof.

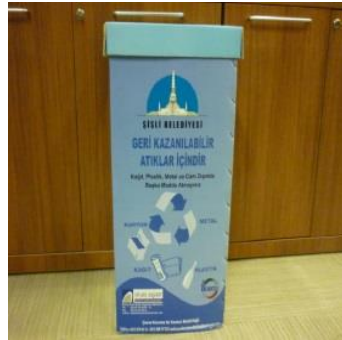
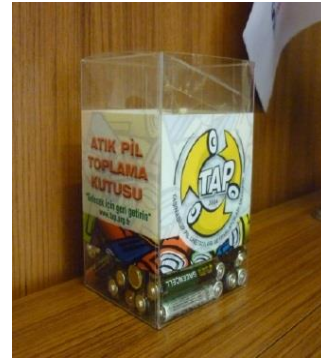
- There is a strict waste management in the building. Before implementing such a policy, analysis of wastes in the building was performed. During the renovation, all debris was sent to recycling. Besides, all of that, remains of food are sent to animal houses through the municipality.

Figure 4.3. (a) Recycle bin in the office. (b) Waste batteries collection box.

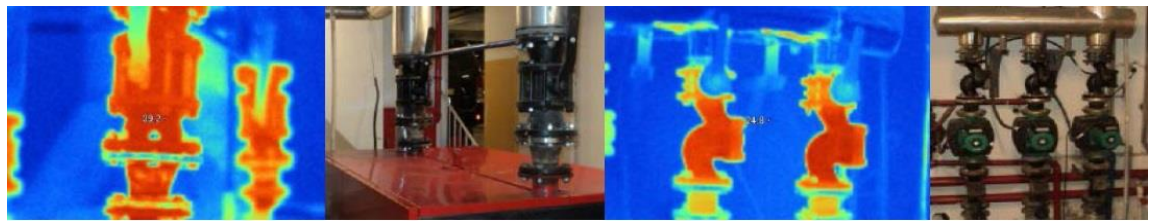
Figure 4.5. Heat leakages in the valves.

- ASHRAE Level 1 and 2 energy audits and daylight measurements were conducted in the building. According to the results, necessary improvements were performed. In 40% of energy consuming systems of the building, sub-metering devices were set up thus it is possible to compare monthly consumption rates. All heating valves in the engine room were controlled with thermal cameras and heat leakages were detected. Then isolation of the valves was performed with insulating materials wrapping them.

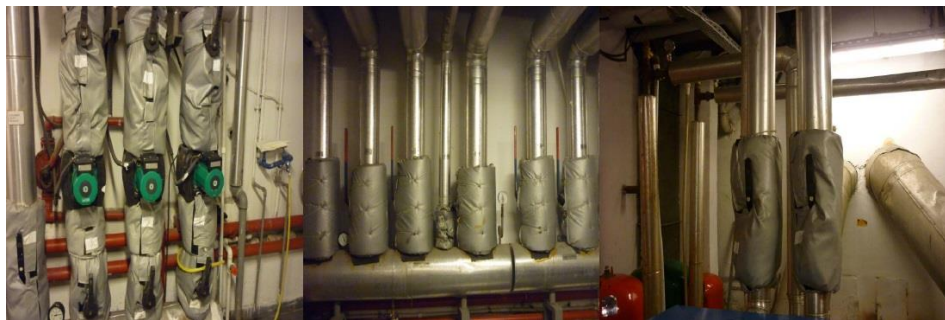
Figure 4.6. Isolation of the valves wrapped with insulating material.

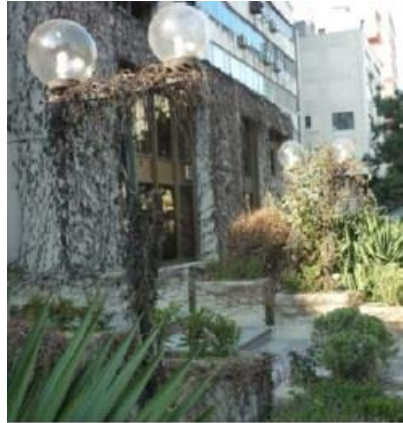
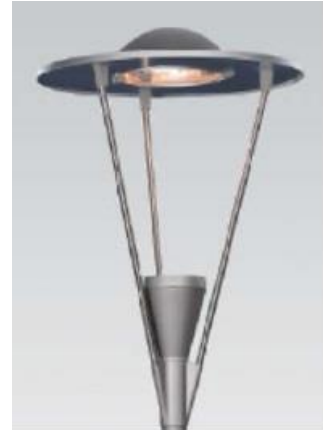
Figure 4.7. (a) Old exterior lighting fixtures.

(b) New exterior fixture.

- Halide halogens of the signboard in front of the building were replaced by LED bulbs which offer long service life and high energy efficiency. Exterior lighting fixtures were pointing to the sky and this made them inefficient hence they were replaced with efficient ones that were installed with a conical cap and so pointed to

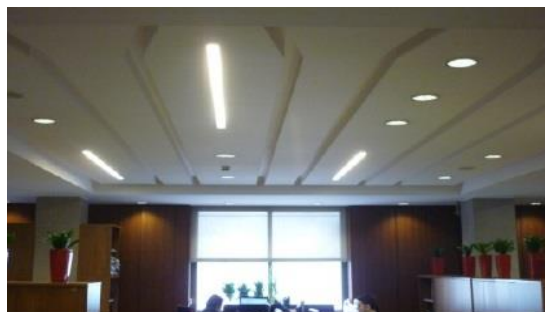
Figure 4.8. LED lamps on the ceiling.

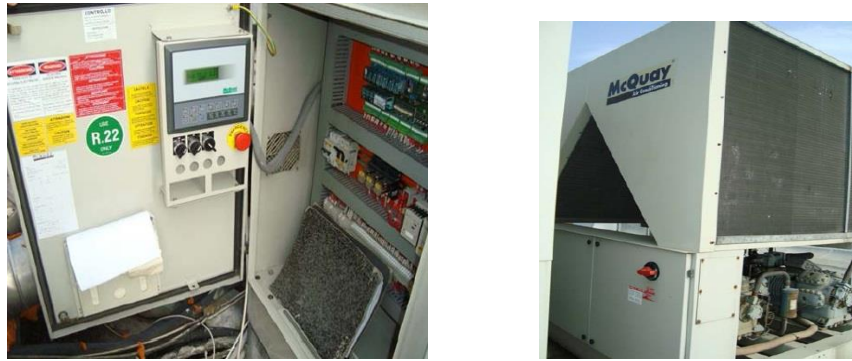
Figure 4.9. (a) Ozone friendly gases in use. (b) Central air conditioning.

- Before renovation, there was natural ventilation in the building: employees used to open the windows when they got warm or wanted to breathe fresh air. Since this was inefficient and insufficient, a mechanical ventilation system was installed in the building. Ozone-friendly gases which are appropriate for Montreal Protocol were chosen to be used in heating and cooling systems. In garage carbon dioxide detectors were placed. When CO<sub>2</sub> amount exceeds a specific amount in the garage then ventilation starts automatically in order to reduce it.

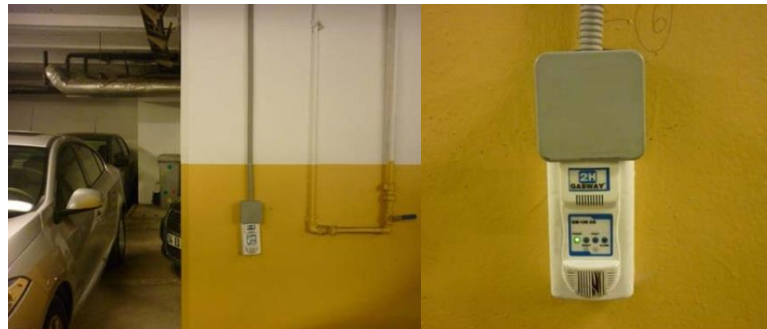
Figure 4.10. CO<sub>2</sub> detectors in the garage.

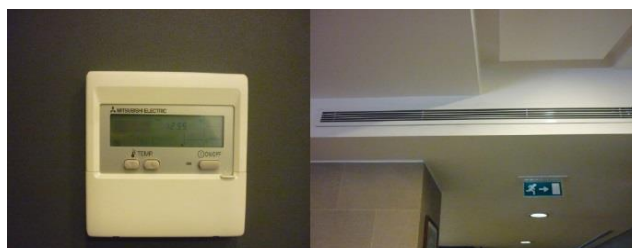
Figure 4.11. Mechanical ventilation system on the floors.

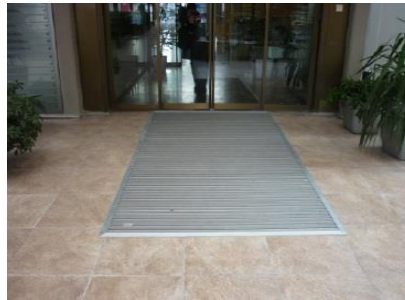
- No smoking is allowed in the building. Smoking area is eight meters away from it. In front of the entrances, 3 meter long doormats were laid. Thus, incoming people step at least three times on the doormat and leave their dirt and dust outside.

Figure 4.12. 3 meter long doormat in front of the building.

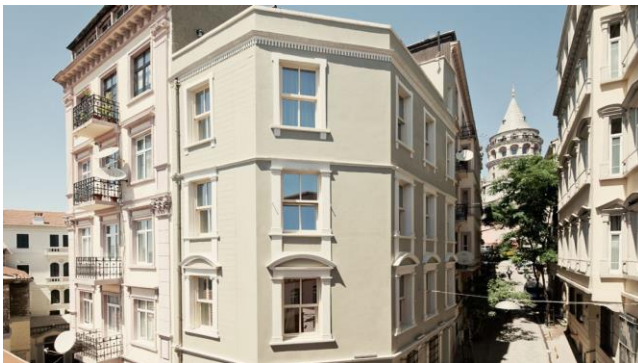
Building B is the first heritage building in Turkey that is certified under LEED after a major renovation work. It serves now as a hotel and was built in the late 1880's. The building is 6-storey, has a construction area of 330 m<sup>2</sup> and located in Istanbul. It is a second degree historical monument and when it was first bought by its current owners several years ago, it was about to collapse. Afterwards it was renovated according to sustainable architecture requirements and certified under LEED for New Construction and Major Renovations (version 2009) with 55 points in 2011 and gained a LEED silver certificate.

Figure 4.13. (a) Outside view of the hotel.

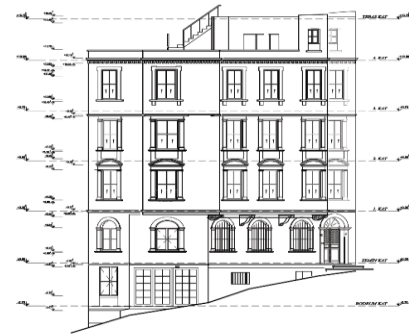
(b) The hotel's lateral section.

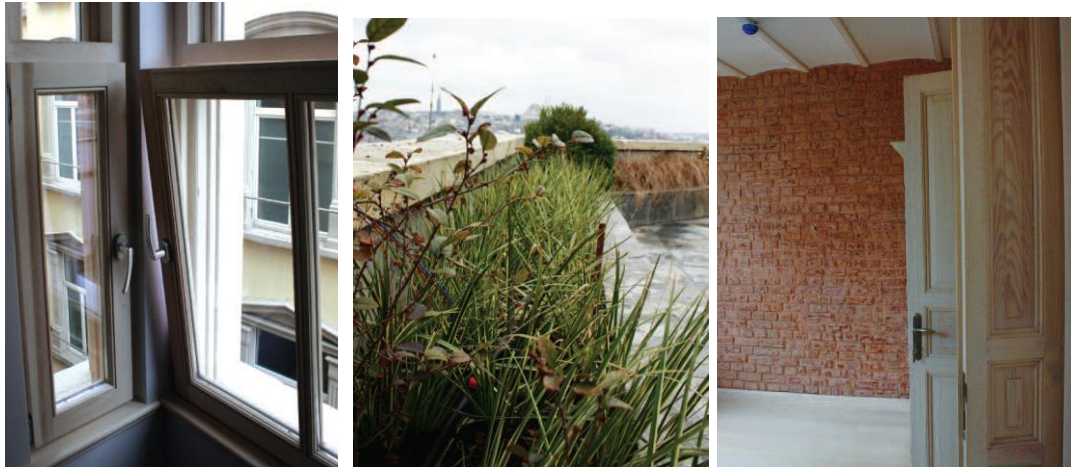
Figure 4.14. (a) Windows.

(b) Green roof.

- Windows are made of special wood and involve glasses with high heat insulation. During design phase, thickness of the glasses was increased. Indoor thermal comfort design was made according to ASHRAE 55 standard. In heating and lighting systems, 100% user controlled switches were preferred by the architect. Monitors were installed in the rooms in order to measure internal air quality.

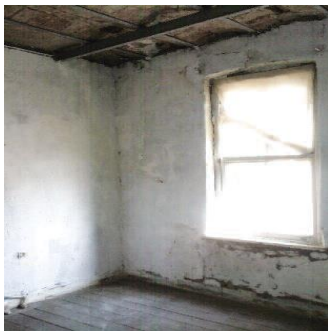
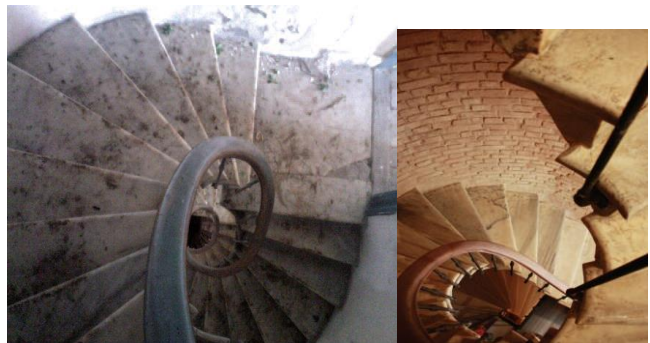
Figure 4.15. (a) Rooms before LEED.

(b) Stairs before and after LEED.

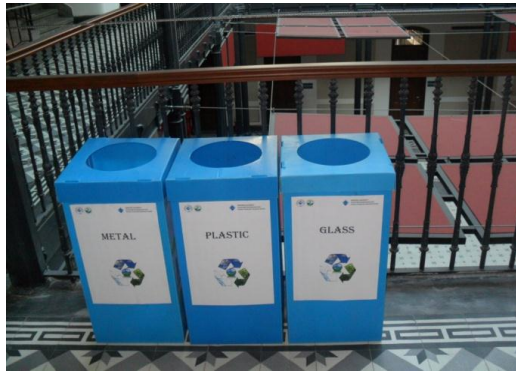
Figure 4.16. (a) Recycle bins on the floors.

- Smoking is forbidden in each floor of the building. People can smoke at a minimum distance of 7.5 m far from the building.
- To encourage bikers, two bicycle parks were built, one of them is open and the other one is roofed and 5% of the capacity of the car park was reserved for low emitting and fuel efficient vehicles only.
- According to proven results taken from the measures of a light meter, 75% of life spaces in the building receive daylight with an intensity of at least 110 Lux and economic lamps were used in lighting installations. Besides, doors and glasses are proper to heat isolation.
- It was projected that a dormitory with a population of 218 students would produce about 600 kg of waste material. It was estimated that 275 kg of it would be

recyclable. So recycle bins were placed in every floor. The total number of the bins is 30 in the building.

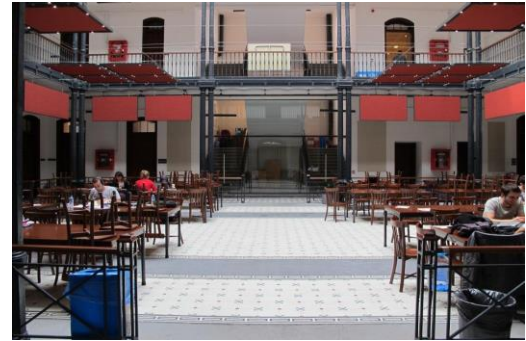
(b) Renewed study hall.

Since thousands of students make use of the study hall every day and they convey complaints or appreciations to the university administration without any hesitation, it is known that there are no complaints about decreased flow rates of taps and shower faucets in the dormitory. Students who work in the study are glad of that there is now effective sound isolation in social activity rooms, lightening of the study hall is much better than before, ventilations of canteens function properly and no smell of grill or furnace infiltrates the study, residents are more satisfied because of increased comfort in the rooms and students who use social activity rooms are also pleased with renewed rooms.

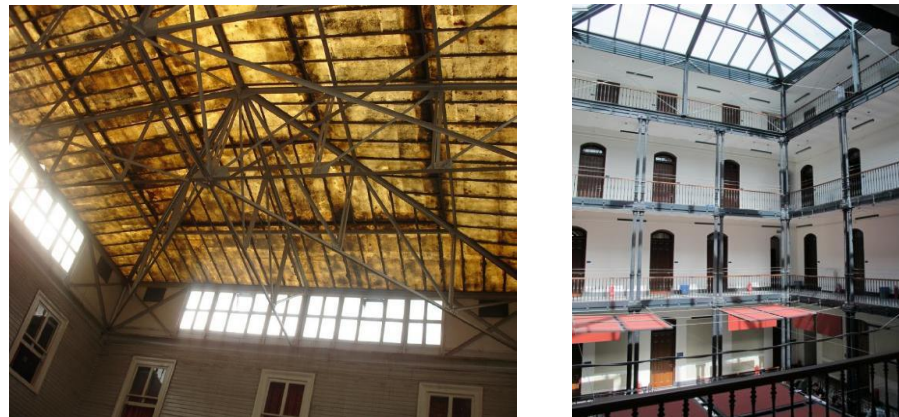
Figure 4.17. (a) Atrium before renovation. (b) Atrium after renovation.

- Last and the most important innovation in Building C was that the atrium in the middle of the building was returned to its original shape: when the building was first built, there was a quadrilateral atrium without any roof on its top located exactly in the middle of the structure. In the past years, the top of the atrium was roofed and mezzanines were added to the building. Then the bottom floor of the atrium was formed into a study hall. Via this renovation project, mezzanines and roof of the atrium were demolished. The top was covered with a glass window, by this way ventilation and lightening requirements of the study hall were satisfied. Natural ventilation was provided. Besides, automatic windows and carbon dioxide detectors were placed on the roof. When fresh air decreases in the study, these windows are opened automatically and provide ventilation.

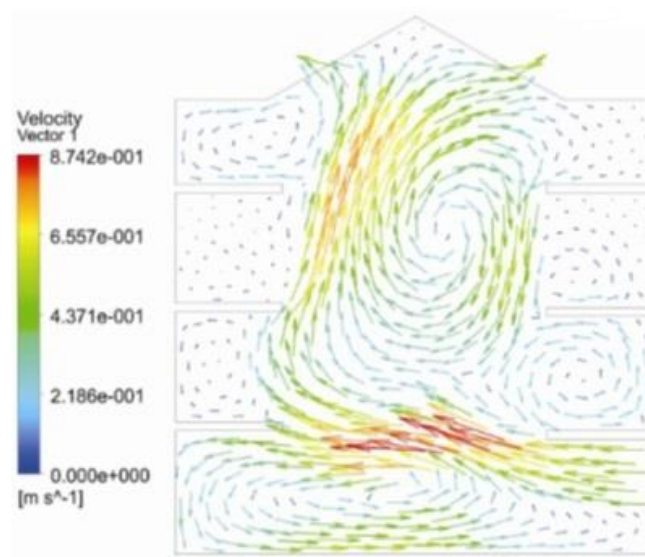
Figure 4.18. CFD model of the atrium.

According to LEED standards, natural ventilation holes must be at a distance of maximum 7.5 meters from where people are. If the holes are at a longer distance, then LEED requests CFD report of indoor places. Since glass roof of the atrium is found at a much higher distance than 7.5 meters, CFD report of the atrium had to be prepared. The project team of the university had no time for these assignments because the documentation process started after the construction works were completed. They had to attend to other construction projects going on within campuses. So the consultant team asked a professor of thermodynamics to prepare the CFD report of the atrium. Completing this report took three months.

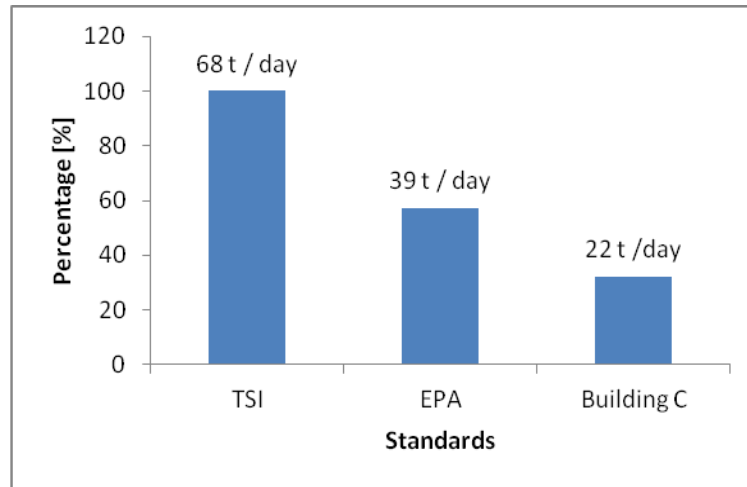
Figure 4.19. Comparison of daily water use according to different standards.

After renewal works were completed, it was calculated that the amount of saved water per year is 3800 tons which is 67% of total amount of water consumed in a year according to Turkish Standards. There is a daily saving of 46 tons of fresh water. In Figure 4.28. comparison with EPA standards can be seen. These values were calculated by multiplying estimated number of users, their usage frequency, usage period and unit consumption rates of the equipment that were used in Building C. On the other hand, yearly amount of black water was reduced 48% according to TS and 30% according to EPA.

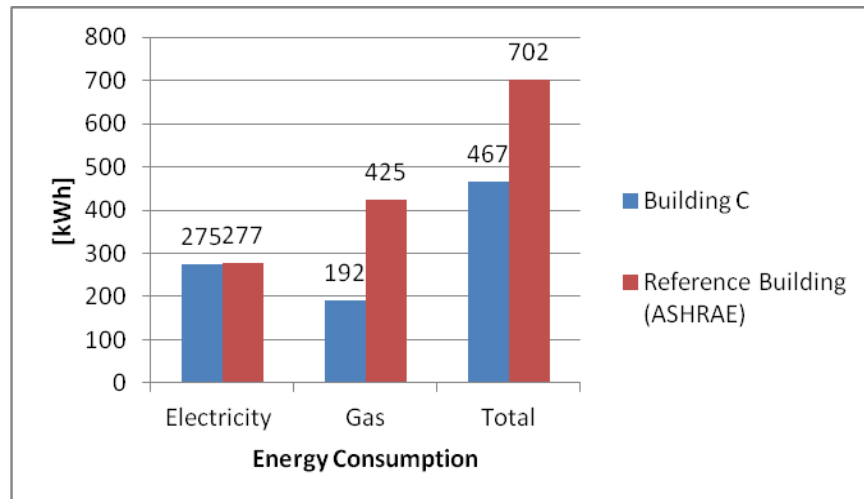
Figure 4.20. Comparison of daily energy consumption.

Last but not least, according to energy modeling which was performed according to ASHRAE 90.1-2007 Standard, it was seen that there is 26% of saving in energy consumption in the building. With current energy prices, it means a saving of 12,000 \$ per year.

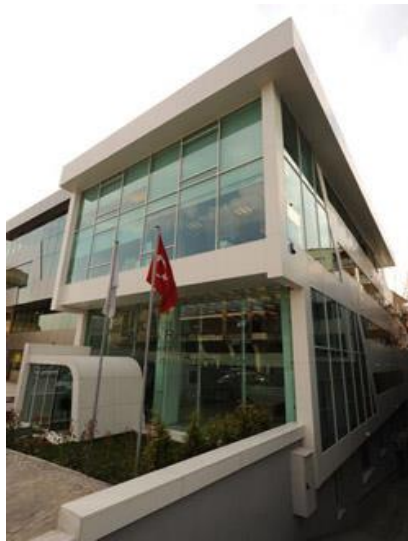
Figure 4.21. (a) Façade of Building D. (b) Meeting room after LEED.

- There is a space of 2 cm width between double glazed windows including argon gas and this provides low thermal conductivity. U value is the inverse of R value and the windows in Building D have a U value of only 1.1 which is the minimum amount existing in the market. They are also ultraviolet resistant. There is an automatic solar shading system consisting of curtains on front side of Building D. Its aim is to prevent sunlight from increasing temperature in the building especially in the mornings.
